# Southwest Museum Rehabilitation Study

Phase I Planning

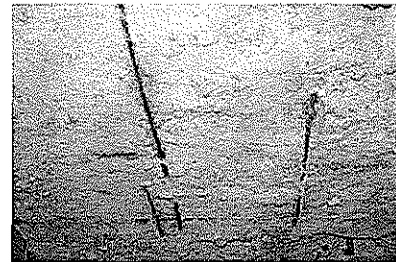
The historic buildings of the Southwest Museum Campus were found to be fairly sound. Exceptions are insufficient shear wall or other lateral load resistance in the east and south walls at the base of Caracol Tower and rusted reinforcing bars observed in the underside of the Museum Store slab.

S001 - Rusted reinforcing bars below museum store

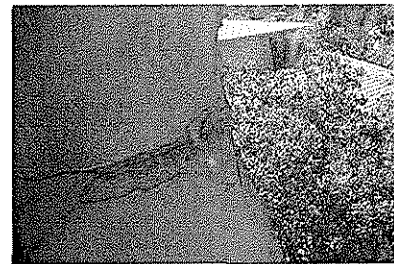
S004 - Caracol Tower - crack at window jamb

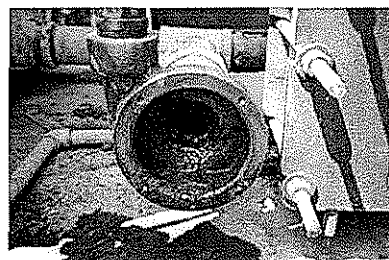
M002 - Back-up pump removed for service

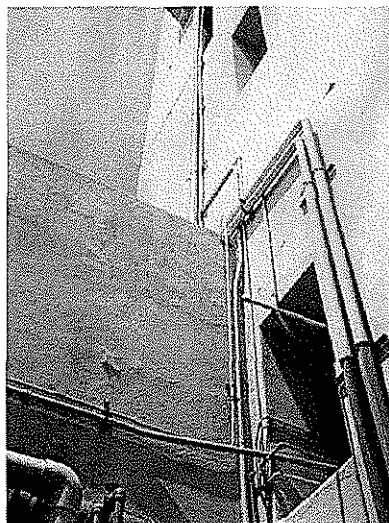
The main piping for this system consists of copper condenser water lines routing exposed up the exterior of the south side of the Caracol Tower, then in through the Tower 6th level (See photos M003 and M004) and then runs across the attic of the central structure. There is a concern this piping may leak and, as it runs above exhibits could damage artifacts.

M003 - Piping from condenser; south face of Caracol Tower

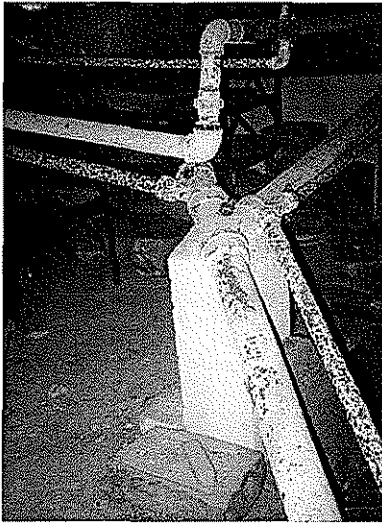
The domestic water piping is galvanized steel. Corrosion has occurred and it is recommended to re-pipe the building with copper. Problems with the site sewer lines have required several repairs.

PO01 - Corroded galvanized steel water pipe

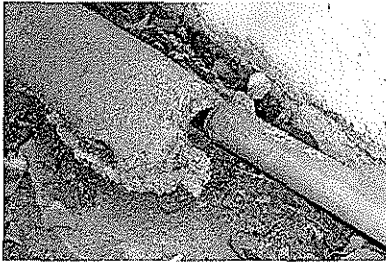
**E004** - Exterior power conduit exposed to moisture

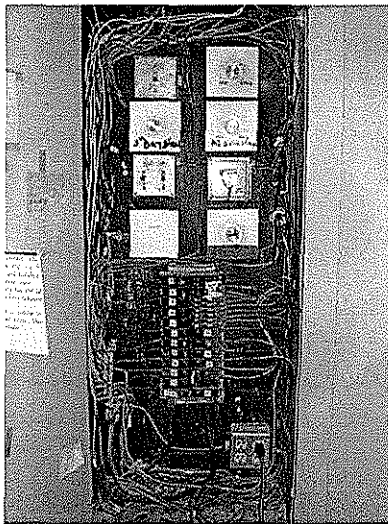
**E005** - Sprague Hall panel showing multiple code violations

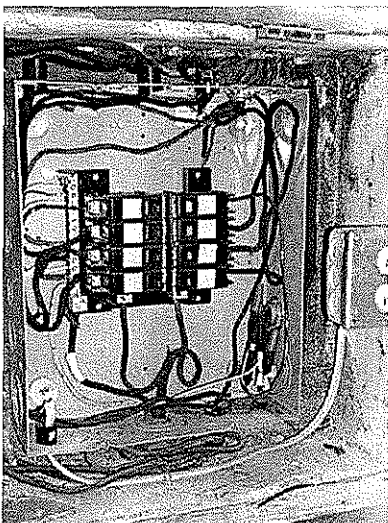
**E007** - Torrance Tower panel showing multiple code violations

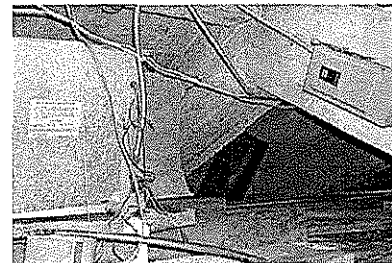
E009 - Main Building attic, illegal wiring conditions

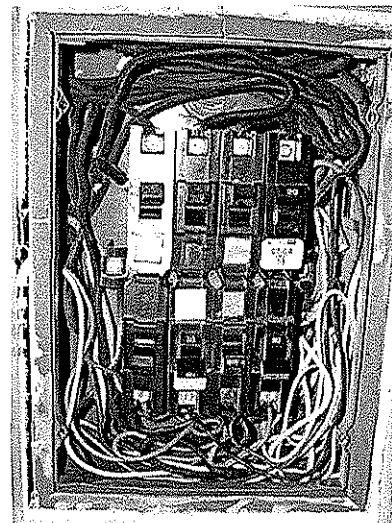
E010 - Administration area panel showing multiple code violations

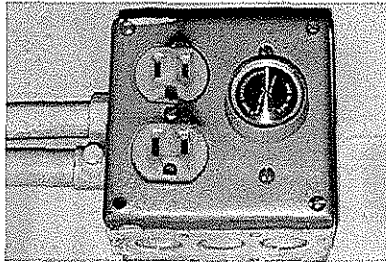
**E011** - Administration area; receptacle showing burn marks

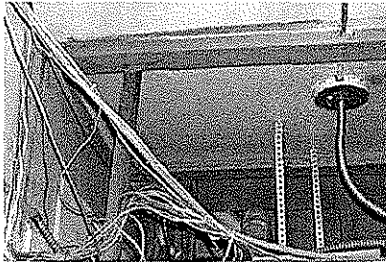
**E012** - Administration area; exposed, illegal wiring condition

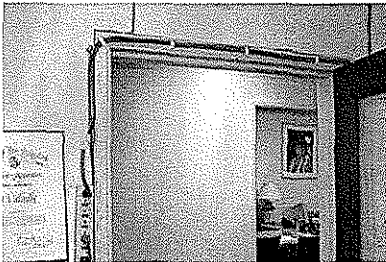
**E013** - Administration area; extension cord used for permanent wiring

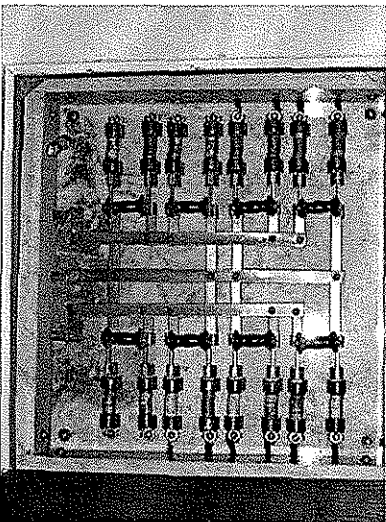
**E014** - Caracol Tower marble panel showing multiple code violations

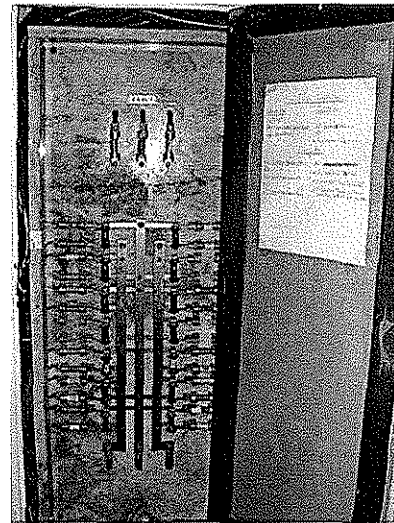
E016 - Plains Hall- marble panel showing multiple code violations

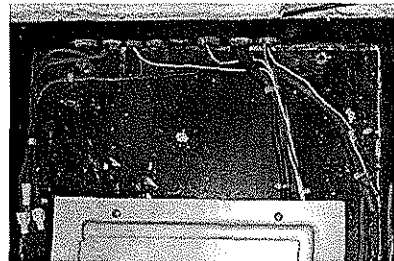
E017 - Upper Southwest Hall panel showing multiple code violations

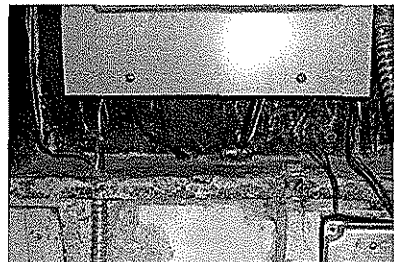
E018 - Bottom of Upper Southwest Hall panel showing illegal switch in panel cavity

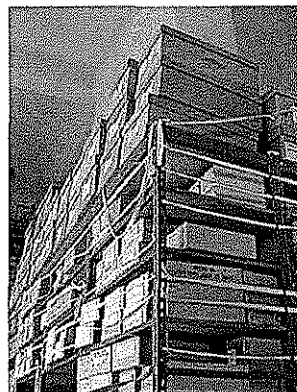
LS003 - High-piled storage in Caracol Tower
