# Appendix B

## **Tree Report**

**Subject:** Tree Evaluation Report for the 1111 South Hill Street Project Site, City of Los Angeles, California

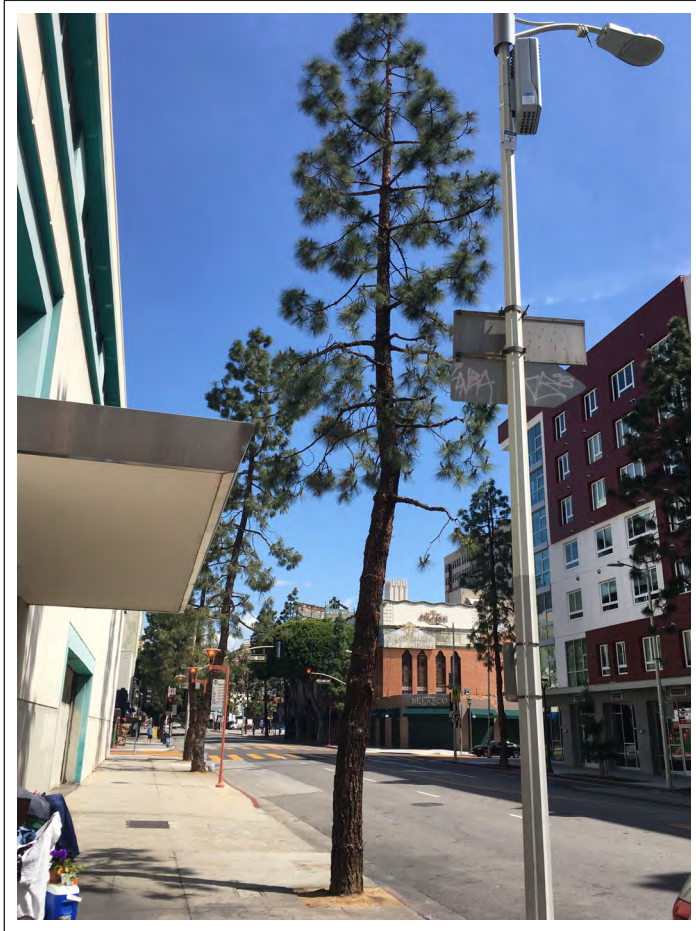
| Tree Number | Tree Species | dbh (in) | Tree Height (ft) | Canopy Width (ft) | Health Rating* | Aesthetic Rating* | To Be Removed | Protect in Place |
|---|---|---|---|---|---|---|---|---|
| 1 | Canary Island pine<br><i>Pinus canariensis</i> | 15.7 | 25 | 15 | 4 | 3 | X | |

March 28, 2020. Overview of Tree 1. Canary Island pine (*Pinus canariensis*).

Project development will require the removal of tree number 1, a Canary Island Pine. The other existing street trees will remain in place and be incorporated into the building's ground floor design. To compensate for the removal of the Canary Island Pine, 2 replacement trees will be planted along South Hill Street.

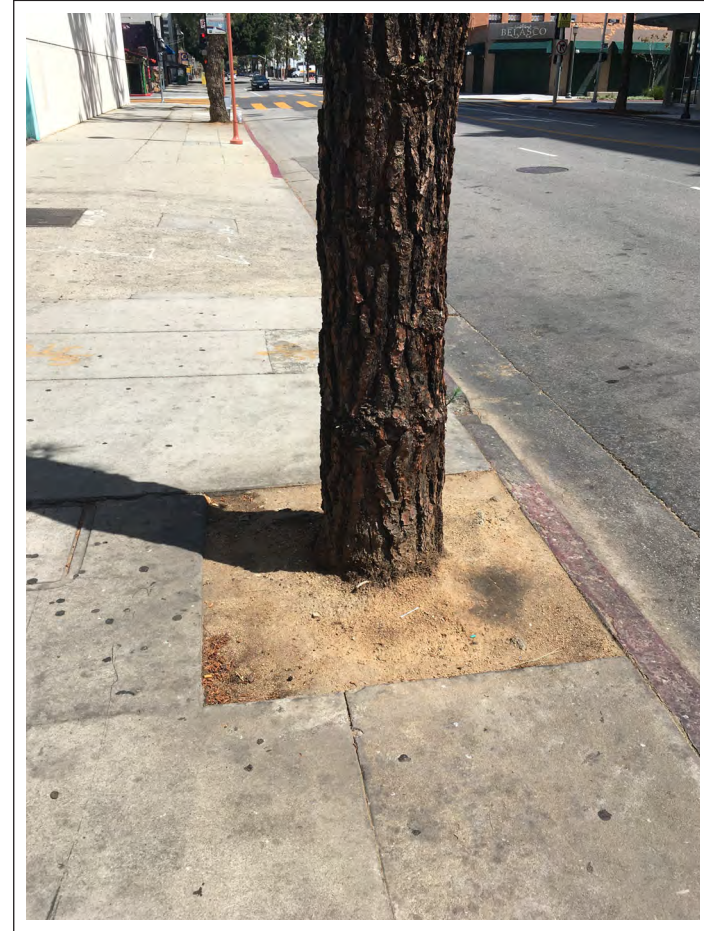
March 28, 2020. View of base of Tree 1. Tree is not causing any damage to sidewalk or curb.

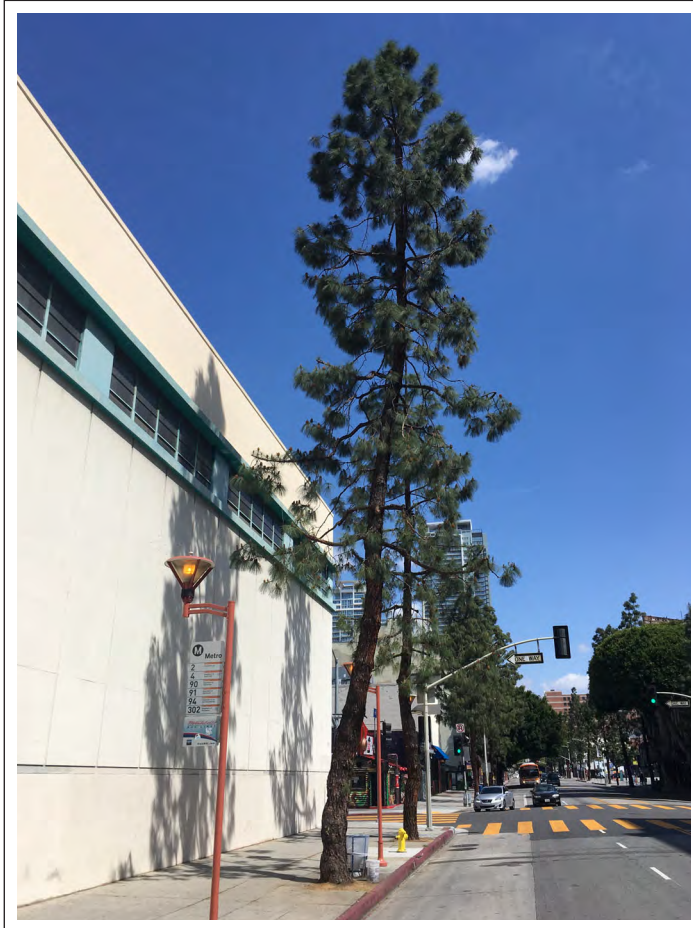
| Tree Number | Tree Species | dbh (in) | Tree Height (ft) | Canopy Width (ft) | Health Rating* | Aesthetic Rating* | To Be Removed | Protect in Place |
|---|---|---|---|---|---|---|---|---|
| 2 | Canary Island pine<br><i>Pinus canariensis</i> | 19.6 | 40 | 20 | 4 | 3 | | X |

March 28, 2020. Overview of Tree 2. Canary Island pine (*Pinus canariensis*).

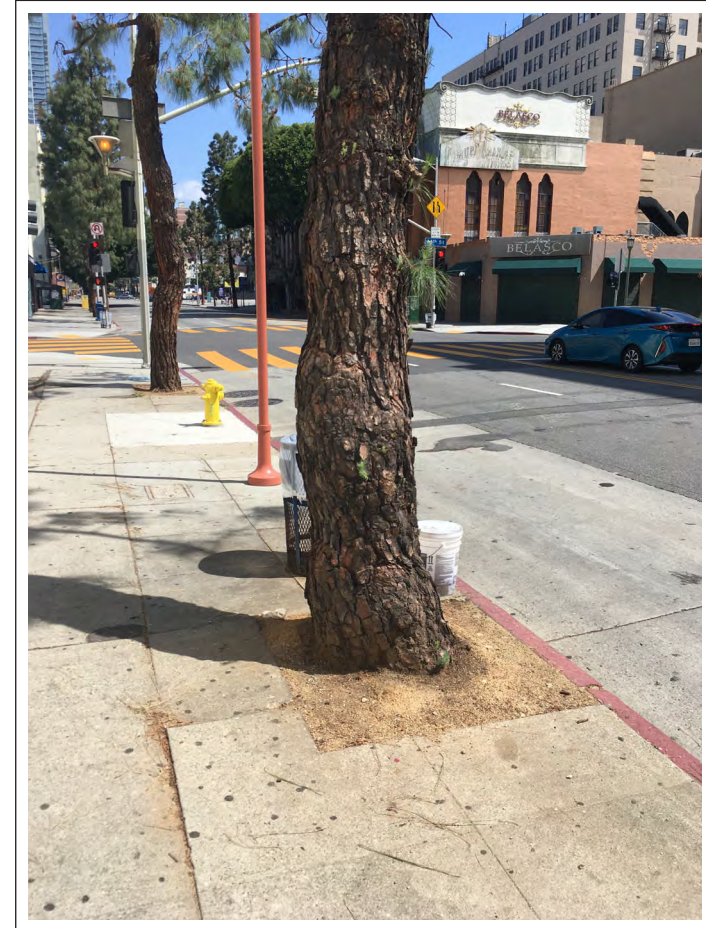
March 28, 2020. View of base of Tree 2. Tree is not causing any damage to sidewalk or curb.

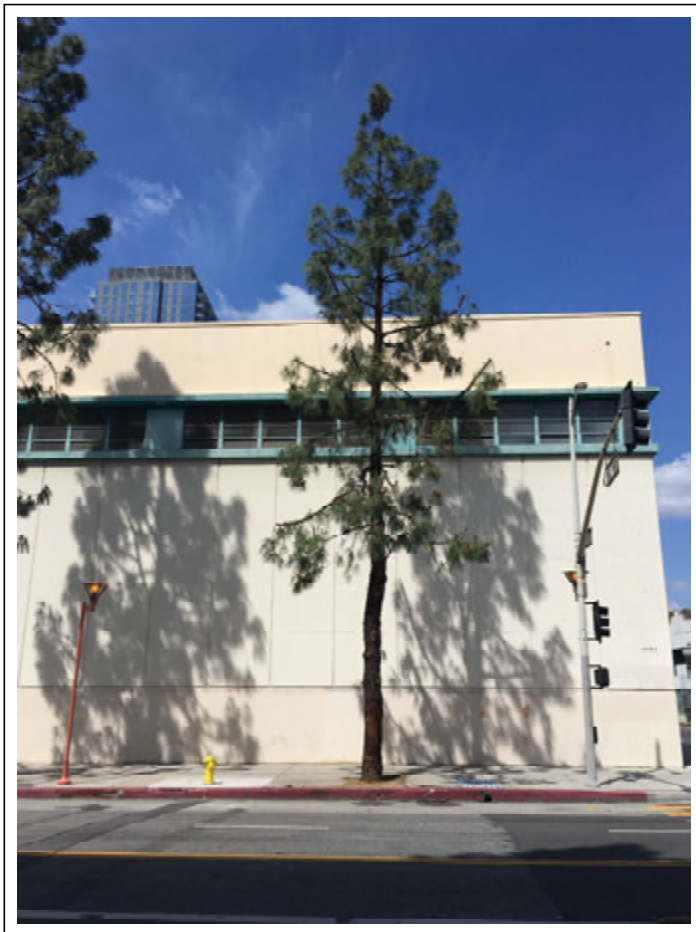
| Tree Number | Tree Species | dbh (in) | Tree Height (ft) | Canopy Width (ft) | Health Rating* | Aesthetic Rating* | To Be Removed | Protect in Place |
|---|---|---|---|---|---|---|---|---|
| 3 | Canary Island pine<br><i>Pinus canariensis</i> | 17.2 | 40 | 20 | 4 | 3 | | X |

March 28, 2020. Overview of Tree 3. Canary Island pine (*Pinus canariensis*).

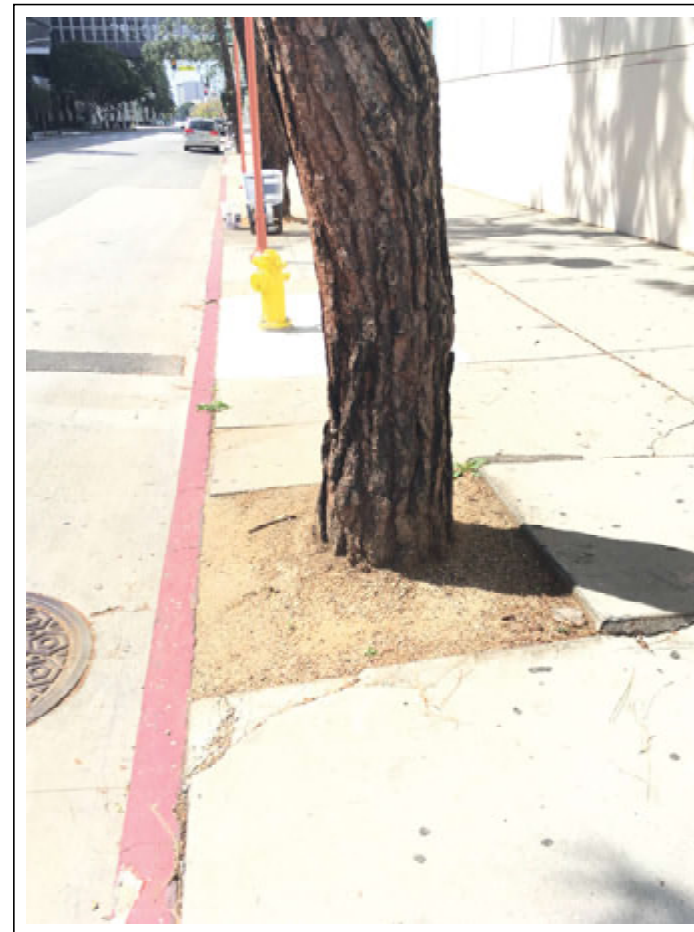
March 28, 2020. View of base of Tree 3. Tree roots have caused approximately two inches of vertical displacement to adjacent sidewalk.

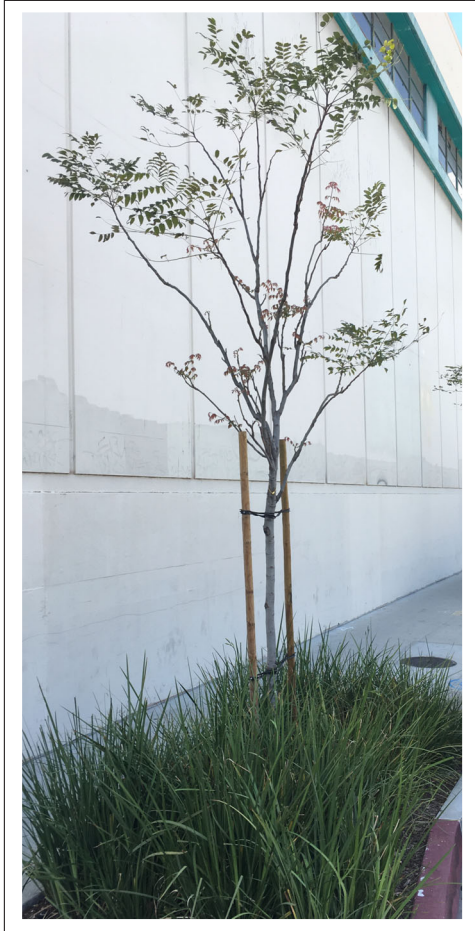
| Tree Number | Tree Species | dbh (in) | Tree Height (ft) | Canopy Width (ft) | Health Rating* | Aesthetic Rating* | To Be Removed | Protect in Place |
|---|---|---|---|---|---|---|---|---|
| 4 | Chinese flame tree<br><i>Koelreuteria bipinnata</i> | 2.2 | 12 | 8 | 3 | 2 | | X |

Overview of Tree 4. Chinese flame tree (*Koelrueteria bipinnata*).

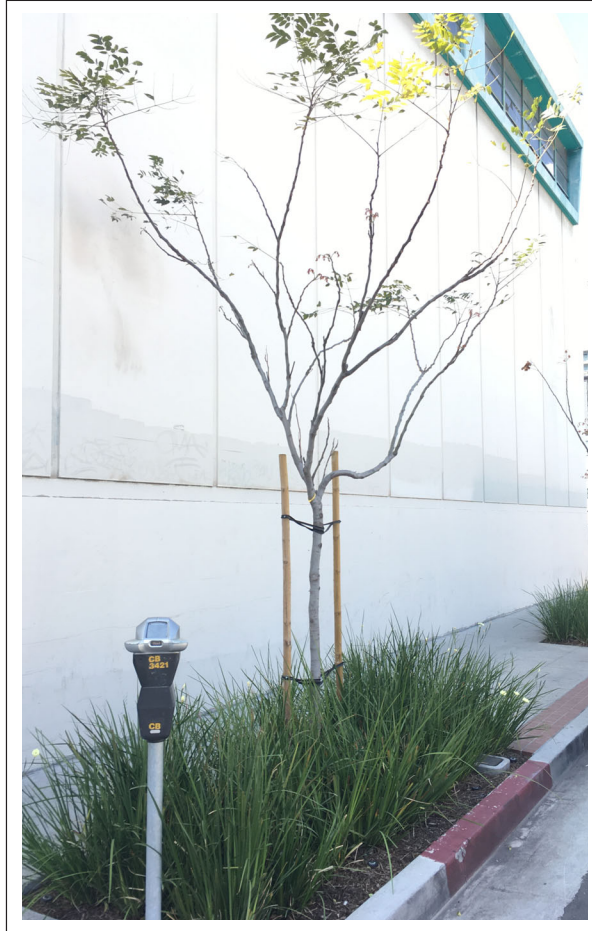
| Tree Number | Tree Species | dbh (in) | Tree Height (ft) | Canopy Width (ft) | Health Rating* | Aesthetic Rating* | To Be Removed | Protect in Place |
|---|---|---|---|---|---|---|---|---|
| 5 | Chinese flame tree<br><i>Koelreuteria bipinnata</i> | 2.5 | 12 | 8 | 3 | 2 | | X |

Overview of Tree 5. Chinese flame tree (*Koelrueteria bipinnata*).

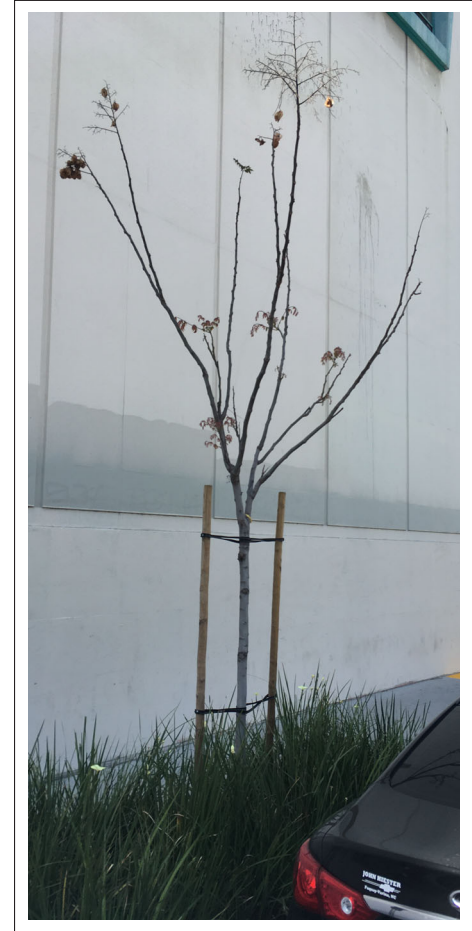
| Tree Number | Tree Species | dbh (in) | Tree Height (ft) | Canopy Width (ft) | Health Rating* | Aesthetic Rating* | To Be Removed | Protect in Place |
|---|---|---|---|---|---|---|---|---|
| 6 | Chinese flame tree<br><i>Koelreuteria bipinnata</i> | 2.3 | 12 | 6 | 2 | 2 | | X |

Overview of Tree 6. Chinese flame tree (*Koelrueteria bipinnata*).

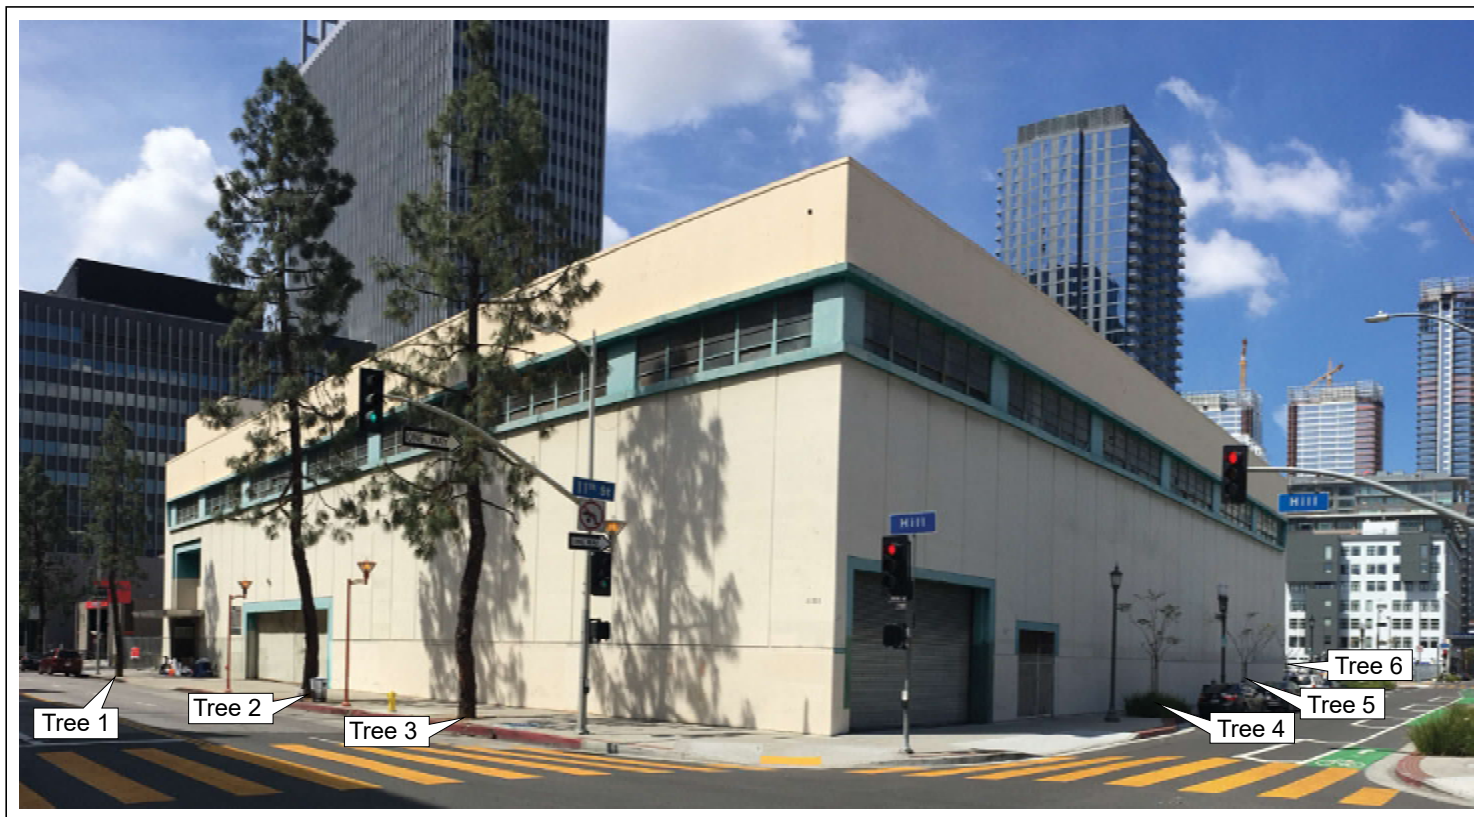
March 28, 2020. Overview of project site conditions, facing southwest.
