# Street Tree Report

For: 1911-1931 Sunset Blvd, Echo Park, CA

*Prepared by:* Greg Applegate, RCA #365  
Arborgate Consulting, Inc.  
1131 Lucinda Way  
Tustin, CA 92780  
714/ 731-6240

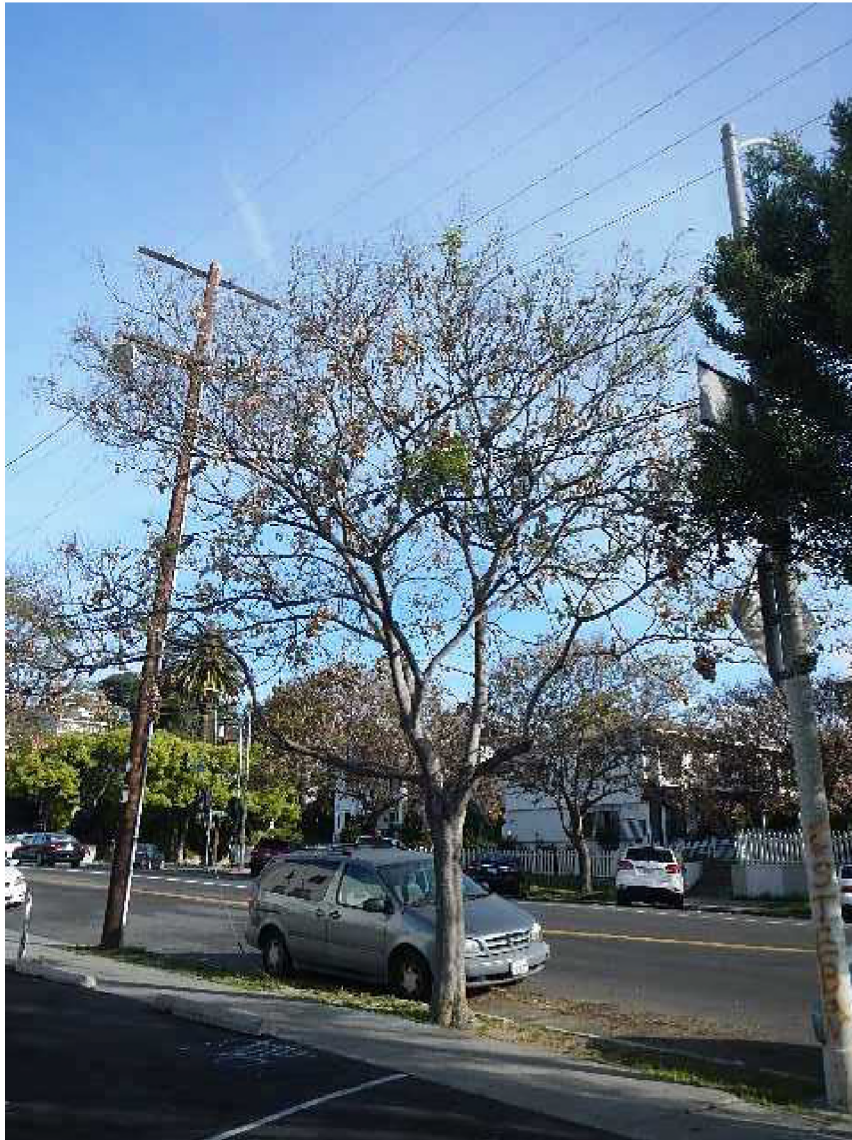
Tree #34, a golden rain tree

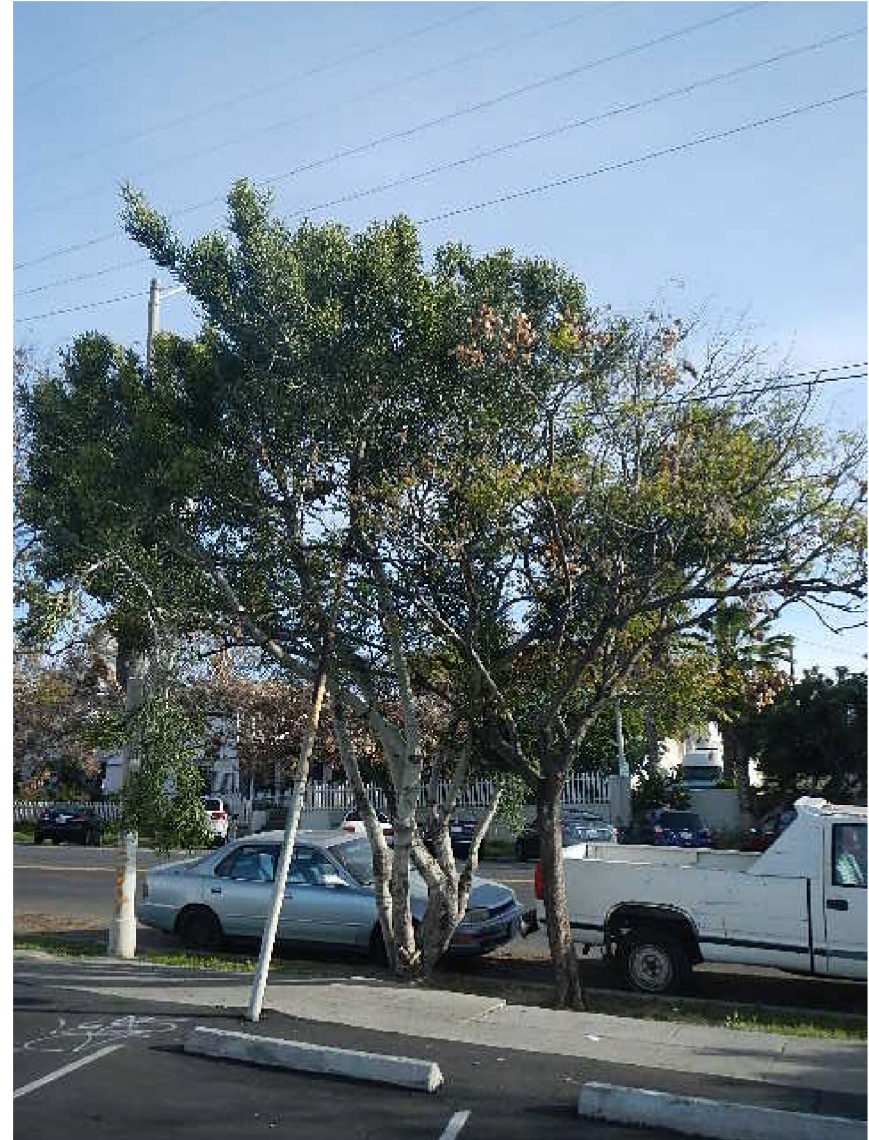
Trees #35 and 36, a pencil tree and a Chinese flame tree.

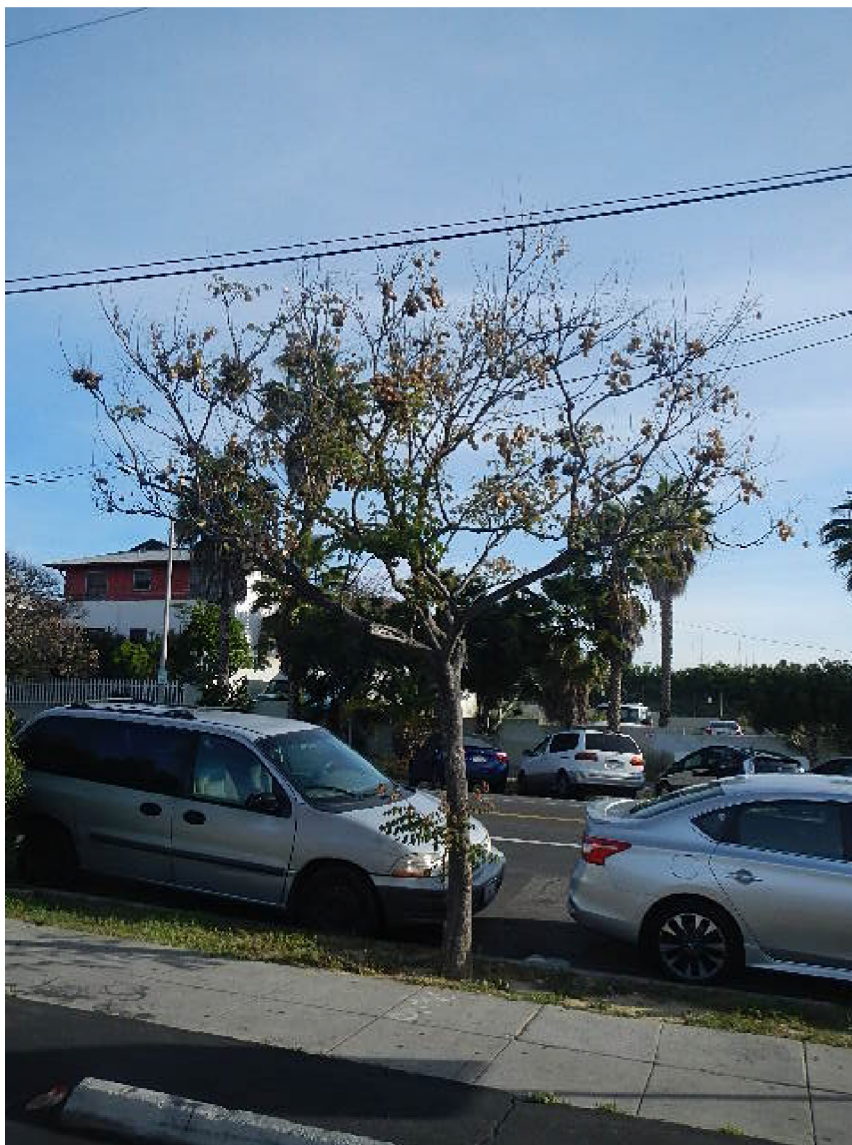
Tree #37, a Chinese flame tree

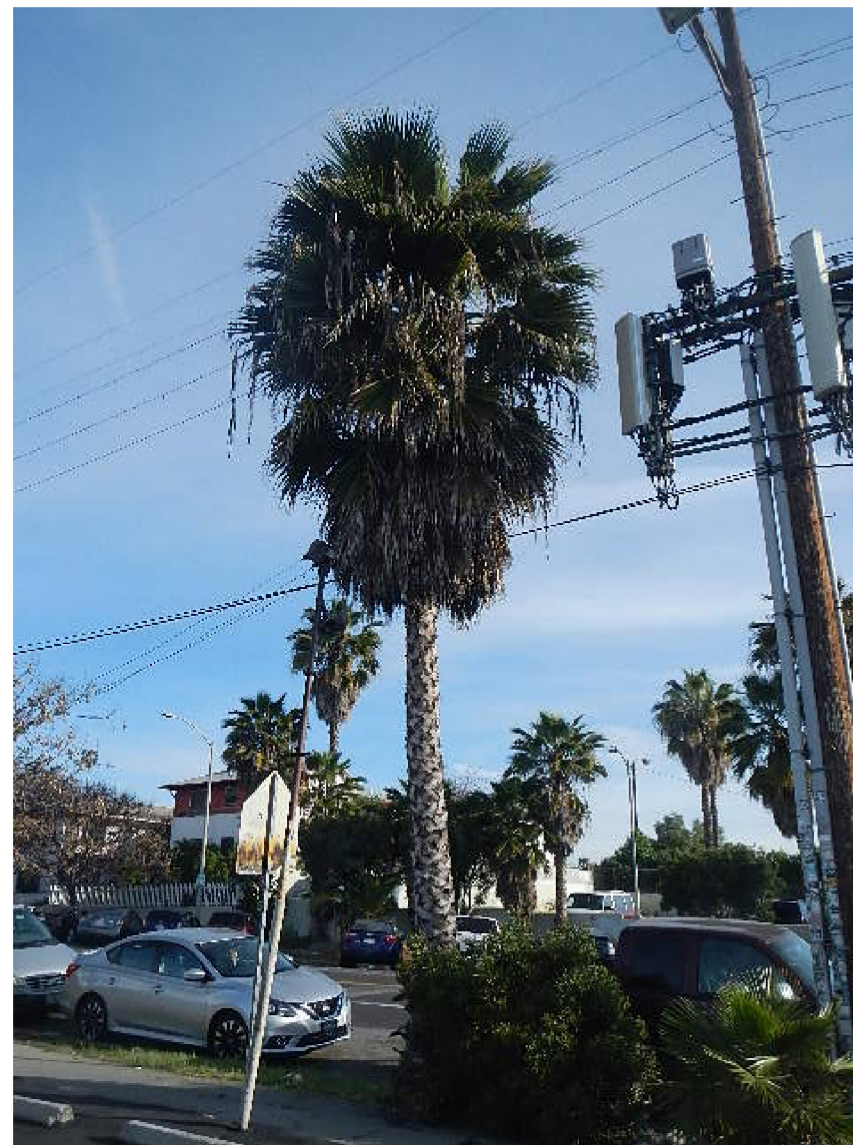
Palm tree #38, a Mexican fan palm.

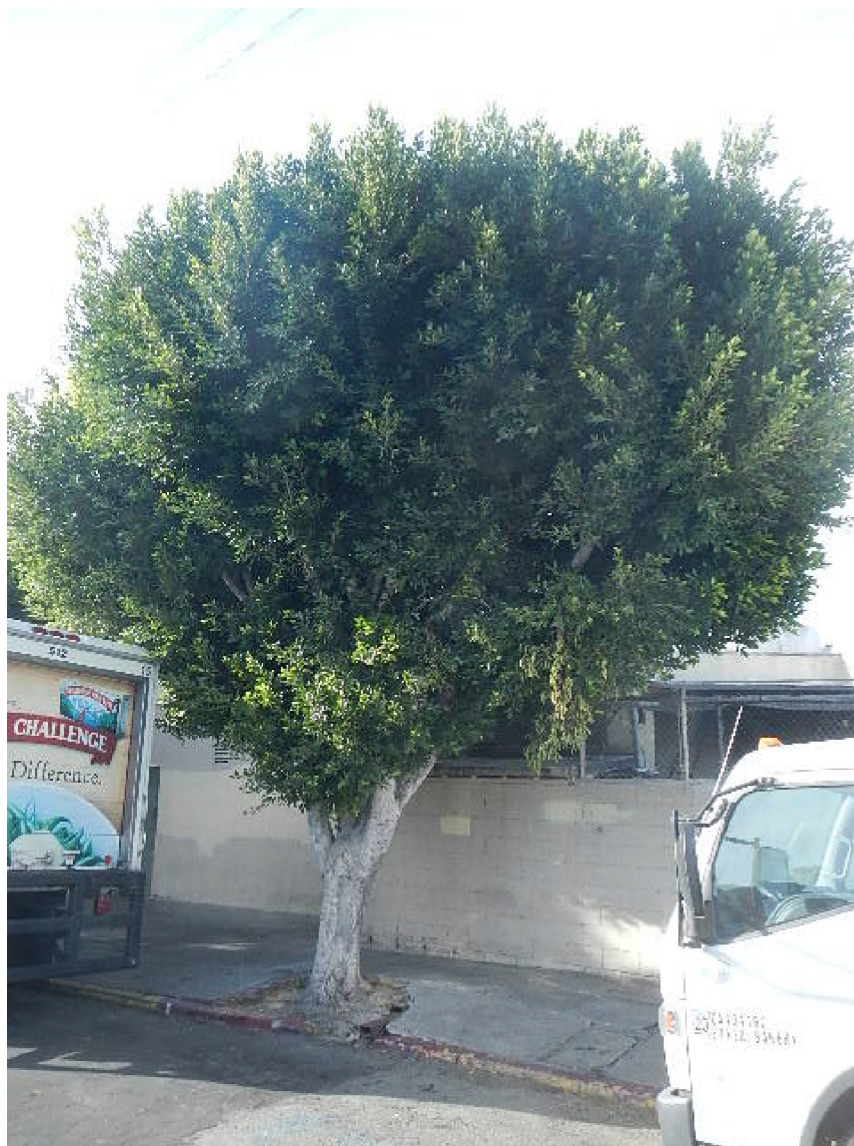
Tree #39, an Indian laurel

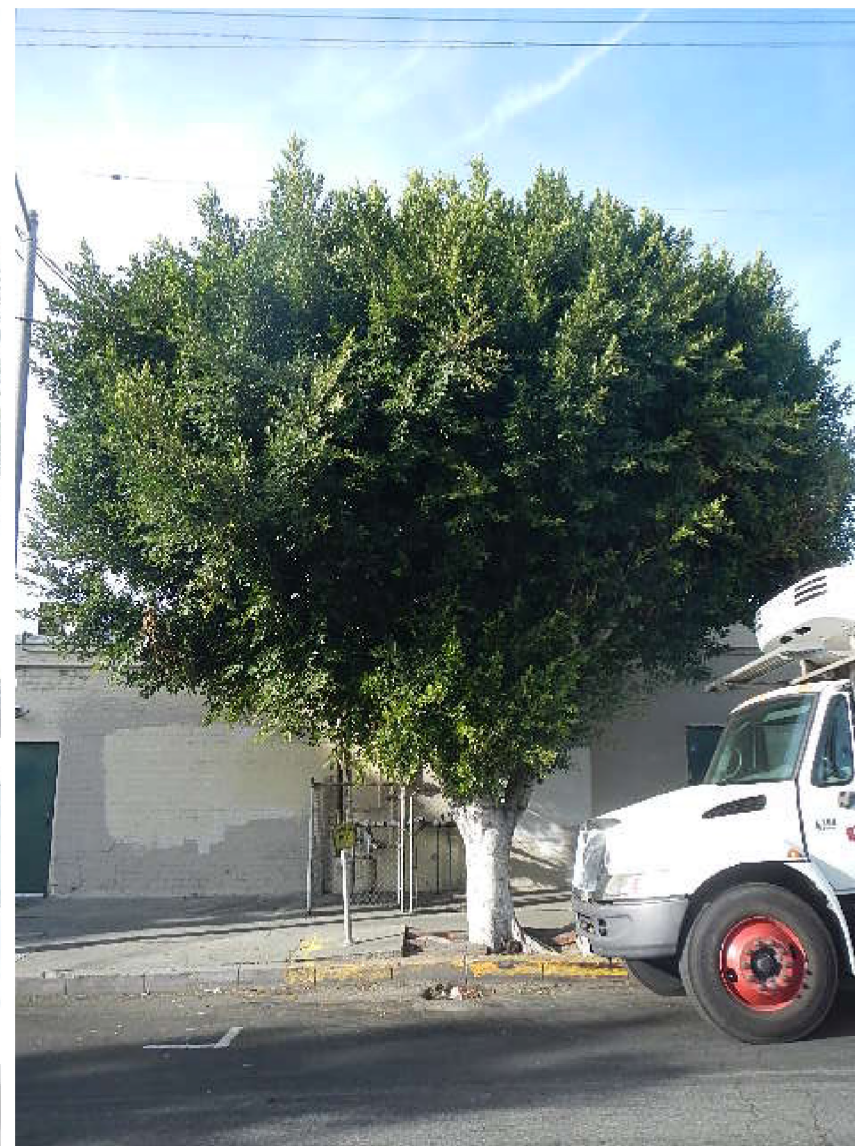
Tree #40, an Indian laurel

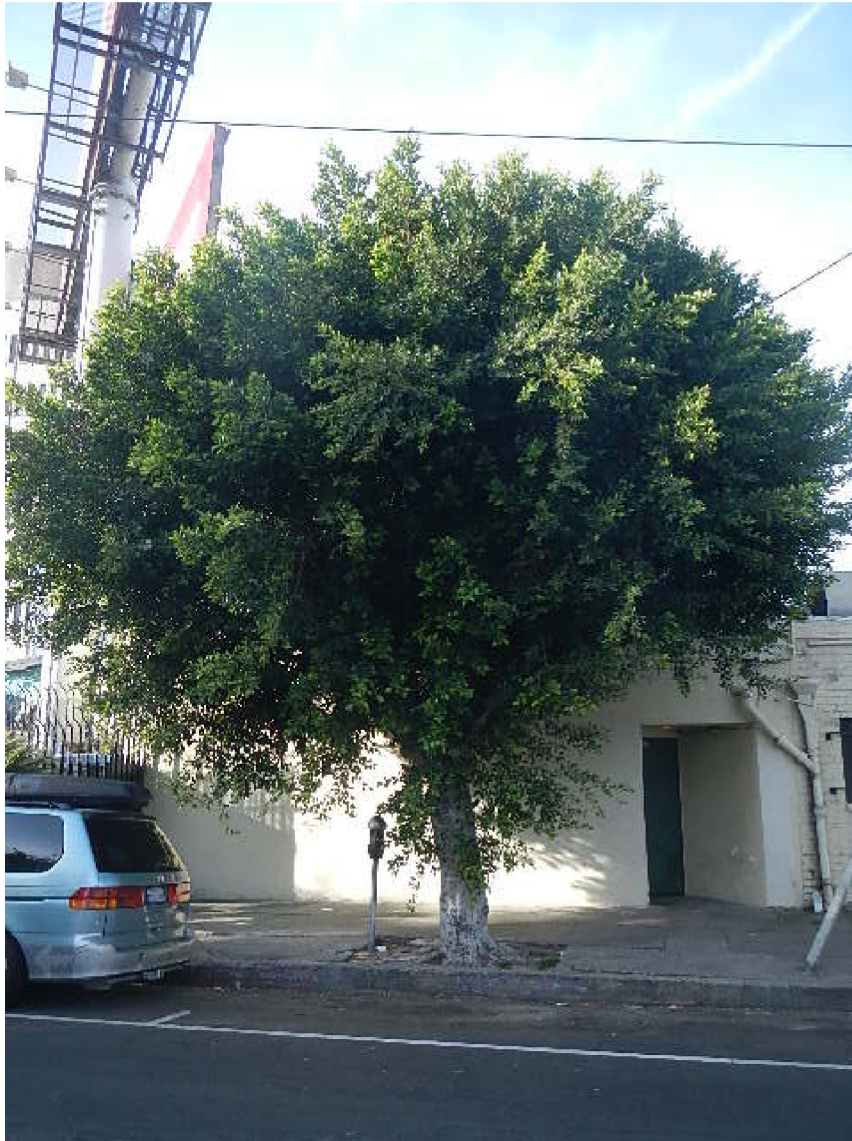
Tree #41, an Indian laurel

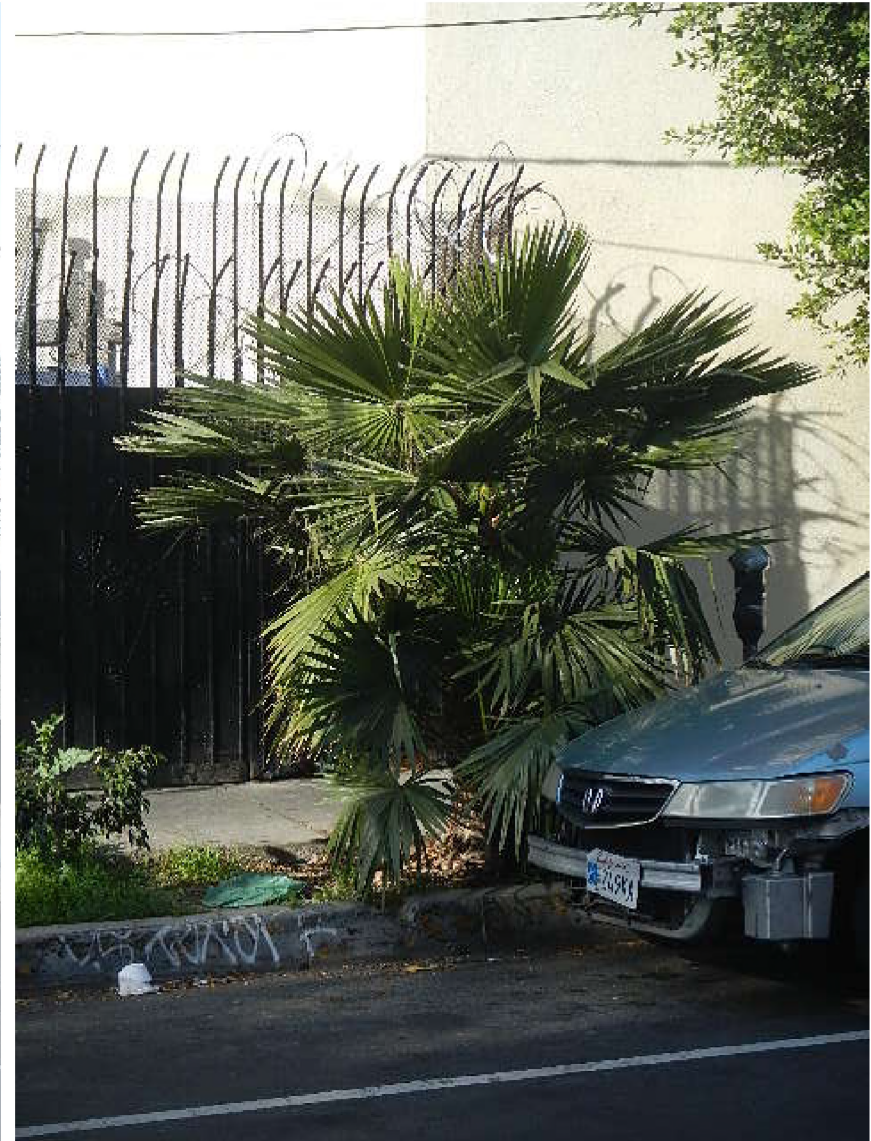
Palm tree #42, a Mexcan fan palm.

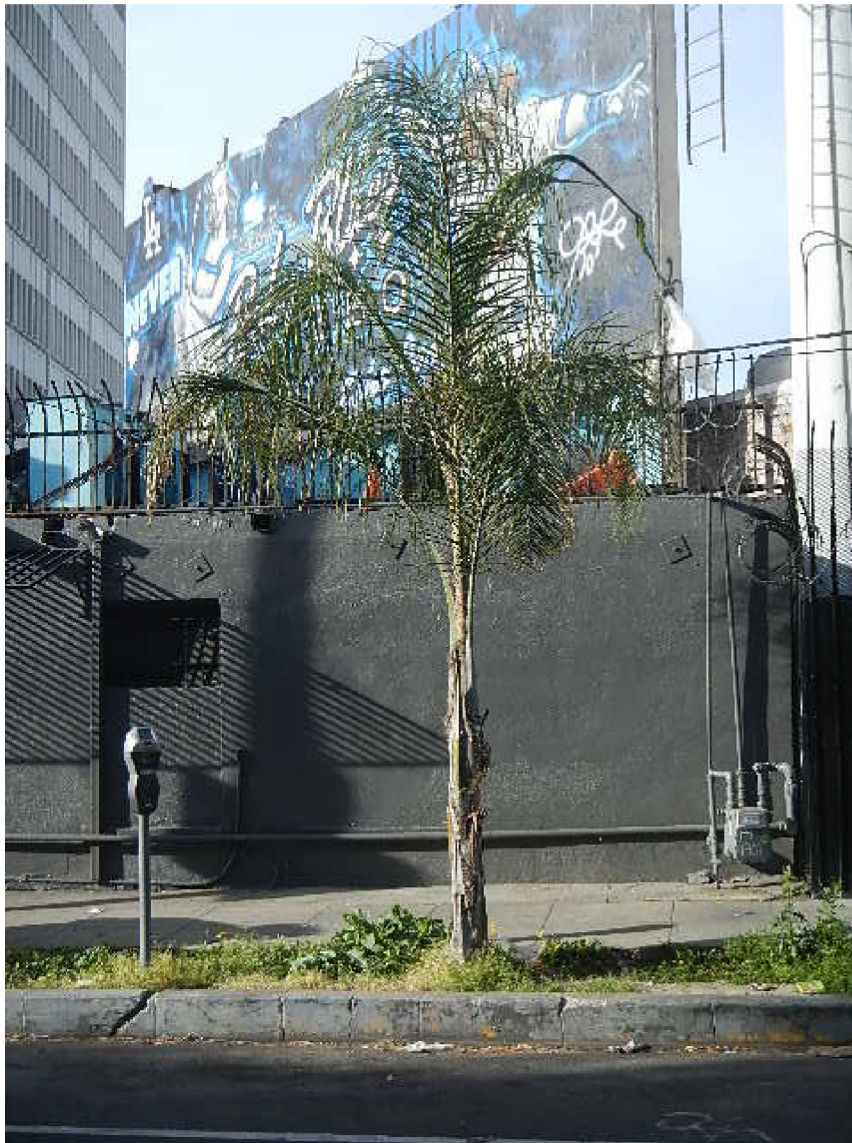
Palm tree #43, a queen palm

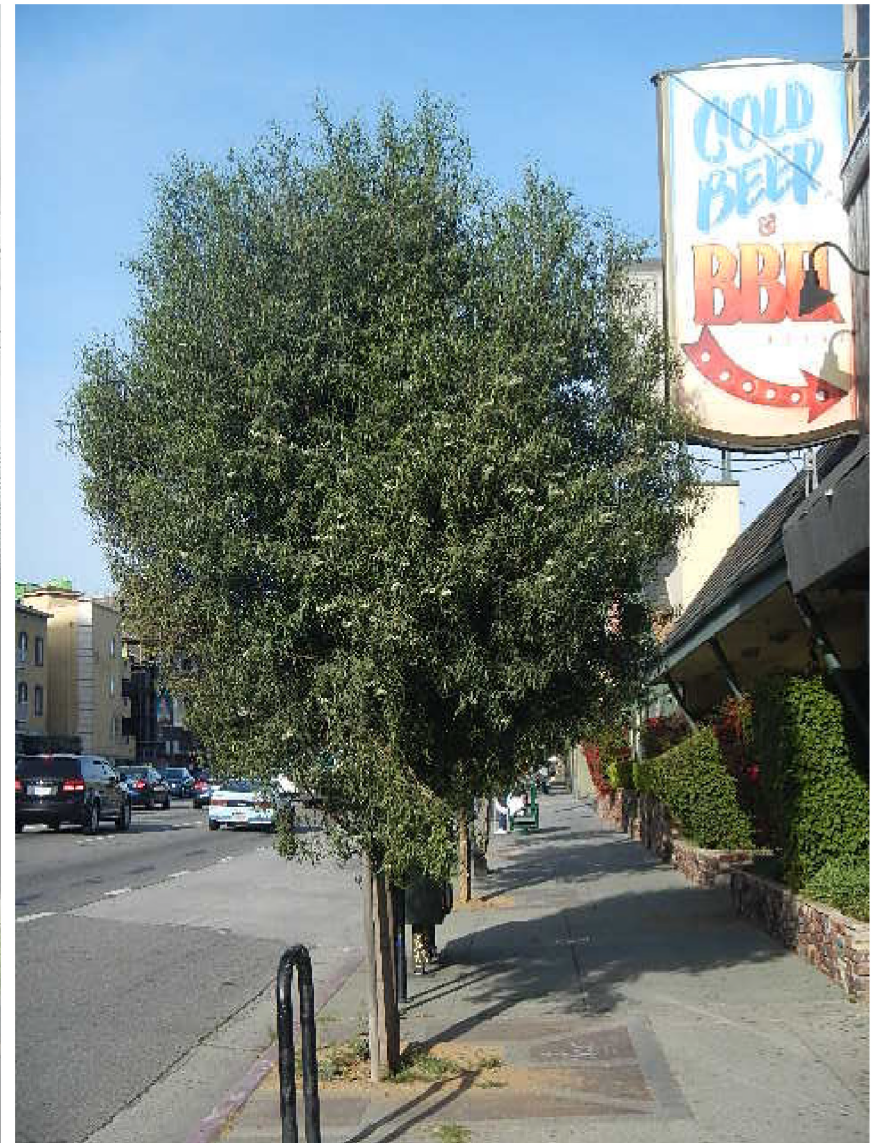
Tree #44, an Australian willow.

1. Remove the existing trees on Reservoir.
2. Get permits to remove the Australian willows on Sunset. These trees will be within the construction site and impact the ability to build the building to the property line as planned. Scaffold, man-lifts, and other equipment will utilize the sidewalk
3. After construction replace the bare Tabebuia on Sunset.
4. Plant any essential mitigation trees in the largest planting space available, or preferably pay into the City's tree fund.
5. If street trees are required along Reservoir, choose them carefully and consider the overhead wires and shade patterns of the building.

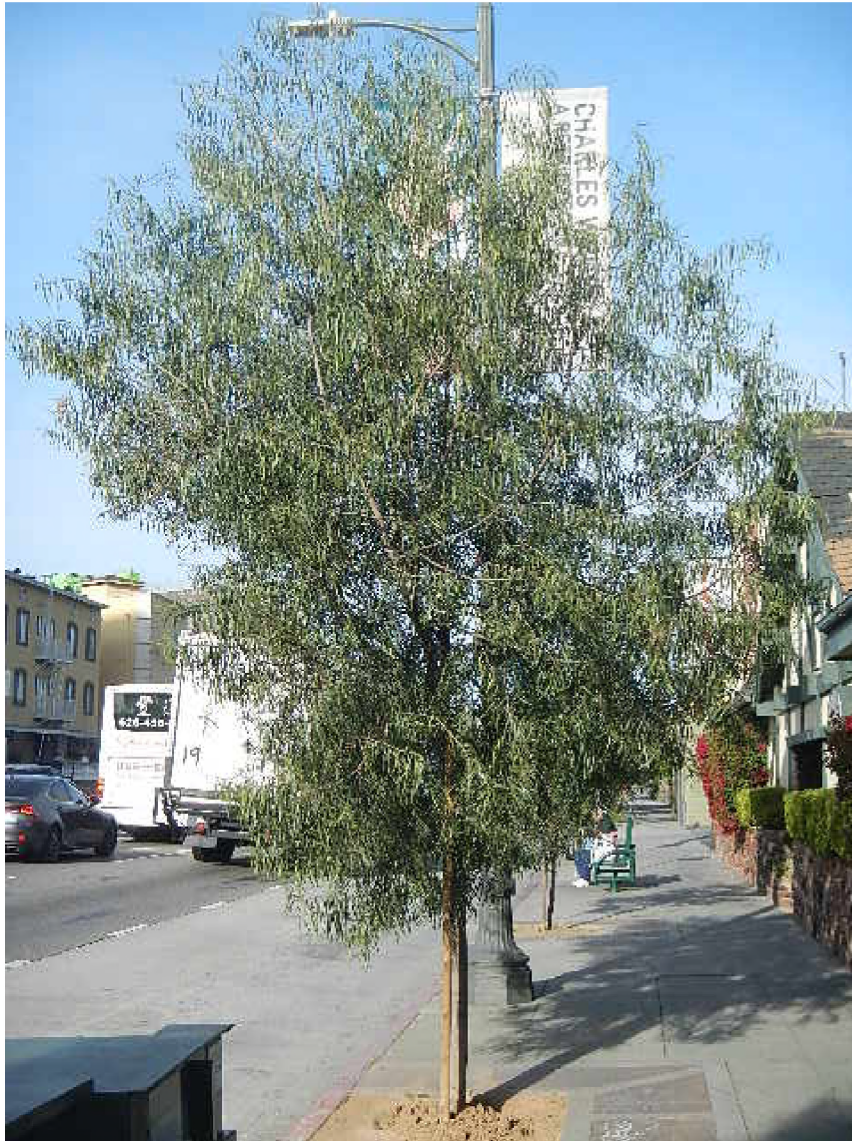
Tree #45, an Australian willow.

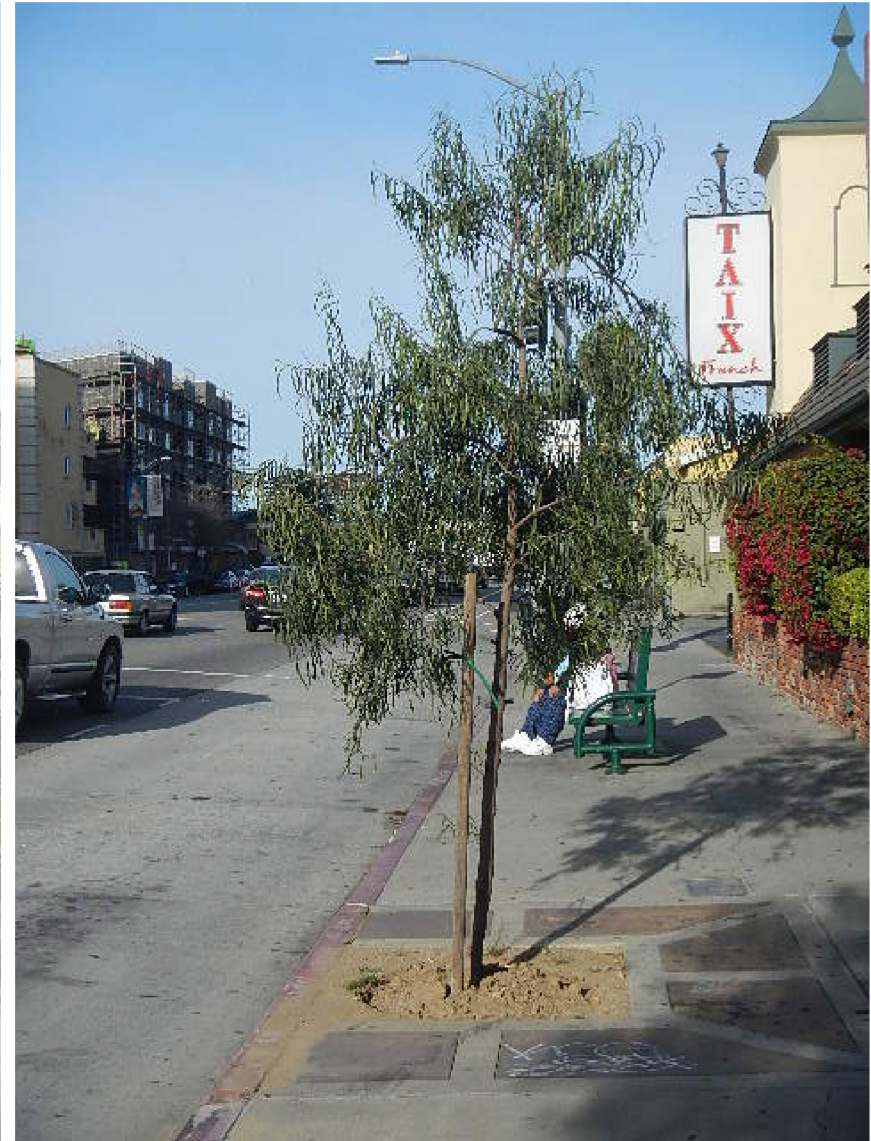
Tree #46, an Australian willow.

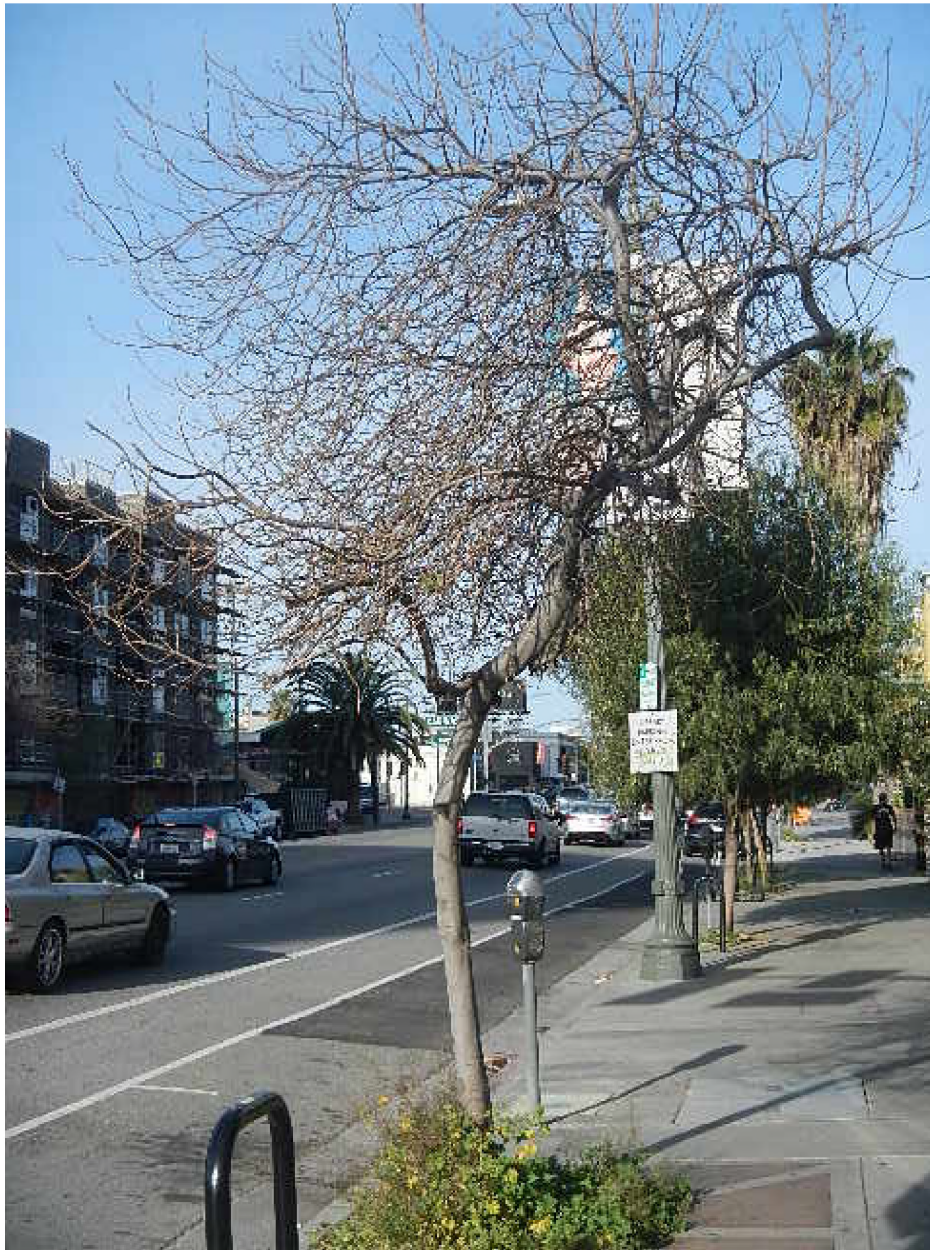
The four street trees along Sunset are three recently planted *Geijera parviflora* and one *Tabebuia avellanedae*, but they are in new, well-finished 4x4-foot cutouts. The Australian willows are drought tolerant and all appeared healthy or in excellent health, even though they were crowded in little 4-foot square cutouts. As long as they have good percolation, they are a hardy species, with few pest problems. The *Tabebuia* is bare, but this is not the season to be bare, but it is not dead. There are no

symptoms of disease or pests. The City may want this replaced. The older Mexican fan palm was healthy, except for the small one that was suppressed under a larger adjoining Ficus tree. There were no clear disease symptoms or pest issues.

Tree #47, a pink trumpet tree
