**Tree Inventory and Evaluation**

Consulting Arborist's Report

# Tree Inventory & Evaluation

For: 5001 Wilshire Boulevard

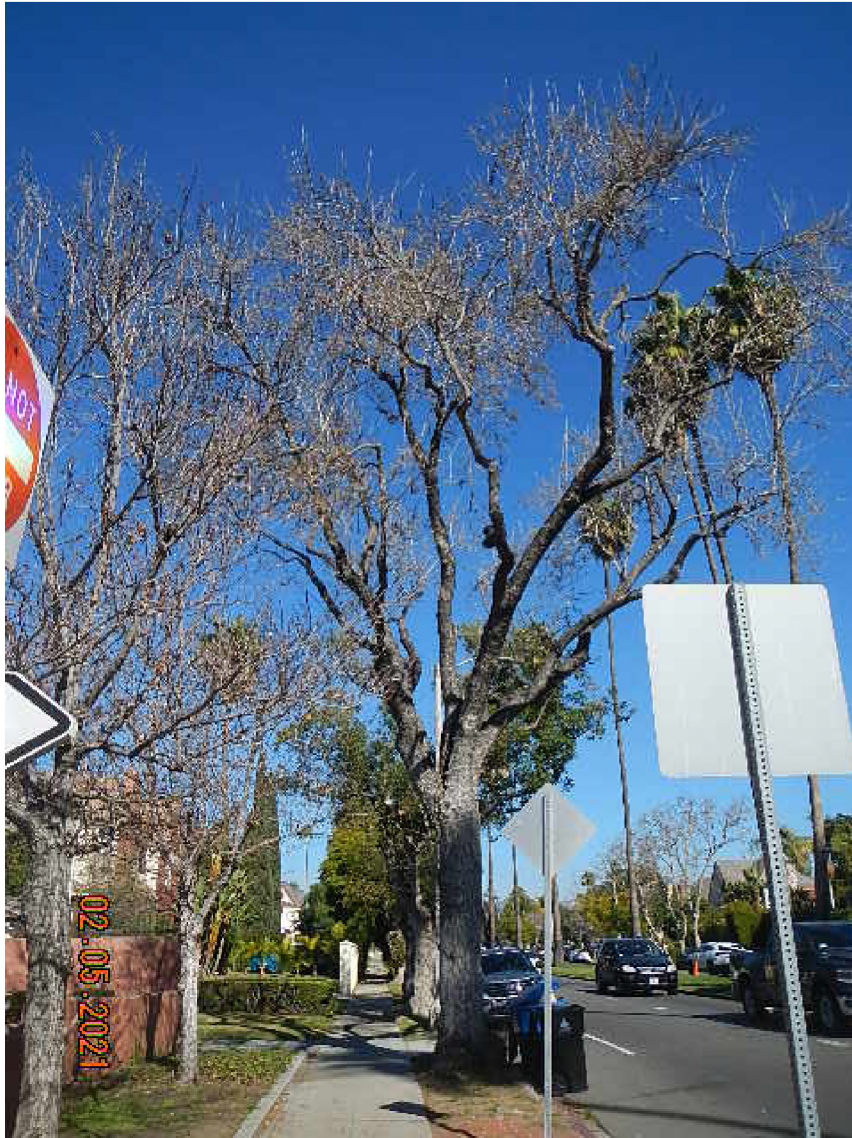
The numbering of the trees begins with the #1 Arizona ash street tree and moves westward across the north edge of the site. There is only one street tree, and it is on Highland. It is in a 4.5' wide parkway. Street trees on the rest of the block are of different genera. Camphors and jacarandas are more common street trees on this section of Highland. Arizona ash is not a common street tree in southern California, and it is not listed in Street Trees Recommended for Southern California. The species and most of the genus is known for large shallow roots. This specimen has the typical large and shallow roots and is starting to lift the sidewalk. Its structure is poor, due to being codominant, with severe included bark, and then being headed and lion-tailed.

#1 Arizona ash on Highland has been lion-tailed and headed.

All site trees will be removed. Only the street tree will remain, and the City should require that it be removed and replaced as well. For these reasons no clearance recommendations are offered. It is the recommendation of this consultant that the street tree be removed. It has now outgrown the space provided, and it may pose a high level of risk.

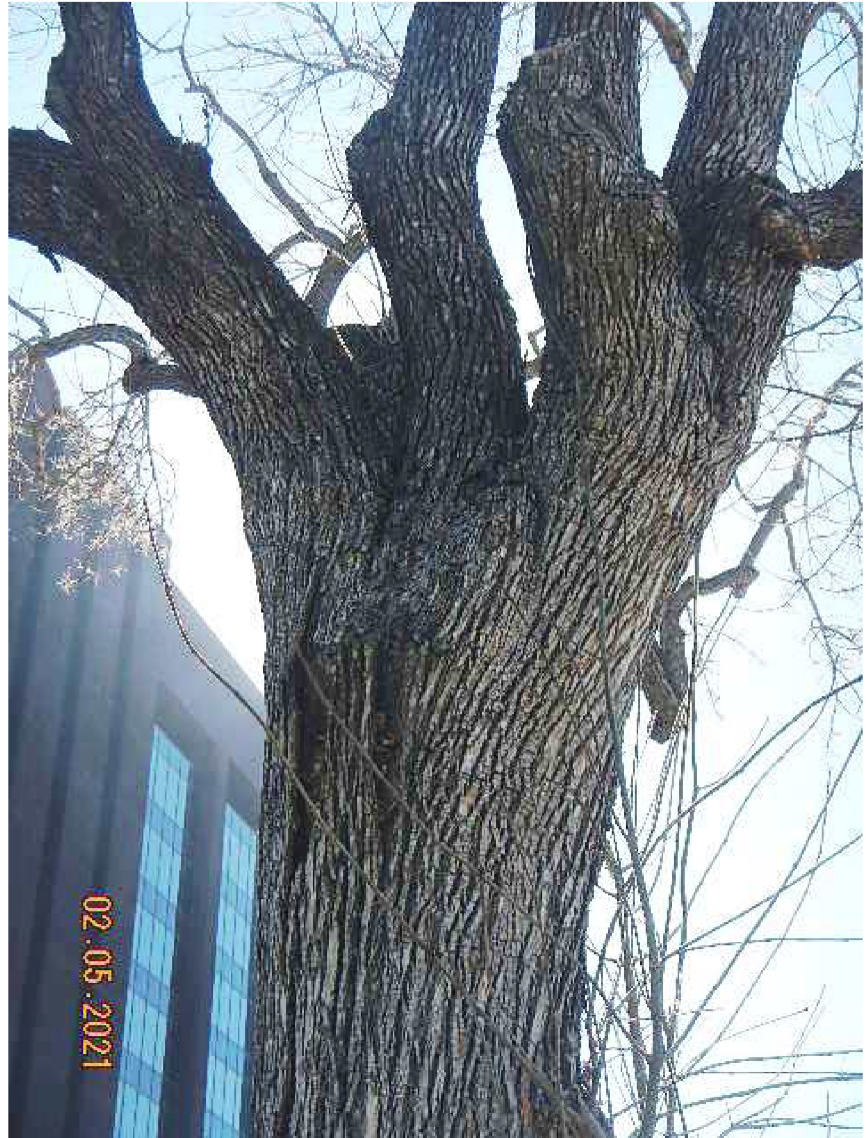
There is only one street tree, and it is on Highland. There are no adjoining street trees on the other surrounding streets. The existing street tree is in a poor state of health and structure. The street tree in this report is a large Arizona ash. The main limb structure is codominant with included bark. It has been headed back and lion-tailed. The bark on the trunk below the limbs is popping off, which is considered a serious warning of possibly imminent limb or trunk failure.

#1 Ash, note included bark and loose bark below – a warning sign

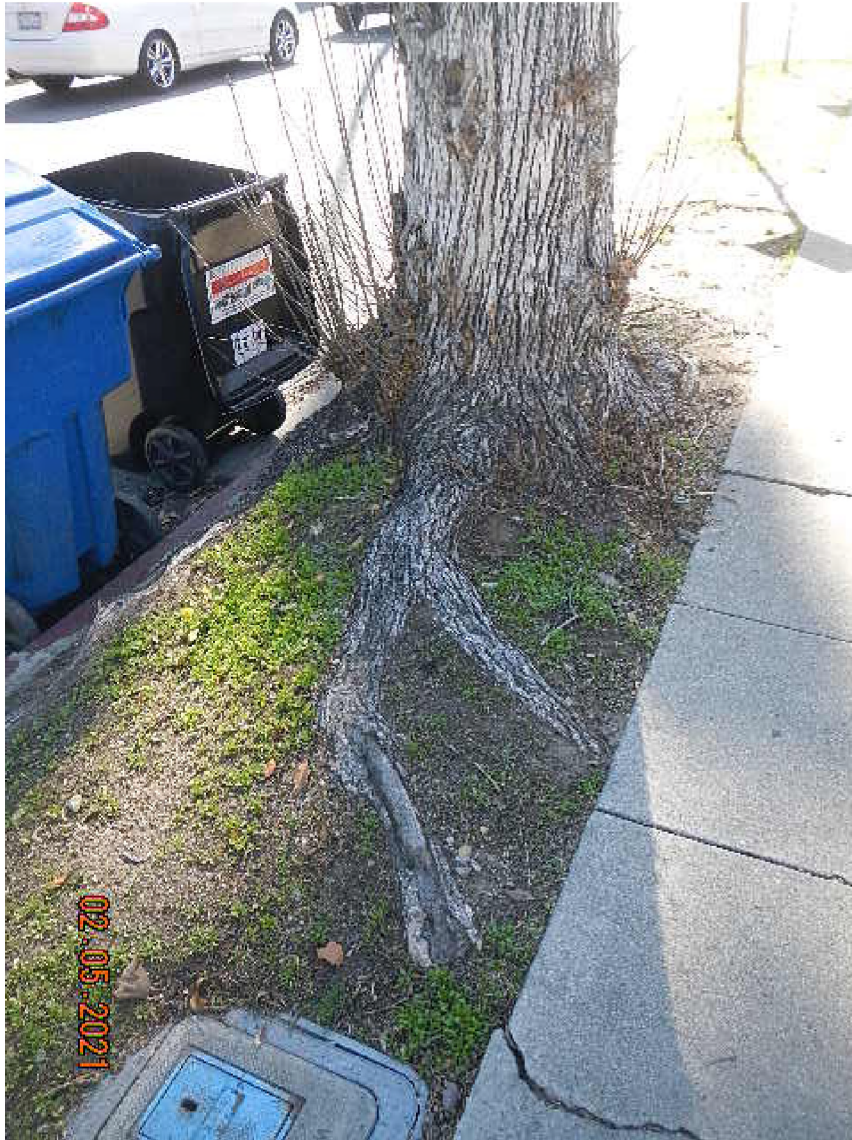
#1 Ash – note surface roots on the north side and damaged sidewalk. #1 Ash – note surface roots on south side

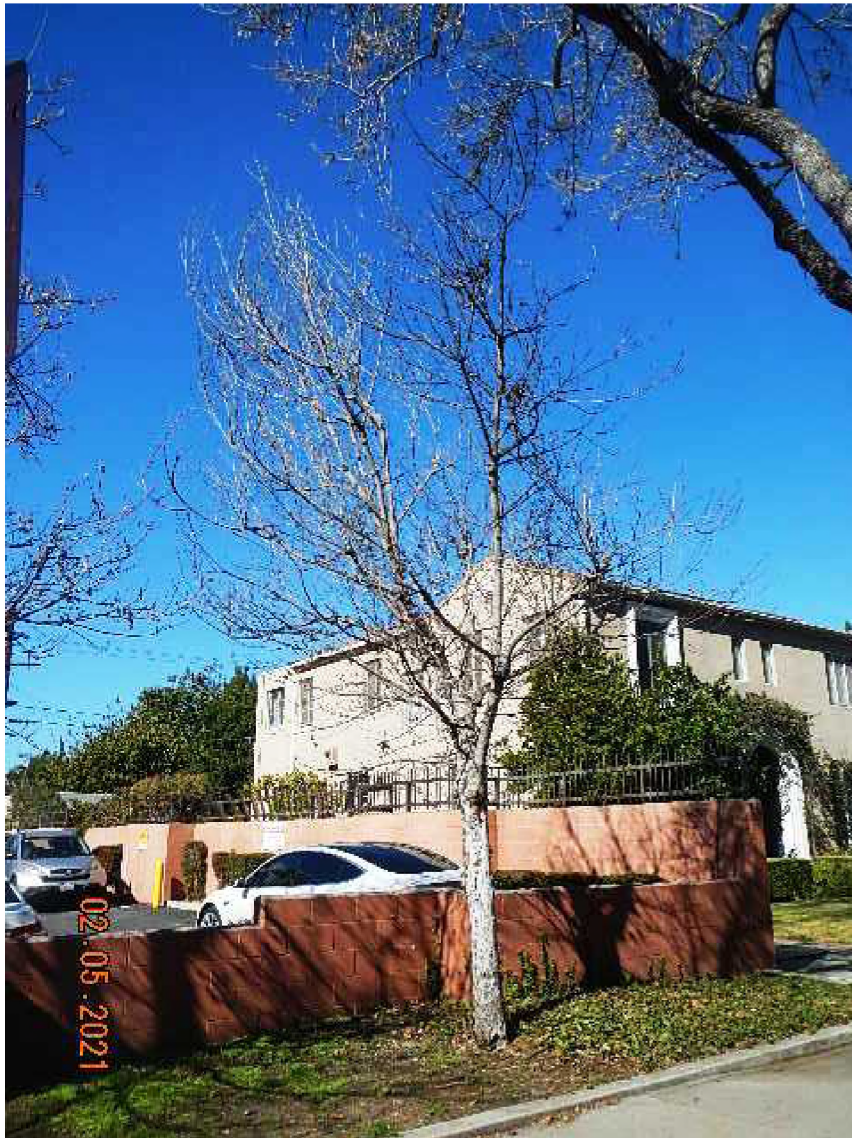
There are two silver maples (#2 &3) on the other side of the sidewalk, in a relatively small planter. The more northern tree is suppressed under the Arizona ash. Two old flush cuts are bleeding and there are many epicormic shoots, probably from over-pruning. The second maple is in front of the other in the same planter. This planter has far too little root space for even one silver maple. The second one is slightly larger, probably due to not being suppressed and having less competition with the ash tree. Silver maple is not even considered a good species in more northern climates. They are fast growing and would not survive long in this planter, even if the project was not built.

#2 Silver maple – note codominant leaders and overhead ash

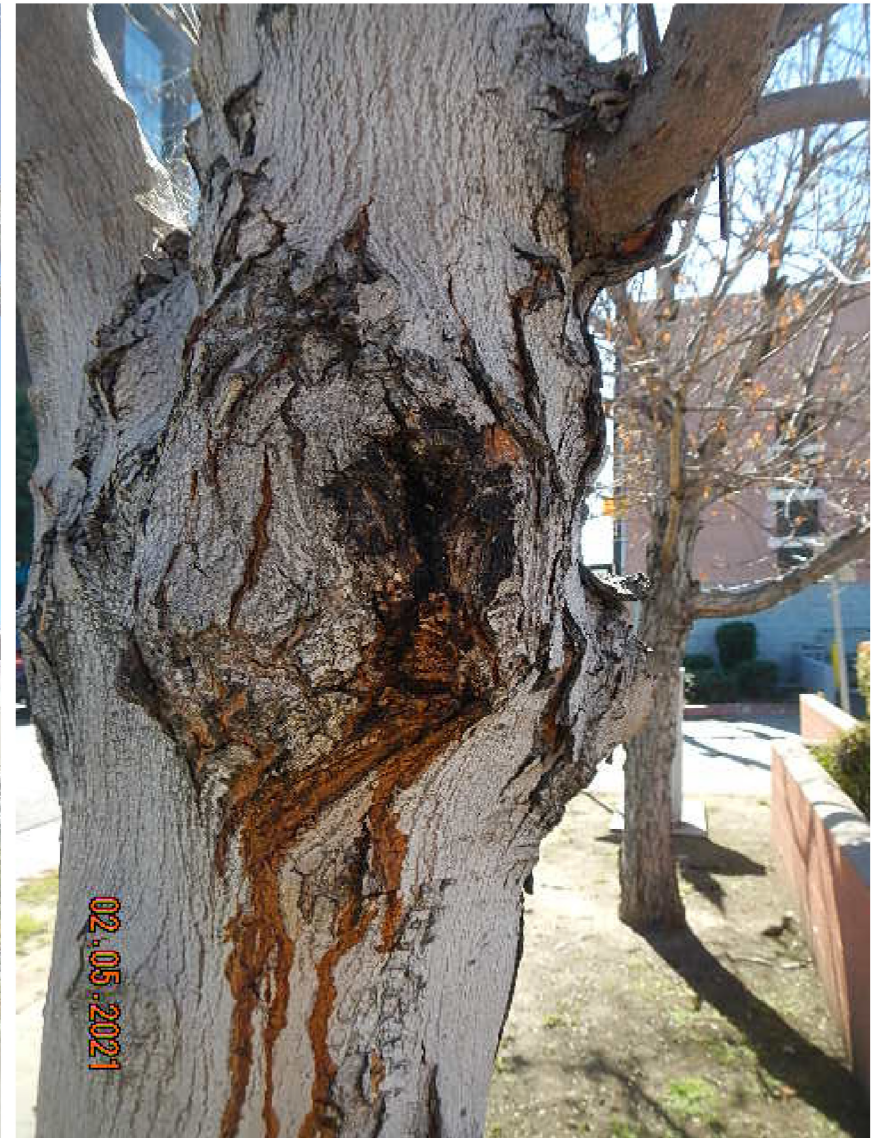
#2 Maple, note bleeding old flush cuts.

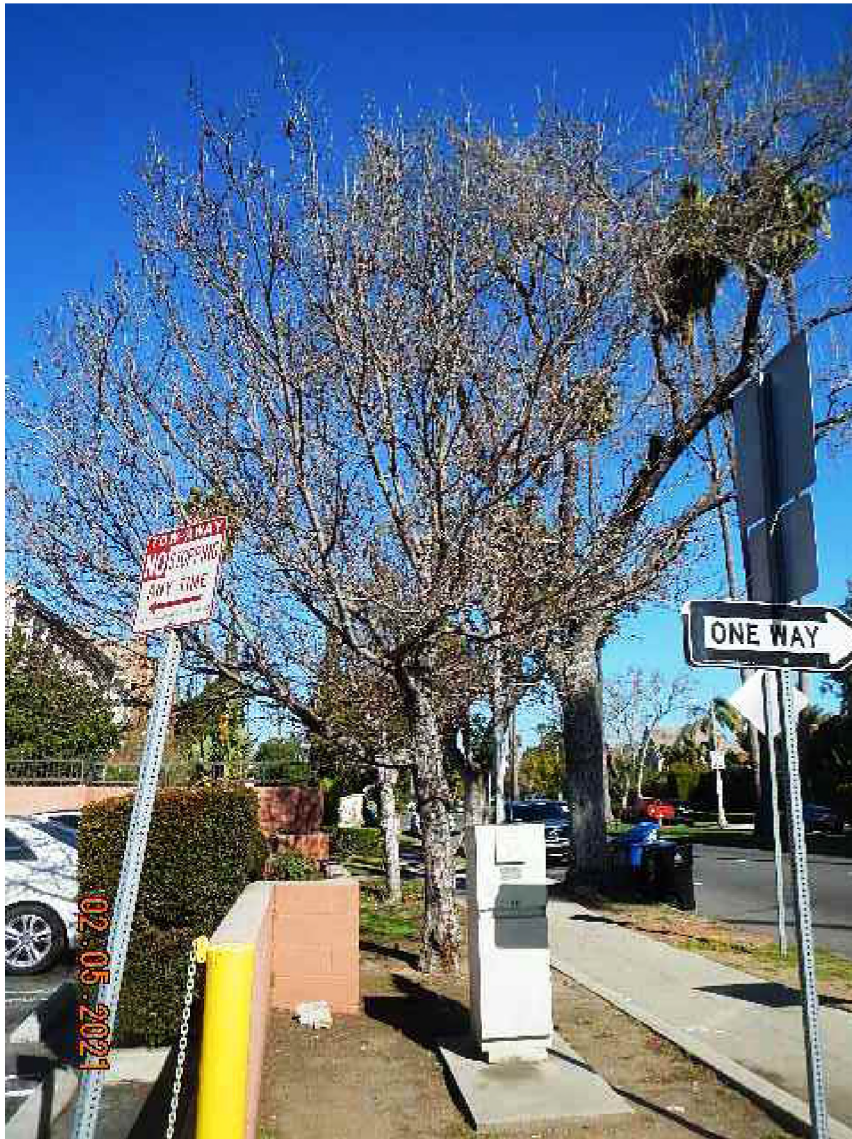
#3 Silver maple – note narrow planter and crowded limbs.

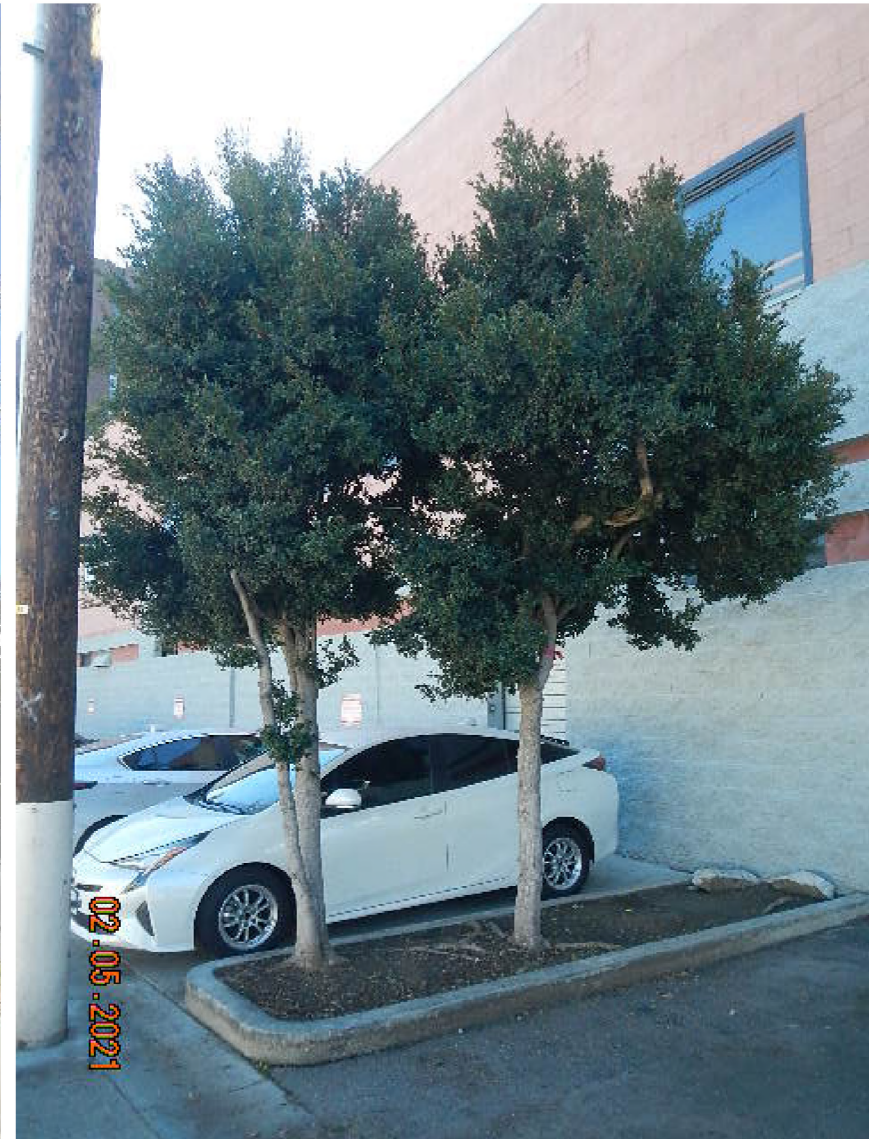
Trees #4 &5 are commonly grown as shrubs or hedges. Compact brush cherry could be a decent small tree, but both are in the same small finger island in the back parking area. Neither was trained to be a tree, but in their small size, it doesn't matter that much, but they would never have an adequate life span with two in such a small root space.

#4 & 5 Compact brush cherries and shallow crowded roots.
