**US EPA Region 9 Enforcement and Compliance Assurance Division  
 Clean Air Act Section 112(r)  
 Inspection Report**

| <b>Inspection Date(s):</b> | May 31, 2024 | <b>Inspection Announced:</b> Yes |
| <b>Company Name:</b> JCI Jones Chemicals, Inc. | | |
| <b>Facility or Site Name:</b> JCI Jones Chemicals, Inc. – Torrance | | |

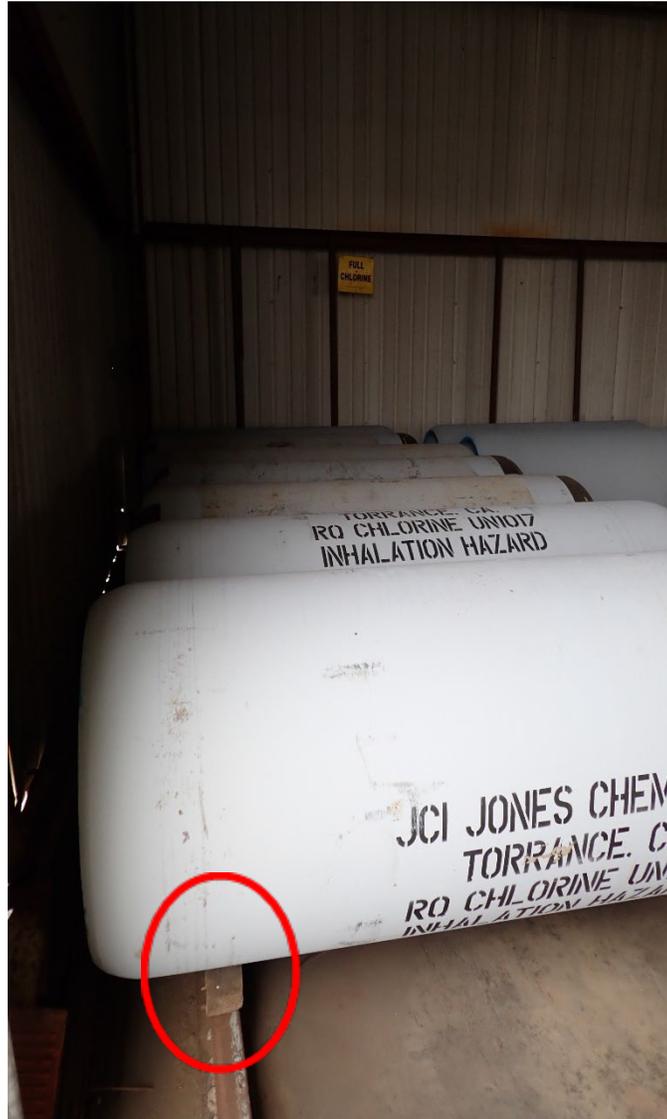
**Photograph 2 - File: P5310002.JPG**

Warehouse: Close-up of full, one-ton chlorine containers that are chocked with a piece of wood.

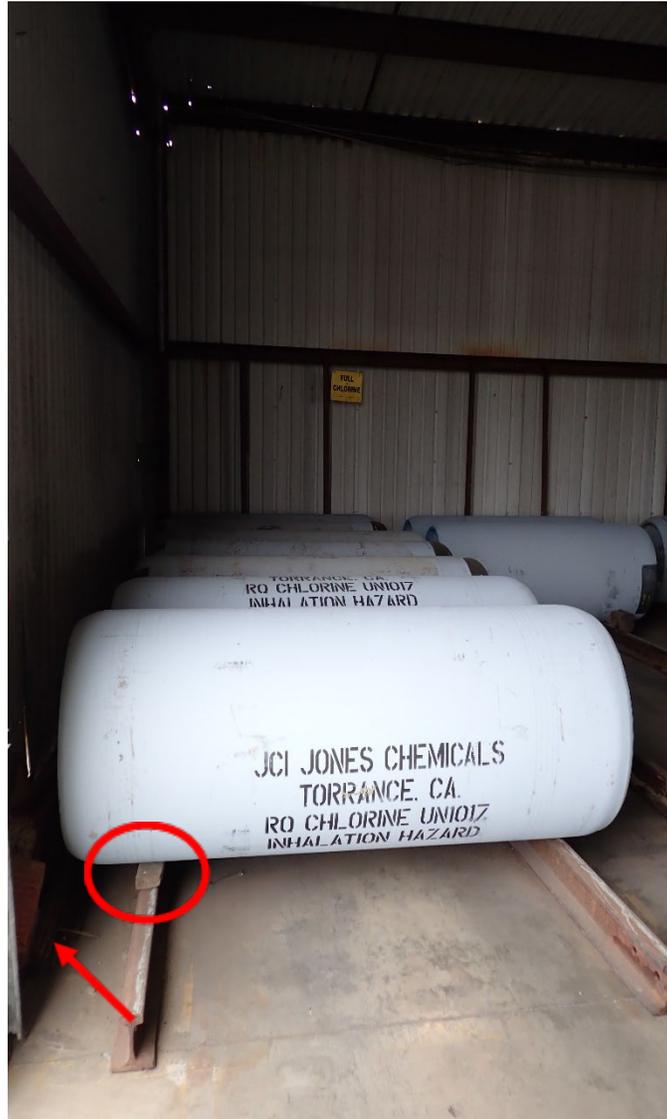
**Photograph 3 - File: P5310003.JPG**

Warehouse: Full, one-ton chlorine containers that are chocked with a piece of wood. EPA observed proper chocks on the side of the container as indicated by the arrow.

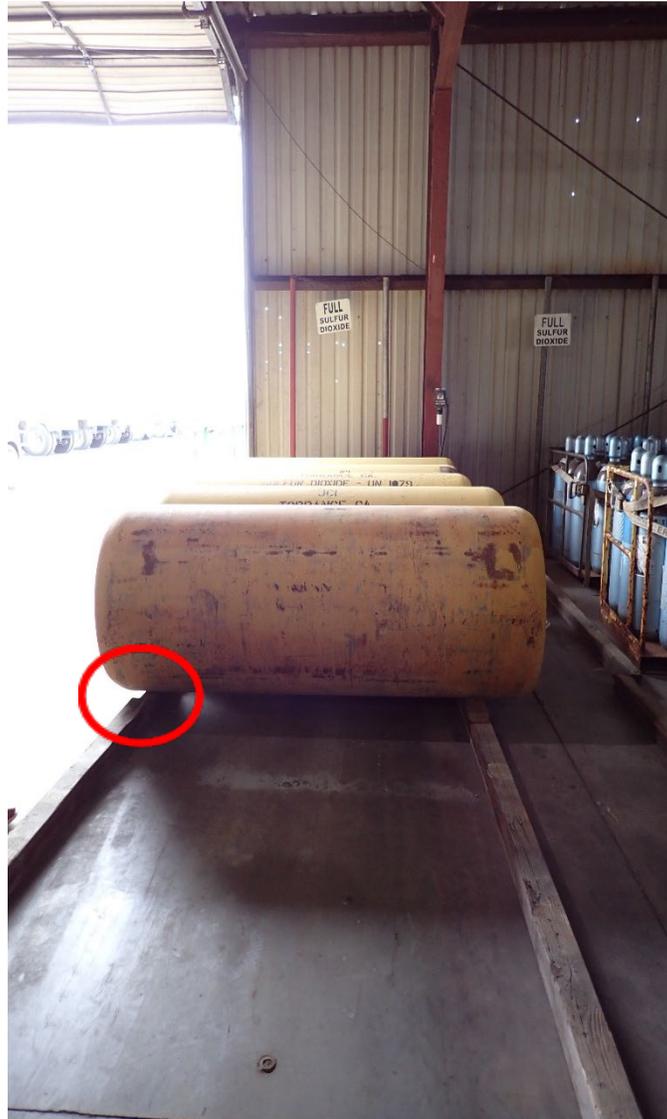
**Photograph 4 - File: P5310004.JPG**

Warehouse: Full, one-ton sulfur dioxide containers that are chocked with a piece of wood.

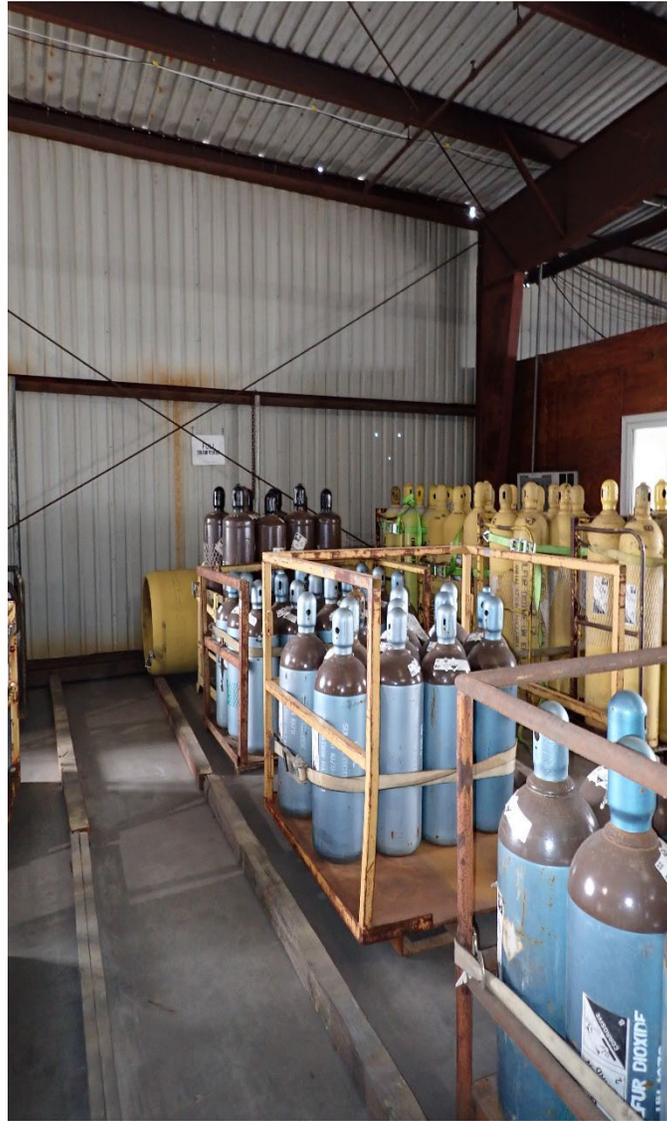
**Photograph 5 - File: P5310005.JPG**

Warehouse: One full, one-ton sulfur dioxide containers that is unchocked, but located behind crated cylinders.

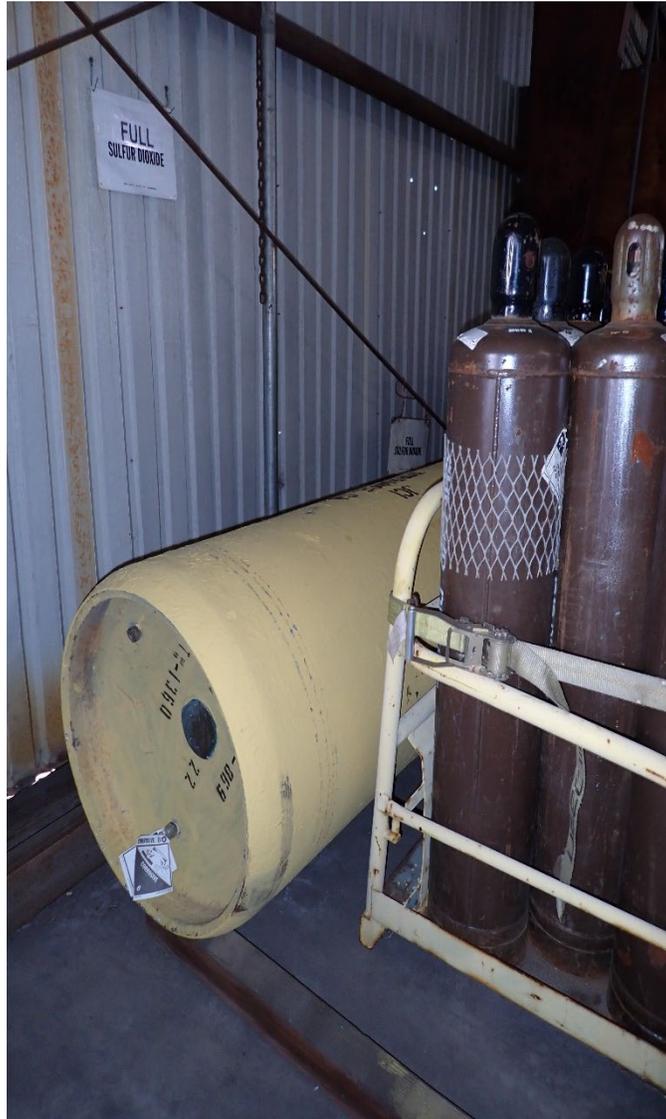
**Photograph 6 - File: P5310006.JPG**

Warehouse: One full, one-ton sulfur dioxide containers that is unchocked, but located behind crated cylinders.

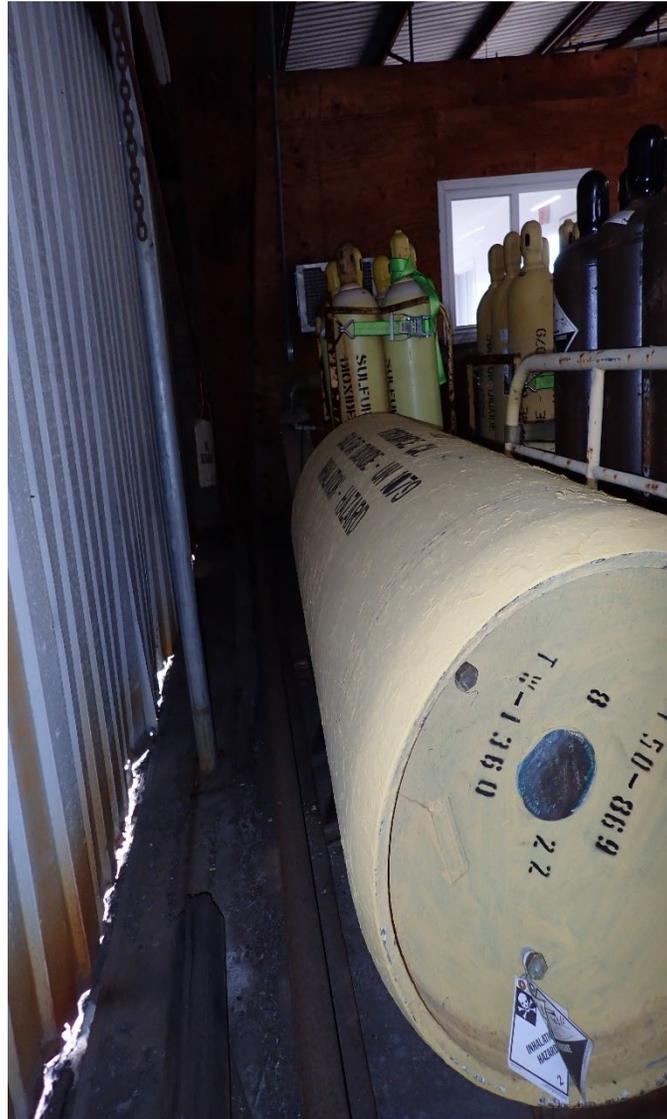
**Photograph 7 - File: P5310007.JPG**

Warehouse: View of full, one-ton sulfur dioxide container that is unchocked, but located behind crated cylinders.

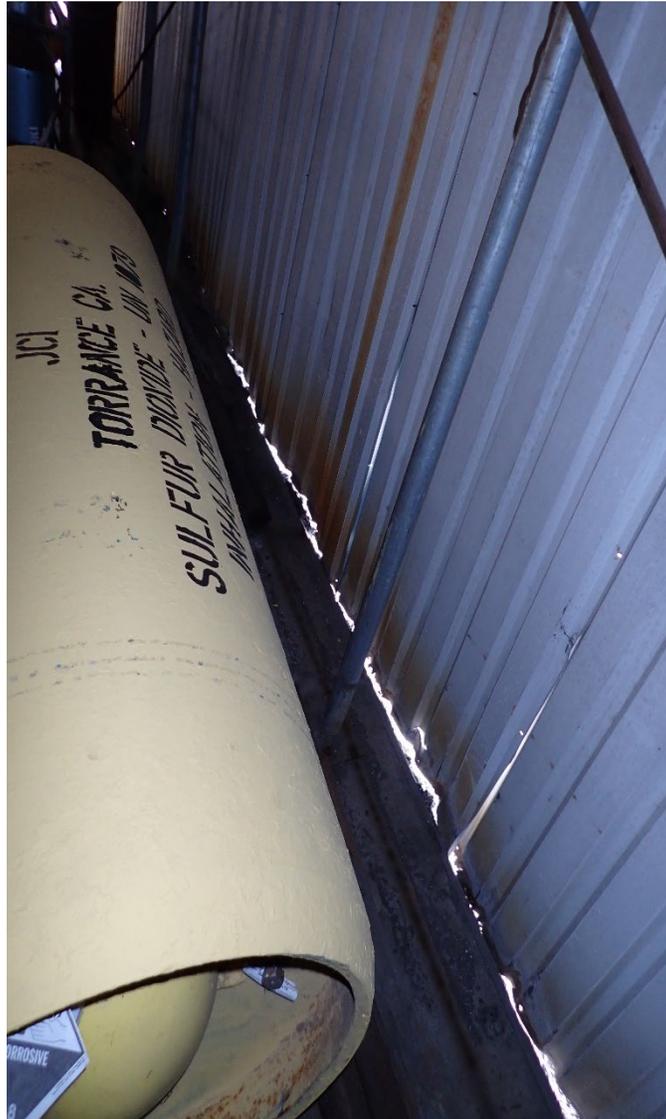
**Photograph 8 - File: P5310008.JPG**

Warehouse: View of full, one-ton sulfur dioxide container that is unchocked, but located behind crated cylinders.

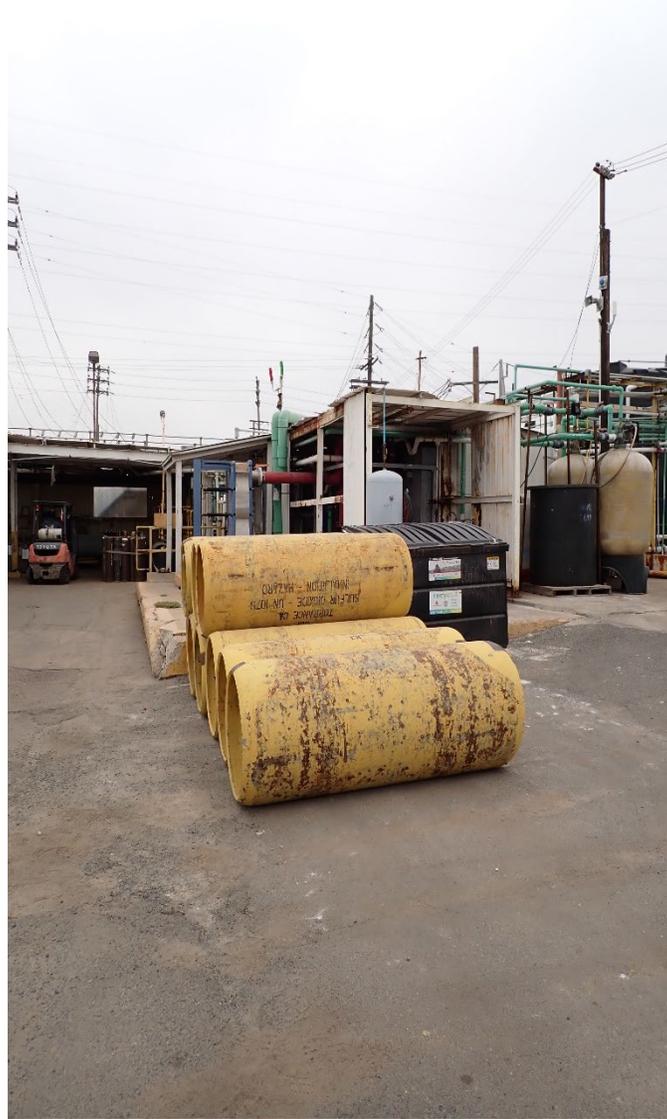
**Photograph 9 - File: P5310009.JPG**

Outside near Fill Stations: View of one-ton sulfur dioxide containers that are unchocked.

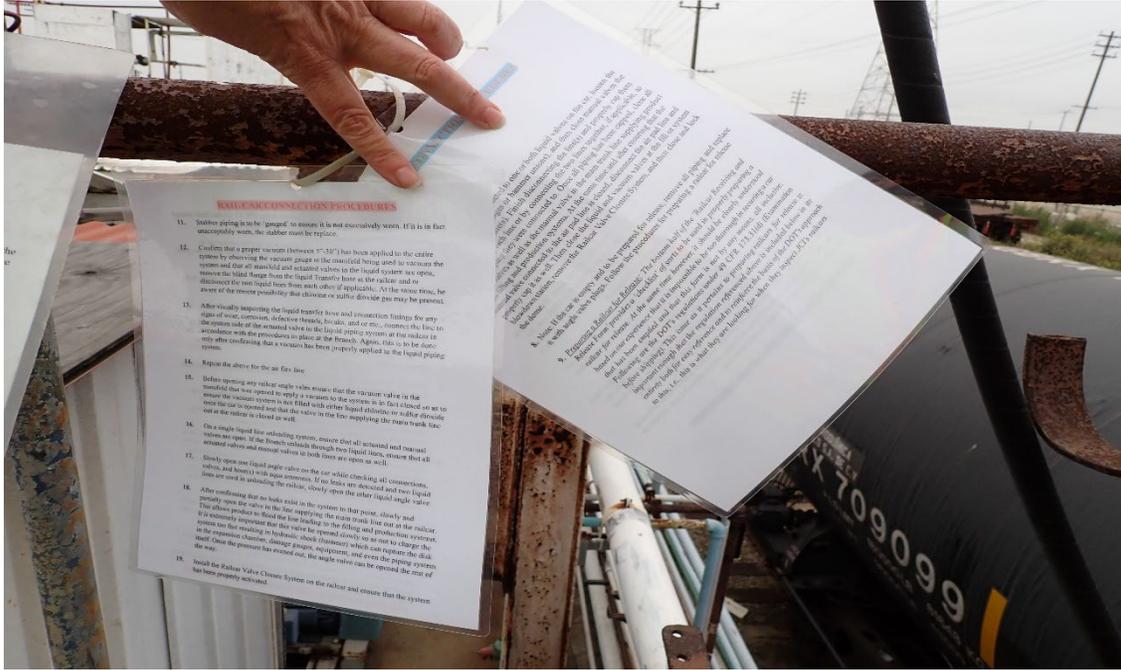
**Photograph 10 - File: P5310010.JPG**

| <b>Area of Concern #3</b> |
|---|
| <b>Description of Observation:</b><br>Inspectors observed laminated Railcar Connection and Disconnection Procedures attached to railing on the Chlorine Railcar Platform (Photograph 10). Procedures are undated and differ from the 2018 version of the Production Manual SOP for Compressed Gas Railcar Disconnection and Release provided by the Facility, available at the time of inspection. Written operating procedures for safely conducting railcar connection and disconnection are not clear if the steps provided to the operator are different from the most up-to-date procedures.<br><br>The Facility revised the Railcar Connection and Disconnection SOP in the Production Manual and checklists posted on the Railcar Platforms to be consistent. Checklists now have a revision date at the bottom for document control. This project was completed June 24, 2024 and is documented in Photograph 41. Since the SOP in the Production Manual needed to be updated after it was found to be inconsistent with the checklist, the Facility did not review the operating procedures as often as necessary to assure that they reflected current operating practices. |

Chlorine Railcar Platform: Railcar Connection and Disconnection Procedures that are laminated and attached to railing. Sheets are undated and not certified operating procedures.

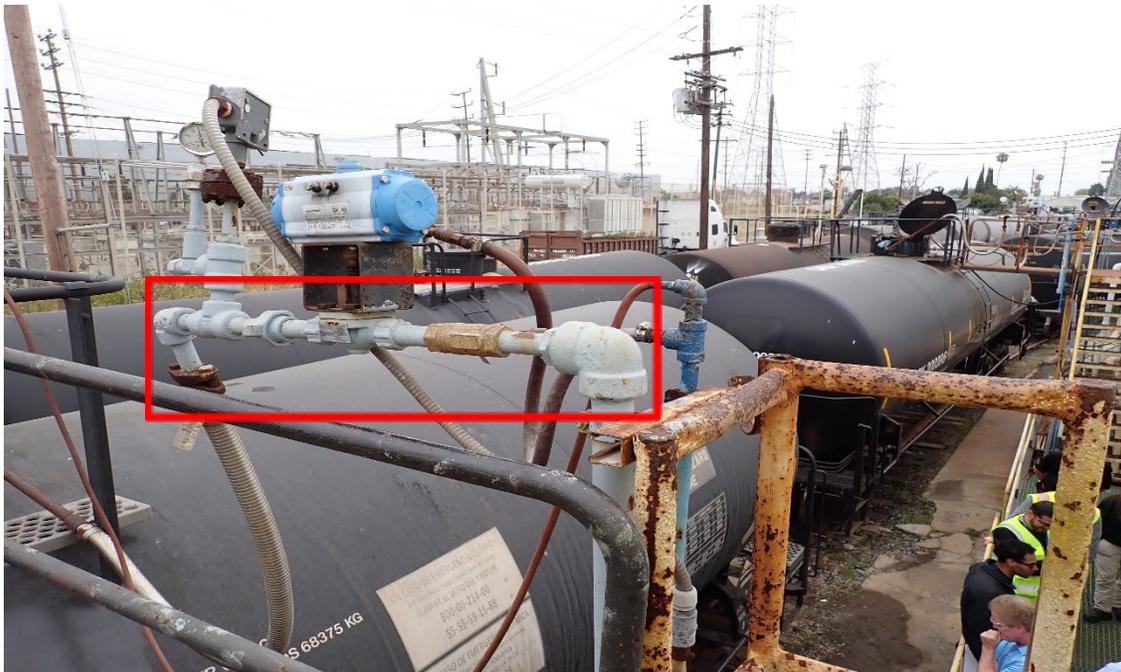
**Photograph 11 - File: P5310011.JPG**

1. Section K314.1 of ASME B31.3 (2020) states for piping with threaded joints, "... (b) Supports shall be designed to control or minimize strain and vibration on threaded joints and seals."
  - Inspectors observed unlabeled chlorine piping shaking while walking up the stairs of the Chlorine Railcar Platform (Photograph 11).
  - Inspectors observed liquid chlorine piping leading to the bleach plant appeared to be unsupported (Photographs 23-25, 30-32).
  - Inspectors observed a caustic soda pipe floating off its support (Photograph 26) and missing a pipe strap (Photograph 27). The pipe strap appeared to have fallen off and was on the ground below the pipe (Photograph 28).

2. Section 3.1 of ASME A13.1 (2015) states that, "Positive identification of the contents of a piping system shall be by lettered legend, giving the name of the contents in full or abbreviated form."
  - Inspectors observed unlabeled, grey chlorine piping leading from the railcar platform (Photograph 11).

Chlorine Railcar Platform: View of unlabeled chlorine piping (grey). The chlorine piping was observed to vibrate/move when personnel walked up and down the stairs off the platform. Support railing was also observed to be corroded, with peeling paint and pitting.

The inspection team has not received documentation showing that supports for the caustic soda pipe have been repaired and liquid chlorine piping from the railcar platform has been labeled.

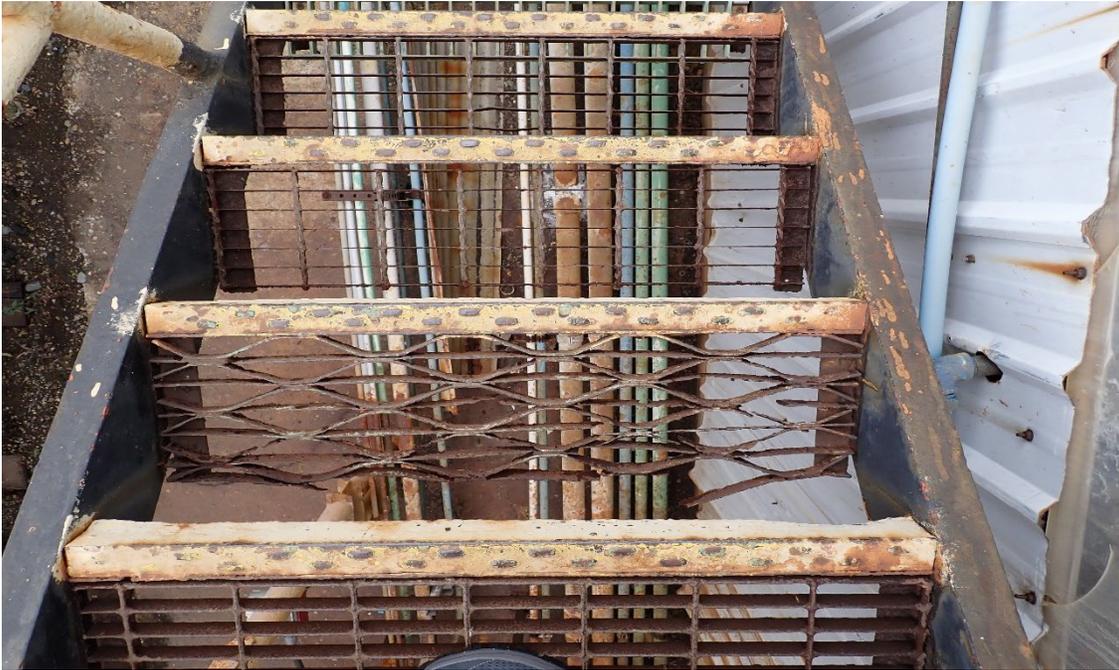
**Photograph 12 - File: P5310012.JPG**

Chlorine Railcar Platform: Stairs for the platform. One of the steps was observed to be severely corroded with broken supports.

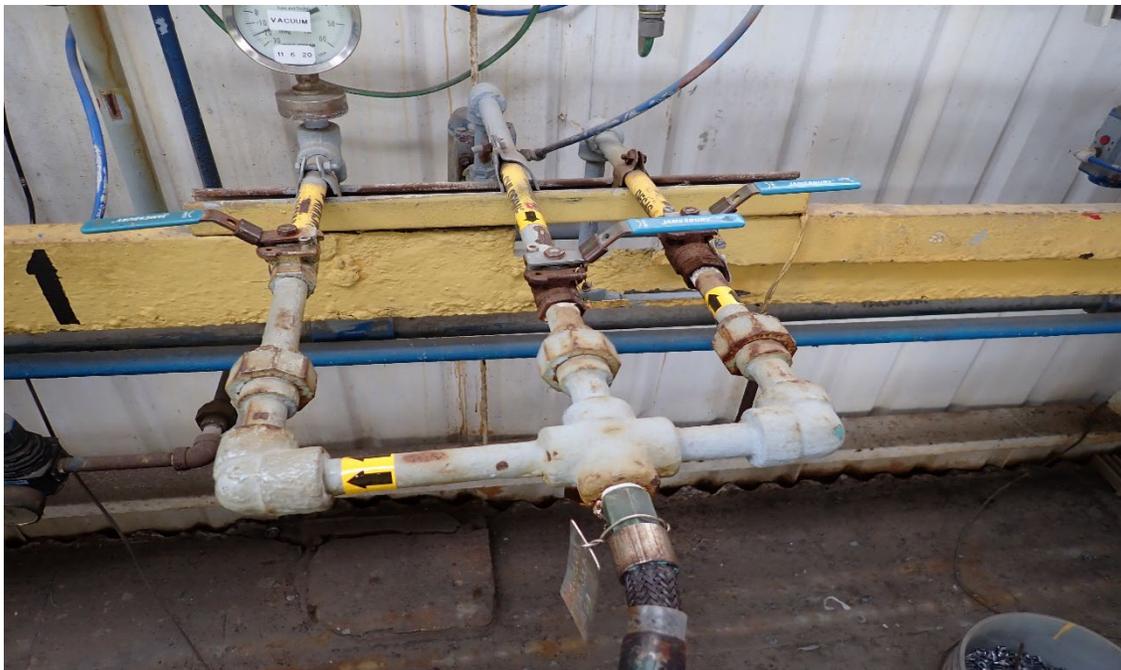
**Photograph 17 - File: P5310017.JPG**

Chlorine Filling Station 1: Valves for fill station 1. Valve on right is observed to be more corroded than other valves. Other valves have missing or broken tags. The valve bonnets on the middle and right-hand valves are corroded.

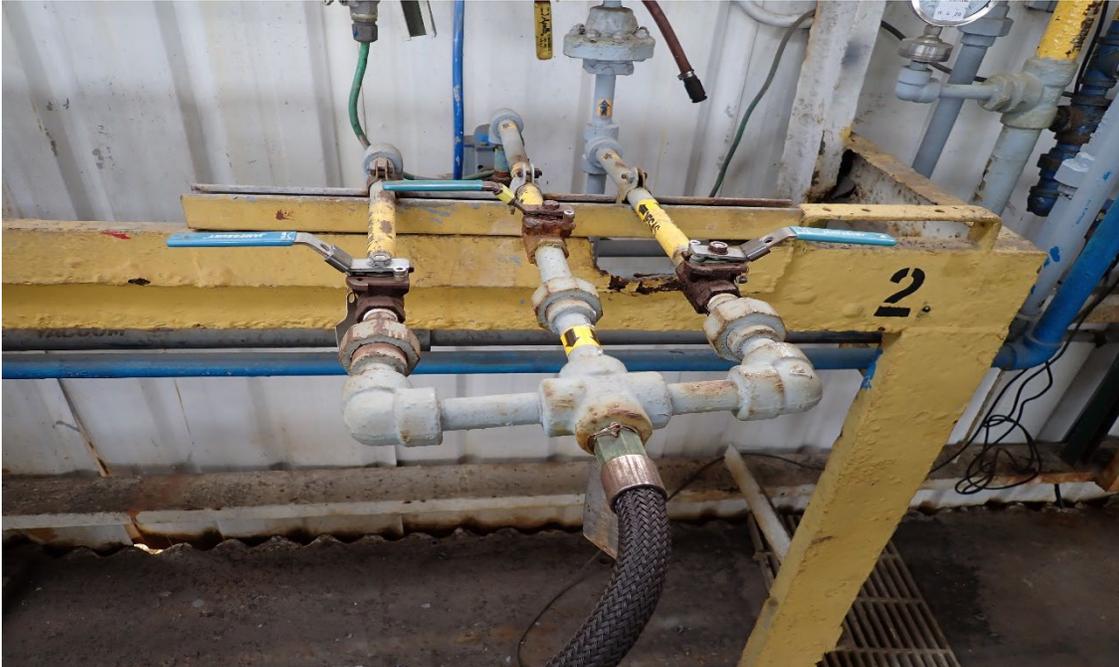
**Photograph 18 - File: P5310018.JPG**

Chlorine Filling Station 2: Valves for fill station 2. Valve on right is observed to be more corroded than other valves. Other valves have missing or broken tags.

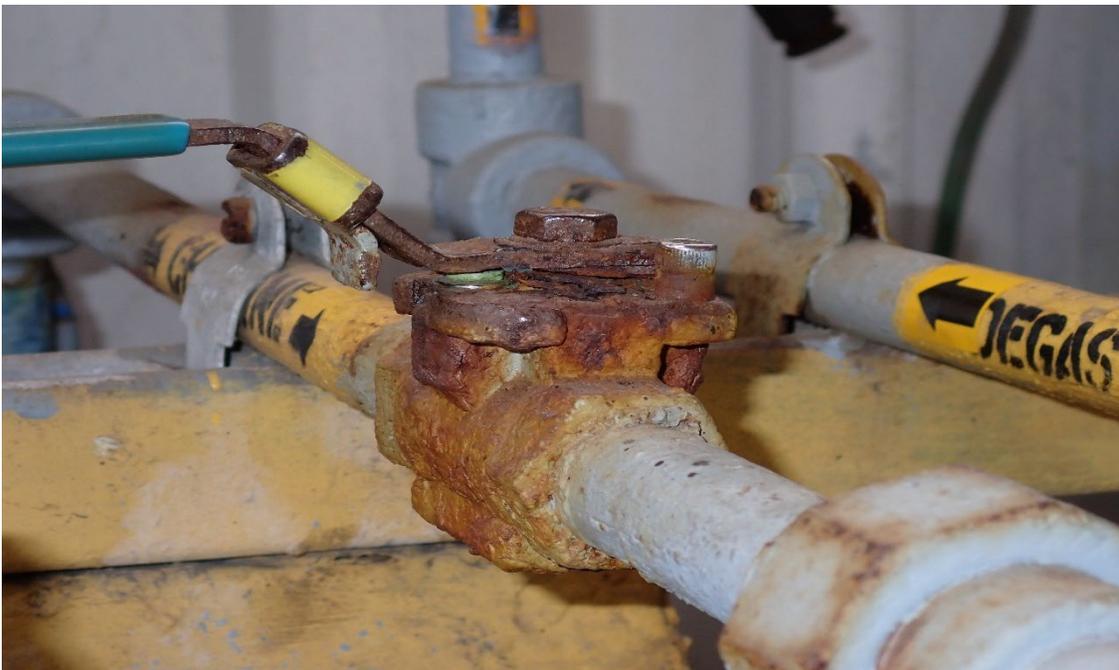
**Photograph 19 - File: P5310019.JPG**

Chlorine Filling Station 2: Close-up of chlorine fill valve (middle valve in Photograph 18). The valve has significant corrosion.

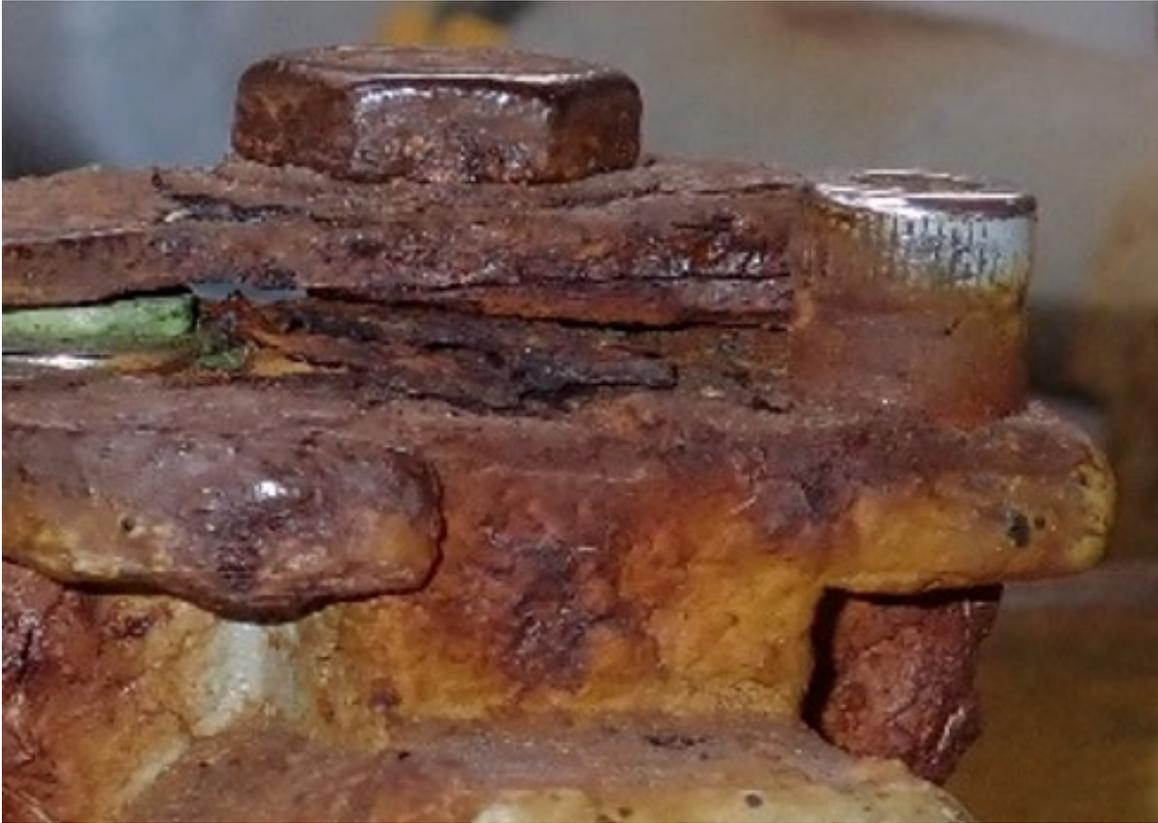
**Photograph 19a - File: P5310019.JPG**

| <b>Description of Observation:</b><br>Several hand valves were observed to be corroded: <ol style="list-style-type: none"><li>1. The compression plate on the liquid chlorine fill valve in Chlorine Filling Station 2 is severely corroded and is disintegrated and the valve body is pitted. (Photographs 18-19).</li><li>2. The manual liquid chlorine fill valve body in Chlorine Filling Station 1 showed signs of surface and pitting corrosion (Photograph 17).</li></ol> <p>Facility staff indicated that the filling station valves are checked regularly for leaks and tracked in the LIMBLE CMMS. However, valves should not be in operation until they fail (e.g., valve leaks). Valves should be replaced or rebuilt on a regular basis.</p> <p>Corrosion was also observed as follows:</p> <ol style="list-style-type: none"><li>3. Bolts and plates of the top of the bleach plant reactor (Photograph 29).</li><li>4. Corrosion on the bottom of the caustic soda piping (Photograph 26).</li></ol> |

Chlorine Filling Station 2: Digital close-up of chlorine fill valve in Photograph 19. The valve compression plate and other parts of the valve have significant corrosion.

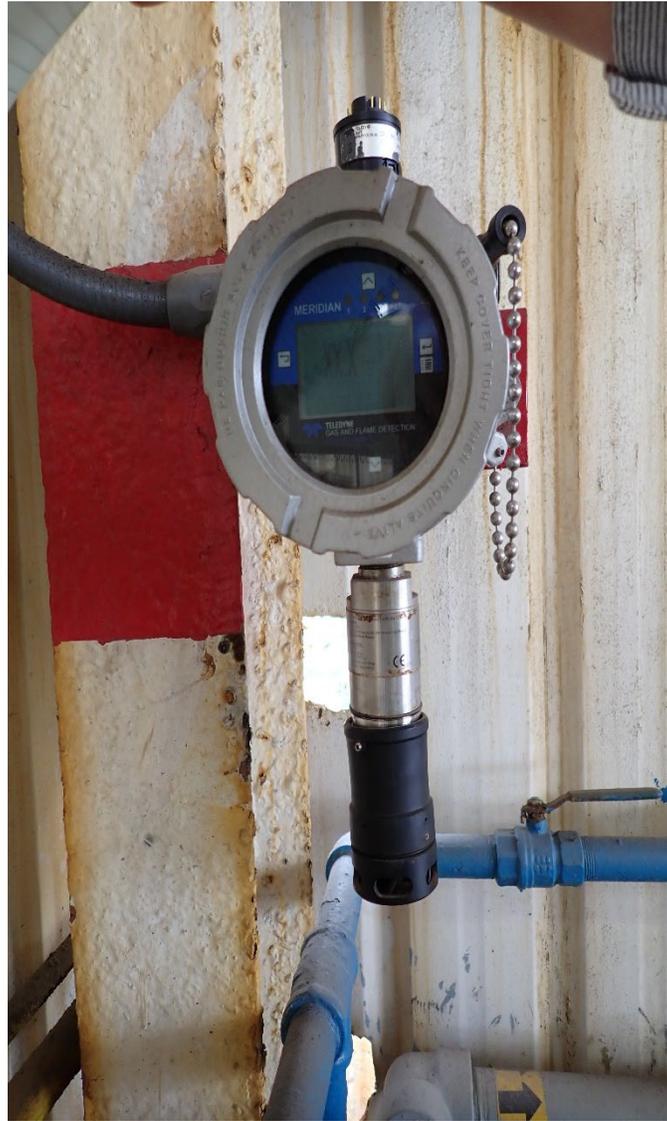
**Photograph 20 - File: P5310021.JPG**

Inspectors observed that Chlorine Monitor #2 for the “CL2 Ton – PRODUCTION Fill Area” read of “XX.X” with a warning flag reading “SYSTEM FAULT”.

Chlorine Filling: Chlorine monitor identified as #2 (green) "Cl2 Ton- PRODUCTION FILL" on Photograph X. The monitor indicates "XX.X." Facility staff indicated that this monitoring was discovered "leaking" the previous day.

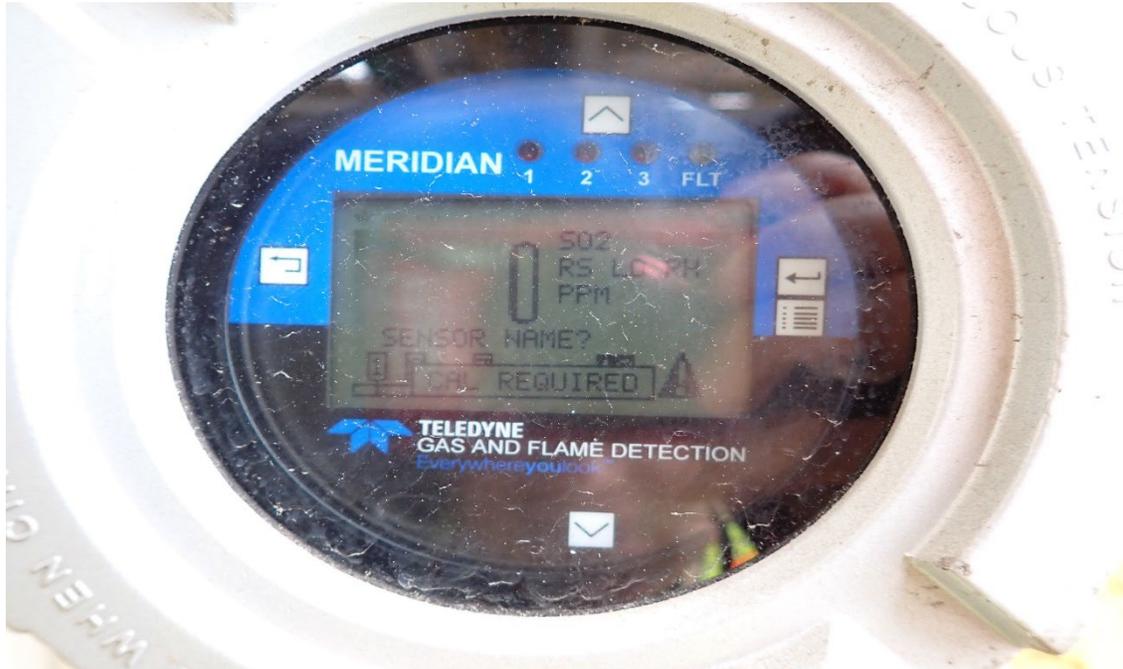
**Photograph 21 - File: P5310023.JPG**

SO2 Filling: SO2 sensor that was observed to be flashing during the inspection. This sensor was documented as #2 (yellow) - "PRODUCTION/SO2" on Photograph X. Facility staff indicated that the flashing light is a reminder to calibrated.

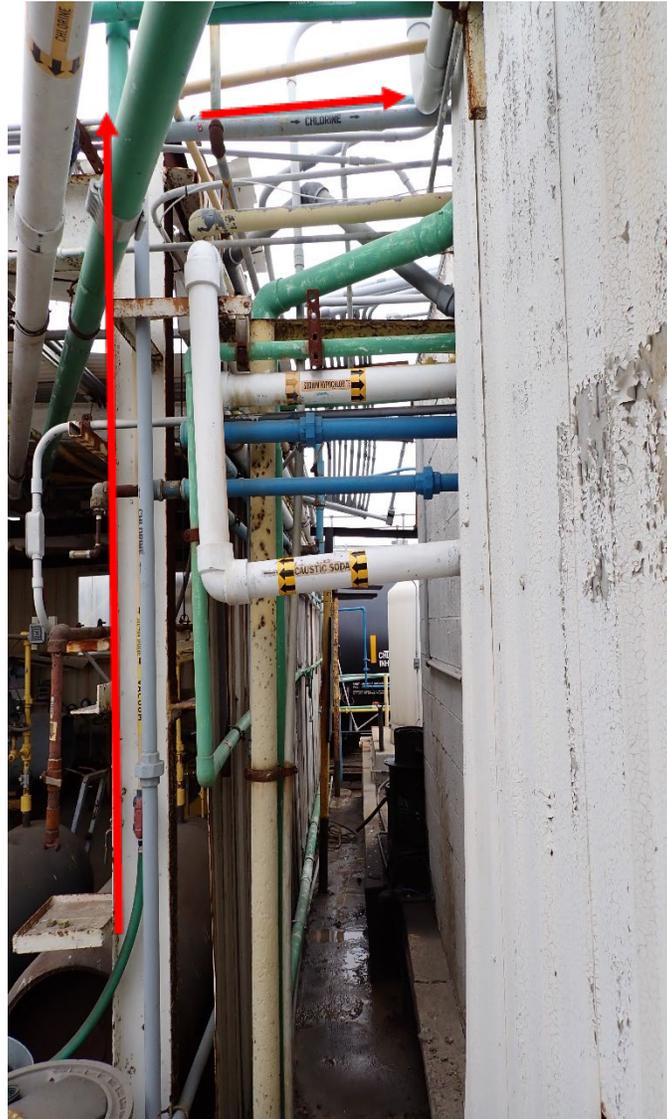
**Photograph 23 - File: P5310025.JPG**

Production Area: Liquid chlorine piping (grey) to the bleach plant. The pipe run appeared to not be adequately supported.

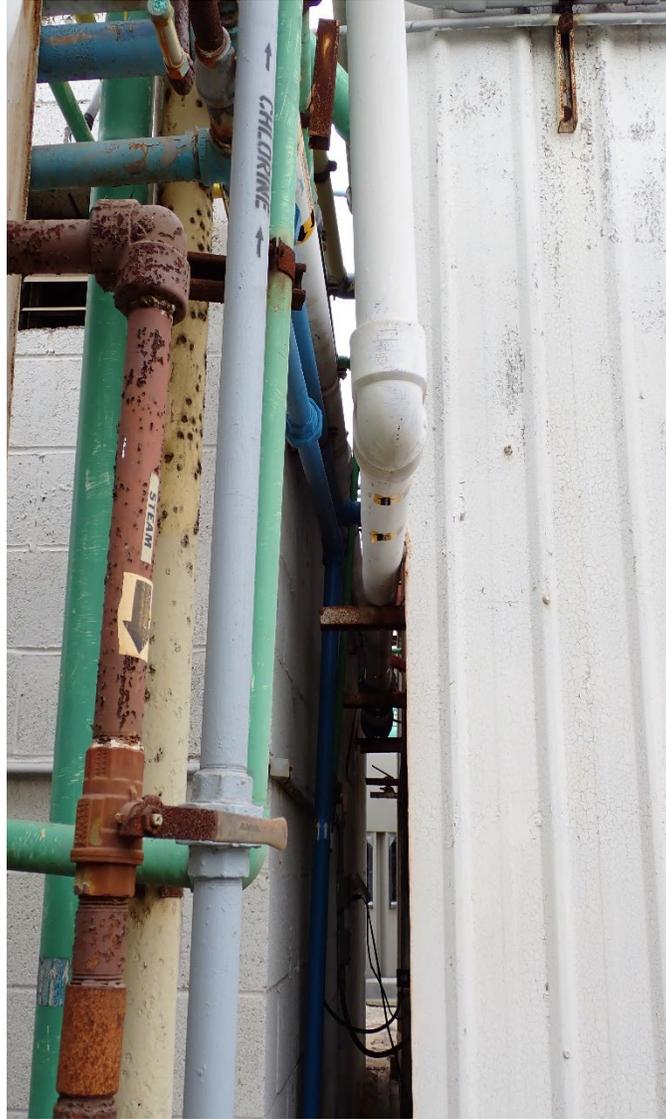
**Photograph 24 - File: P5310026.JPG**

Production Area: Liquid chlorine piping (grey) to the bleach plant. The pipe run appeared to not be adequately supported.

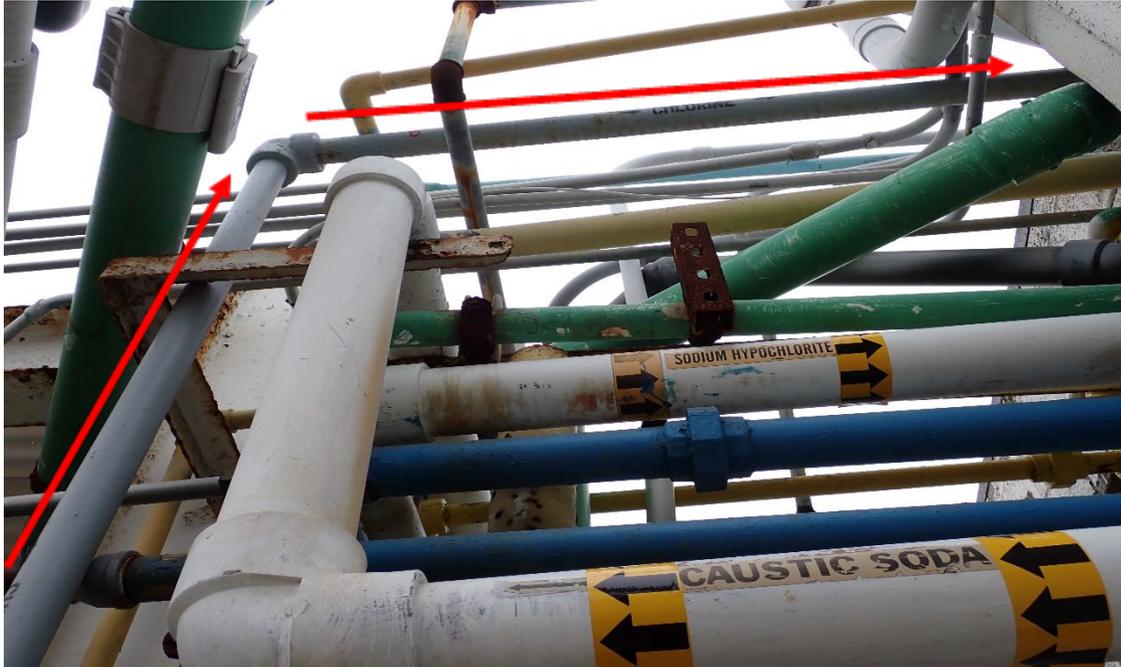
**Photograph 25 - File: P5310027.JPG**

Production Area: Liquid chlorine piping (grey) to the bleach plant. The pipe run appeared to not be adequately supported.

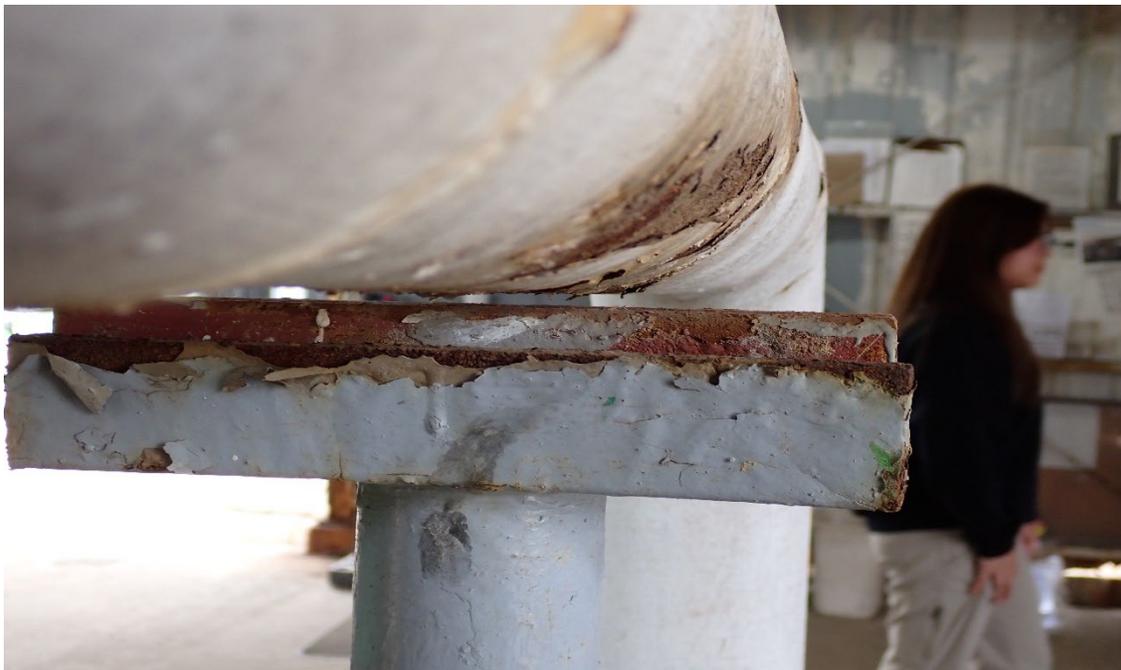
**Photograph 26 - File: P5310028.JPG**

Production Area: Caustic soda piping that is corroded and not properly supported.
