**Barry Building  
Stairs & Benches Safekeeping**

**Report**  
of  
**James C. Wolf**

**January 15, 2024**

ASCE 41-13 Seismic Assessment

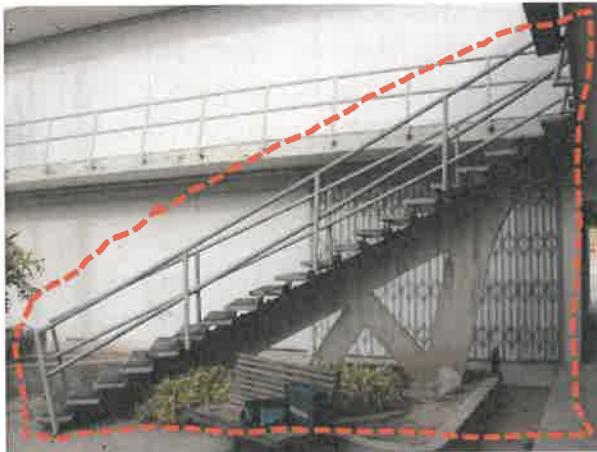
NORTH STAIR

- Each staircase will be relocated intact in one piece including existing foundation. Conceptualized Lifting Carriage can be found in Section VI.
- Dashed lines represent the proposed boundary of separation of the component pieces for moving.

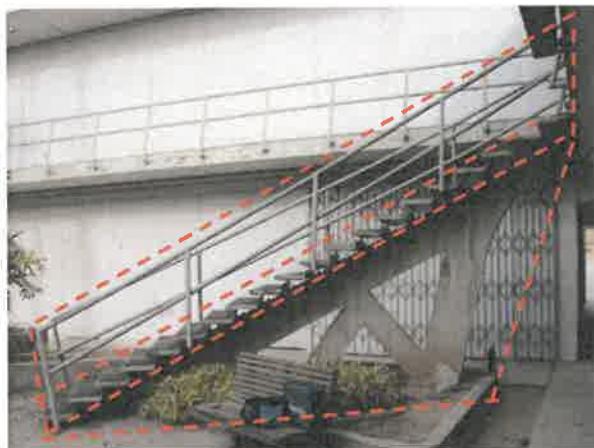
**NORTH STAIR**

- Each architectural pierced concrete super structure, after dismantling treads and railings, will be relocated intact in one piece including existing foundation. Conceptualized Lifting Carriage can be found in Section VII.
- Dashed lines represent the proposed boundary of separations of the component pieces for moving.

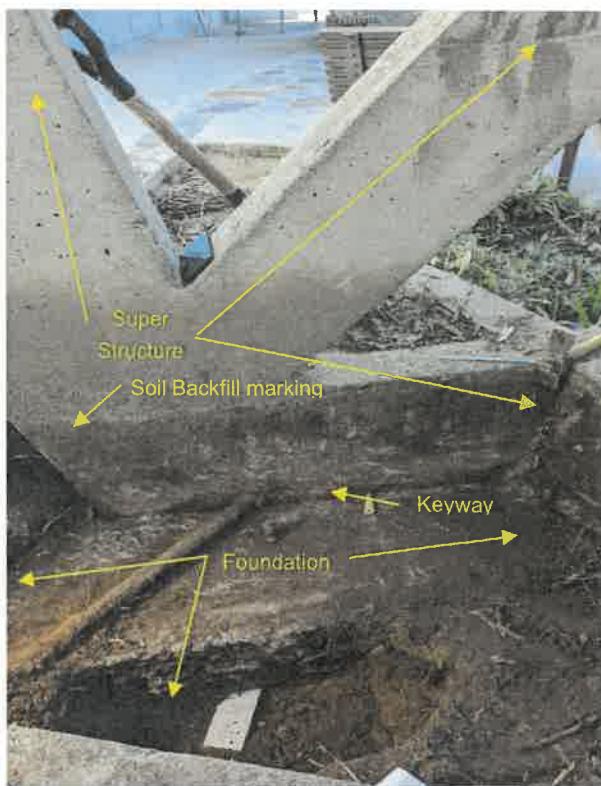
## **Exploratory Excavation: Detail of Architectural Pierced Concrete Super Structure and Foundation**

Careful hand excavation using shovel and whisk broom not disturbing concrete super structure or foundation. Shows Architectural Pierced Concrete Super Structure and Foundation, appear to be consistent with design drawings. Super Structure seated into Foundation keyway

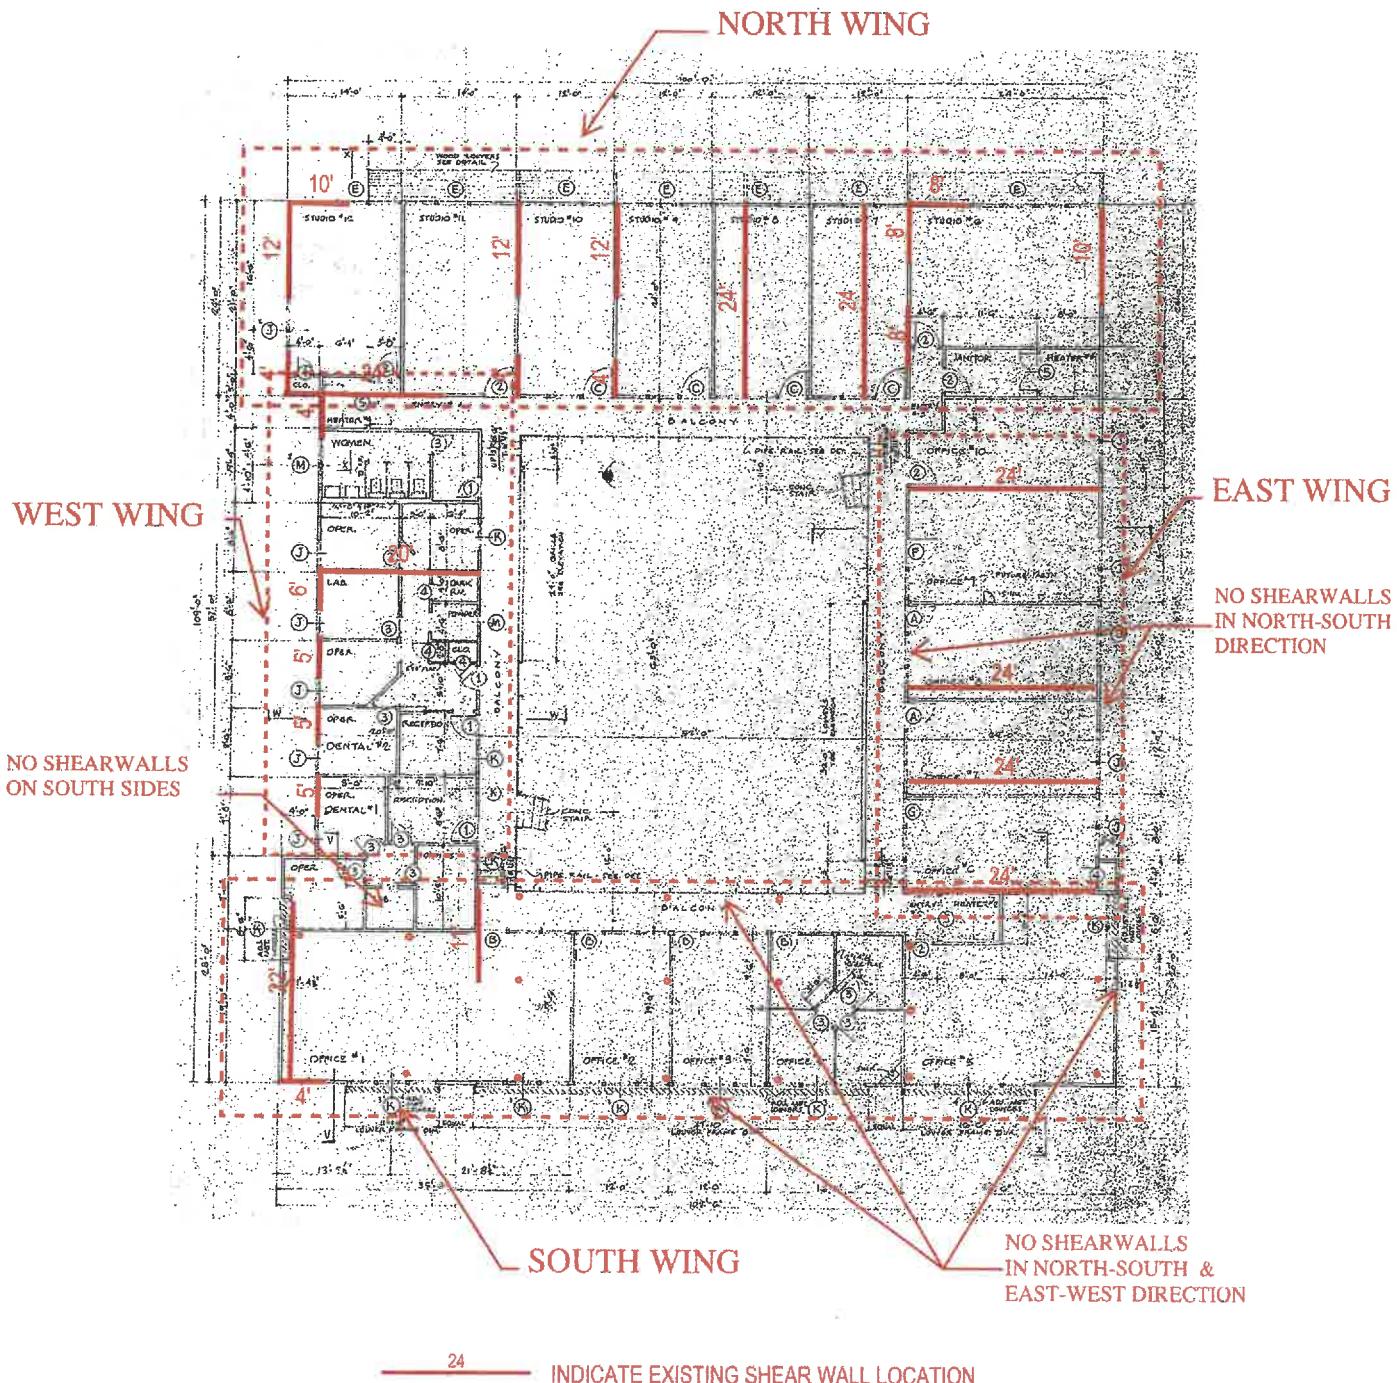
**Figure 3.1: Existing Shear Wall Locations**

<b>16.1 Basic Checklist</b>		
<b>Item</b>	<b>Non-Compliant/Unknown</b>	<b>Description</b>
Load Path	Non-Compliant	Discontinuous horizontal diaphragms occur at second floor and roof. Vertical elements of seismic-force-resisting system (such as wood shear walls or frames) were not found at all sides of the perimeter. Interior demising walls do not form a complete seismic-force-resisting system as they are discontinuous between floors.
<b>16.1.2LS Life Safety Basic Configuration Checklist</b>		
<b>Item</b>	<b>Non-Compliant/Unknown</b>	<b>Description</b>
Load Path	Non-Compliant	See 16.1 for Description
Weak Story	Non-Compliant	Vertical discontinuities of seismic-force-resisting system were not found at all sides of the perimeter. Interior demising walls do not form a complete lateral bracing system as they are discontinuous between floors.

Soft Story	Unknown	Stiffness of the seismic-force-resisting system cannot be confirmed, as the seismic-force-resisting system (wood shear walls) are not found at all sides of perimeter, and wood shear walls are found discontinuous between floors.
Vertical Irregularities	Non-Complaint	Vertical elements of seismic-force-resisting system (Wood shear walls) were found discontinuous between floors.
Torsion	Unknown	The story center of rigidity cannot be confirmed.
Oversizing		
<b>16.3LS Life Safety Checklist for Building Type W2: Wood Frames, Commercial and Industrial</b>
