**ENCLOSURE: REPORT FROM WSP**

Regarding: Barry Building (11973 San Vicente Boulevard, Los Angeles, CA 90049)  
Opponent Expert's Report review

**Exhibit D – Englekirk Complete Seismic Assessment  
Report , dated June 6, 2022**

**ASCE 41-13 Seismic Assessment**

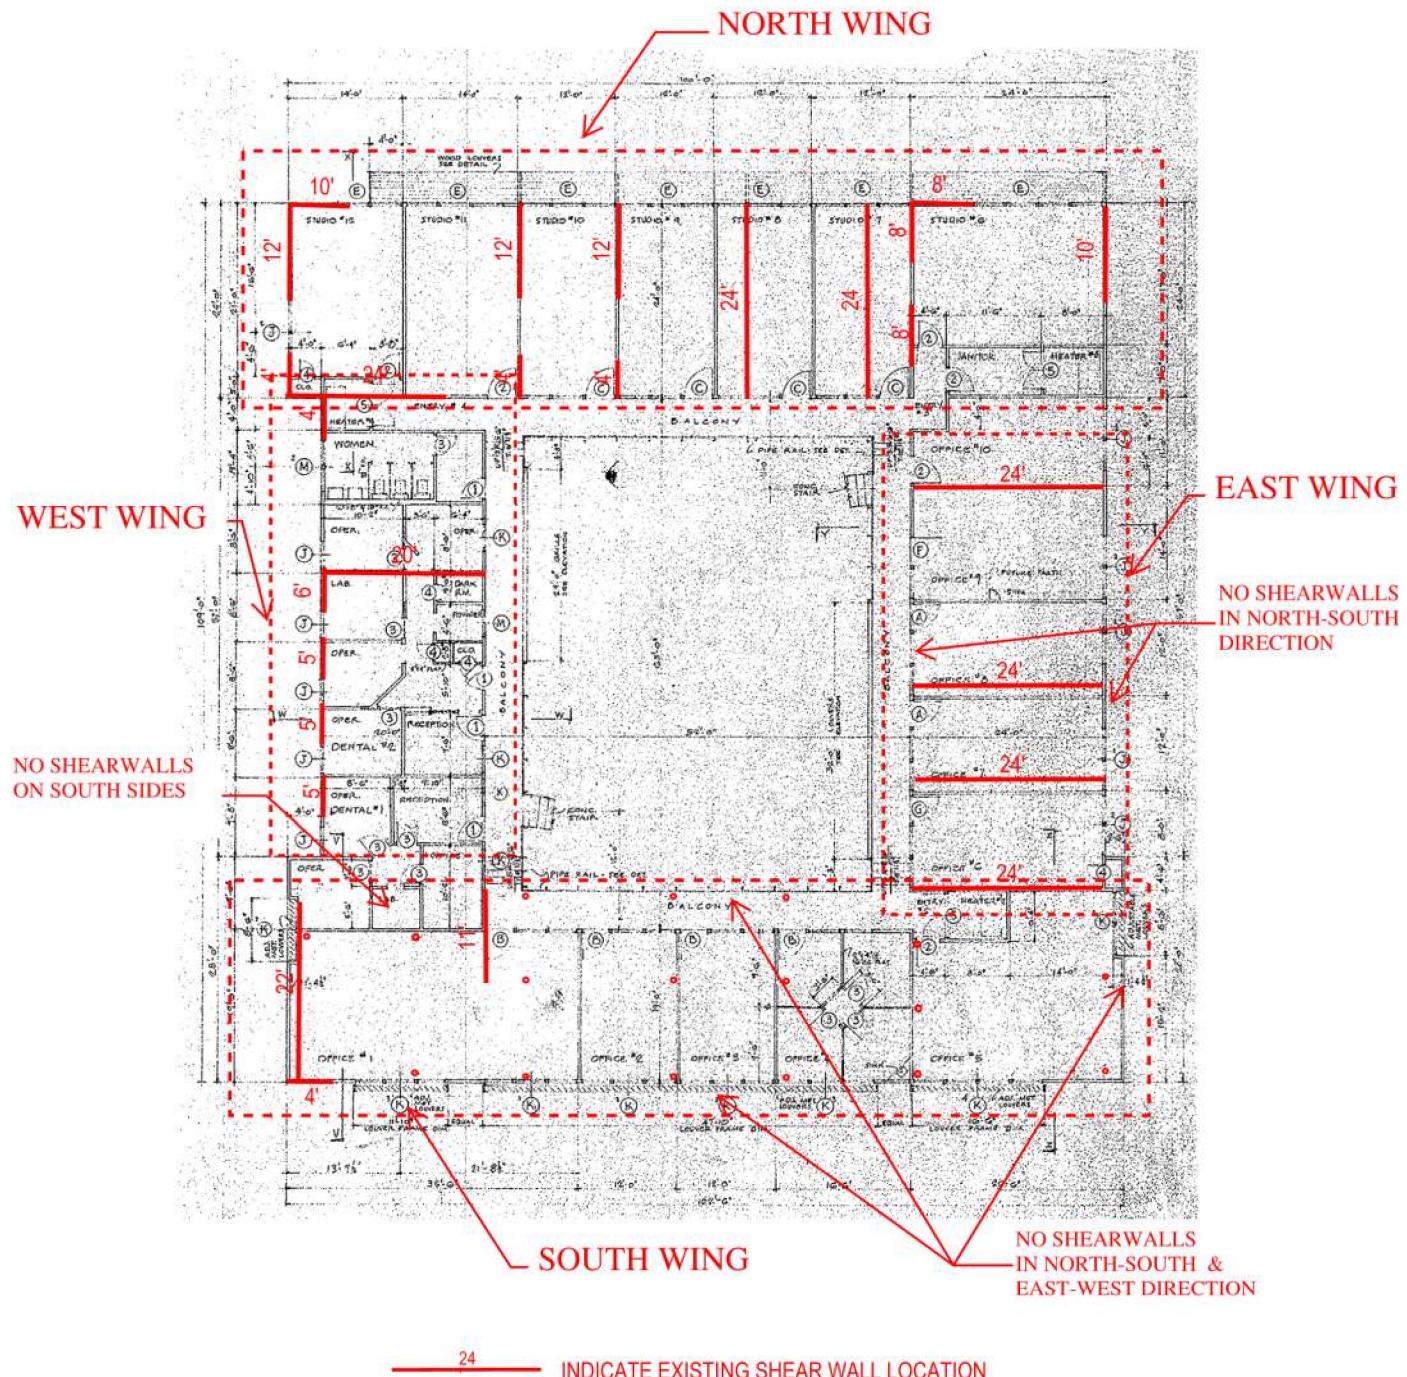
**Figure 3.1:** Existing Shear Wall Locations

The south wing that faces San Vicente Boulevard utilizes a pass-through at the ground floor that accesses the interior courtyard. As a result, there are no bearing walls that extend to the foundation. Instead, the second floor is supported on a series of steel columns. There are some exterior walls on the eastern side, but they are discontinuous between floors.

<b>16.1 Basic Checklist</b>		
<b>Item</b>	<b>Non-Compliant/Unknown</b>	<b>Description</b>
Load Path	Non-Compliant	Discontinuous horizontal diaphragms occur at second floor and roof. Vertical elements of seismic-force-resisting system (such as wood shear walls or frames) were not found at all sides of the perimeter. Interior demising walls do not form a complete seismic-force-resisting system as they are discontinuous between floors.
<b>16.1.2LS Life Safety Basic Configuration Checklist</b>		
<b>Item</b>	<b>Non-Compliant/Unknown</b>	<b>Description</b>
Load Path	Non-Compliant	See 16.1 for Description
Weak Story	Non-Compliant	Vertical discontinuities of seismic-force-resisting system were not found at all sides of the perimeter. Interior demising walls do not form a complete lateral bracing system as they are discontinuous between floors.

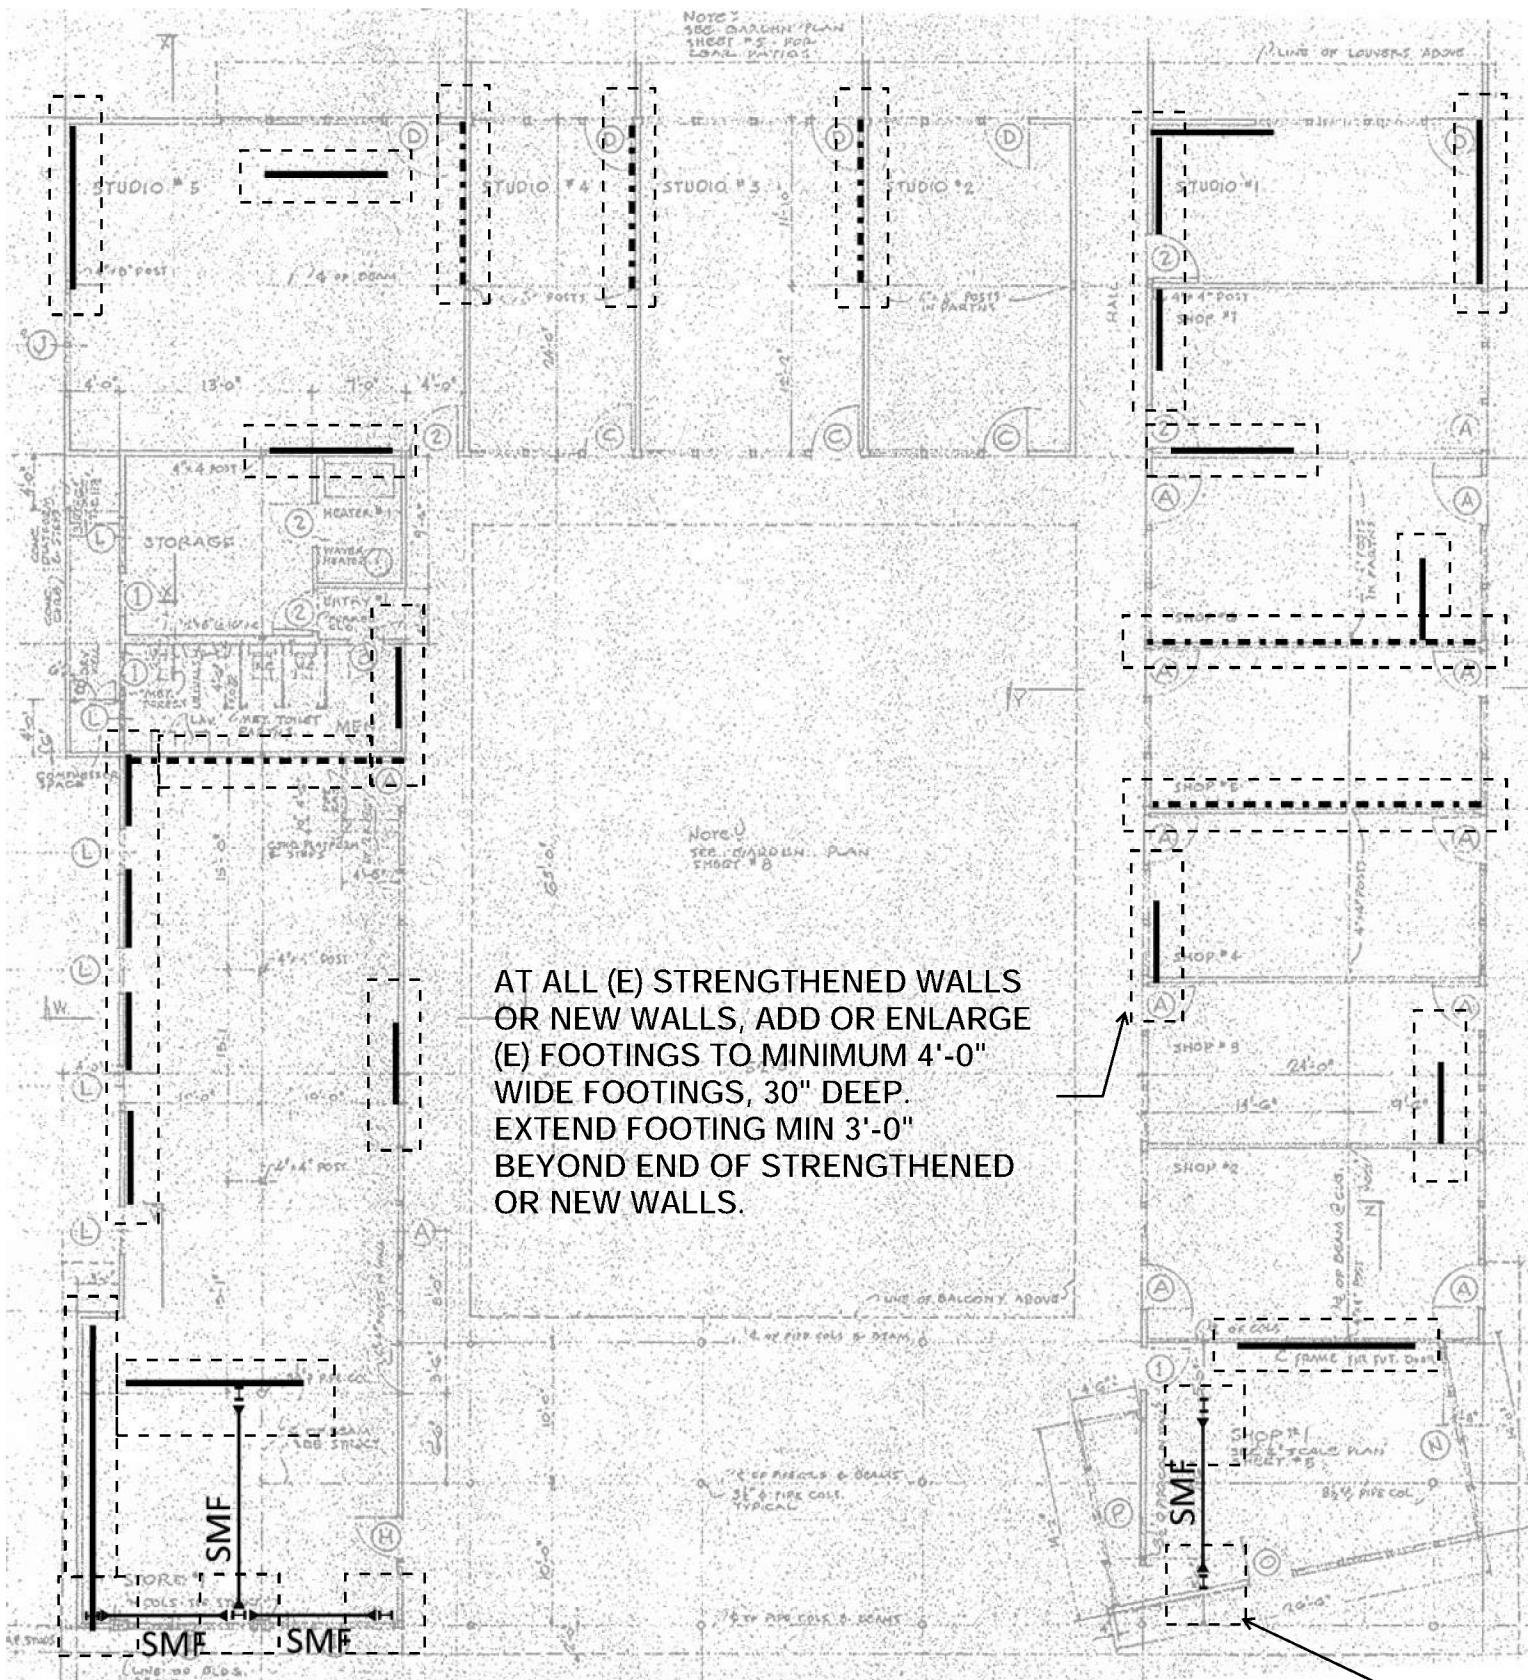
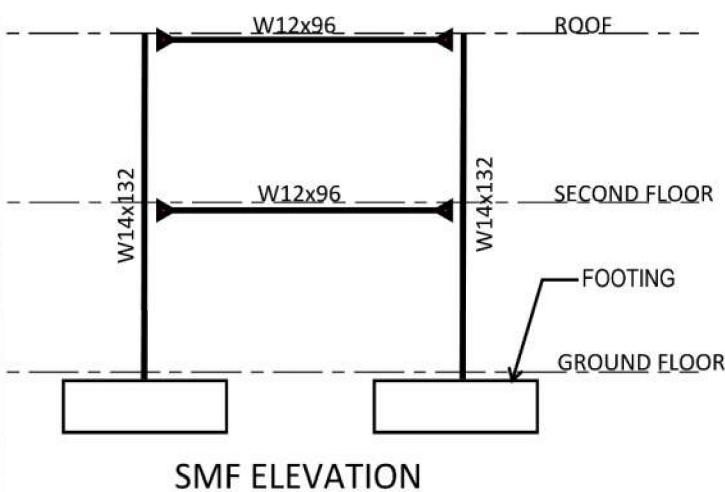
**Figure 7.1:** Conceptual Shear Wall and Steel Moment Frame Locations

The analysis indicates high demand over capacity ratios for all parts of the existing building. These high ratios indicate that the building is likely to suffer significant damage when subject to a moderate to strong earthquake in the Los Angeles basin. Some portions of the building have no significant seismic resisting elements that can resist the seismic forces from the roof and second floor and can result in a possible collapse when subject to a moderate to strong earthquake. These structural deficiencies represent life safety hazards to occupants in and around the building. The above mentioned seismic retrofits would correct the structural deficiencies identified in this report.

- 10'-0" LONG WOOD SHEAR WALL w/1/2" PLYWOOD & 10d@3":12, ADD (2) SIMPSON HD14 AND 4x8 POST EA END.

----- STRENGTHEN (E) WOOD SHEAR  
WALL w/1/2" PLYWOOD &  
10d@3":12, ADD (2) SIMPSON  
HD14 AND 4x8 POST EA END.

TYPICAL AT ALL FLOOR AND ROOF:  
ADD 3/4" FLOOR AND ROOF PLYWOOD  
OVER (E) SHEATHING AND NAIL  
w/10d@4:12.

— NEW FOOTINGS 6'-0" x 6'-0" x  
— 30" DEEP FOOTINGS UNDER  
ALL SMF COLUMNS, U.N.O.
