**Re: SUPPLEMENTAL INFORMATION IN SUPPORT OF THE APPEAL:  
DEMOLITION BY NEGLECT AND MAINTENANCE FAILURE  
11973-11975 West San Vicente Blvd. (Demolition of the  
Barry Building, HCM #887), Council File No. 25-1518,  
ENV-2019-6645-EIR; April 21, 2026 City Council Meeting,  
Agenda Item 29**

Photos of The Barry Building (Exterior)  
11973 – 11975 San Vicente Boulevard, Los Angeles, CA 90049

**Photos of The Barry Building (Courtyard)**  
**11973 – 11975 San Vicente Boulevard, Los Angeles, CA 90049**

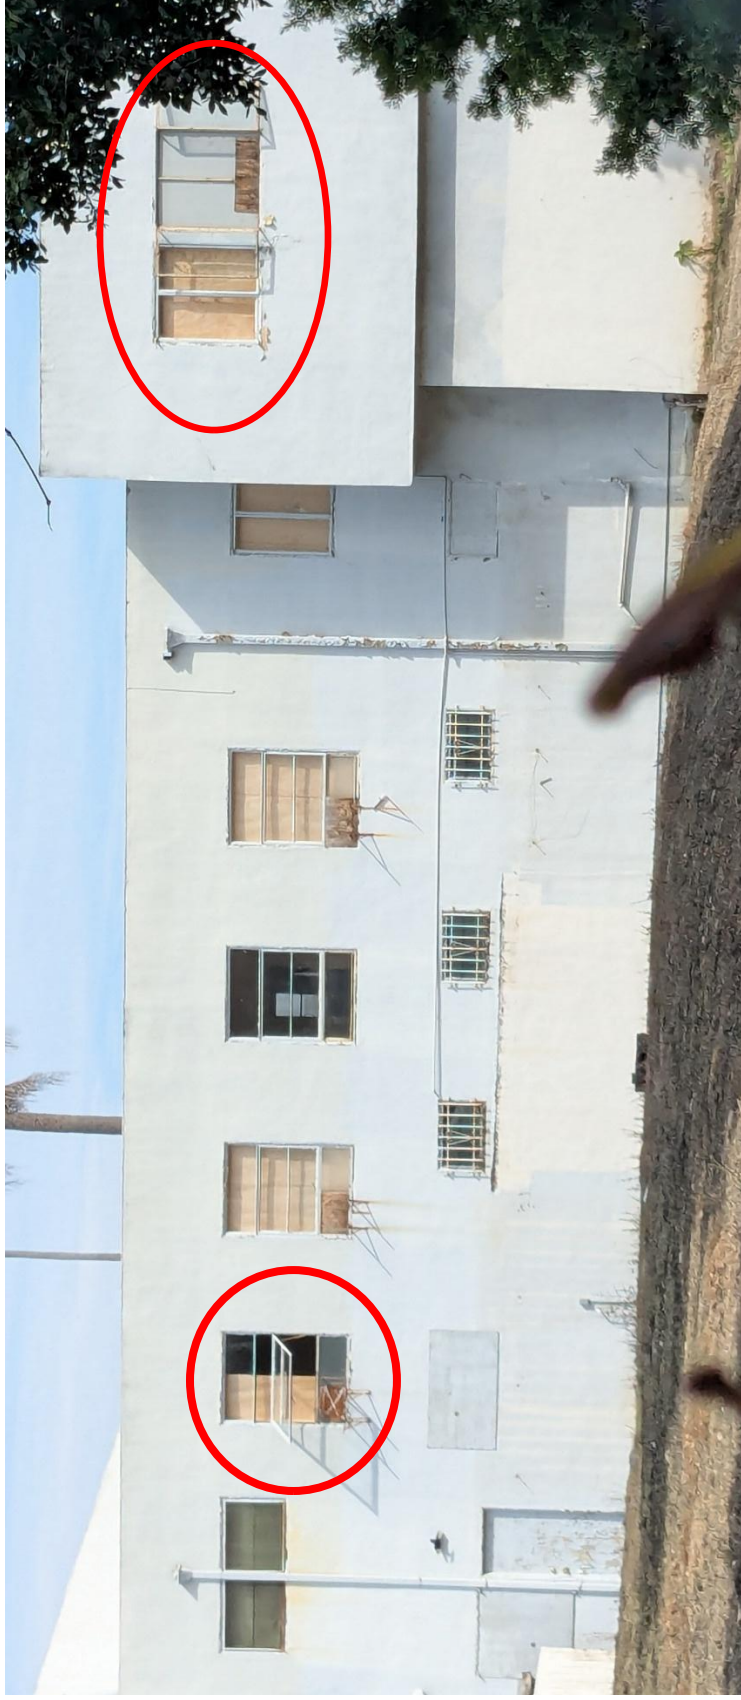
Photographic evidence from 2025 and 2026 reveals a significant and preventable breach of the building envelope. Most notably, numerous windows have been left open and unsecured for an extended period. This exposure is particularly damaging due to Wind-Driven Rain (WDR). Technical documentation emphasizes that WDR is a primary source of moisture-related deterioration in buildings, as wind pressure forces liquid water into the interior structure. By leaving windows open, the owner has effectively bypassed the building's primary defense,

1. West Side showing Open Windows, 02-03-2025 (Circled in red)

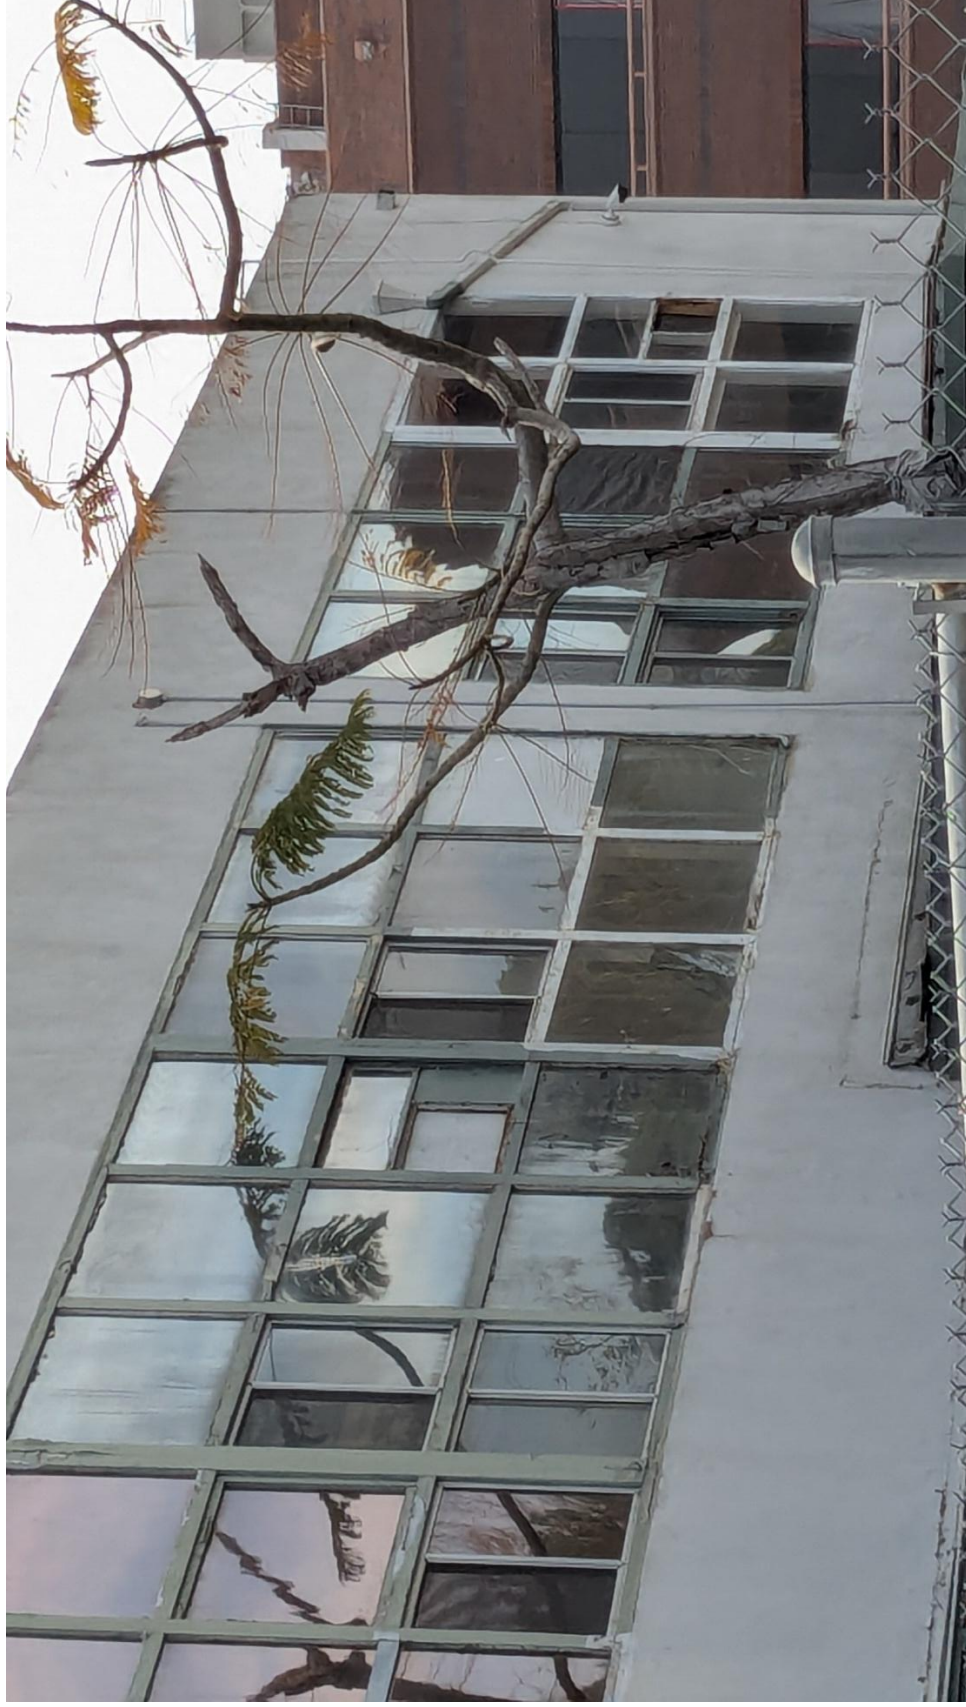
2. North Side showing deterioration, 02-03-2025

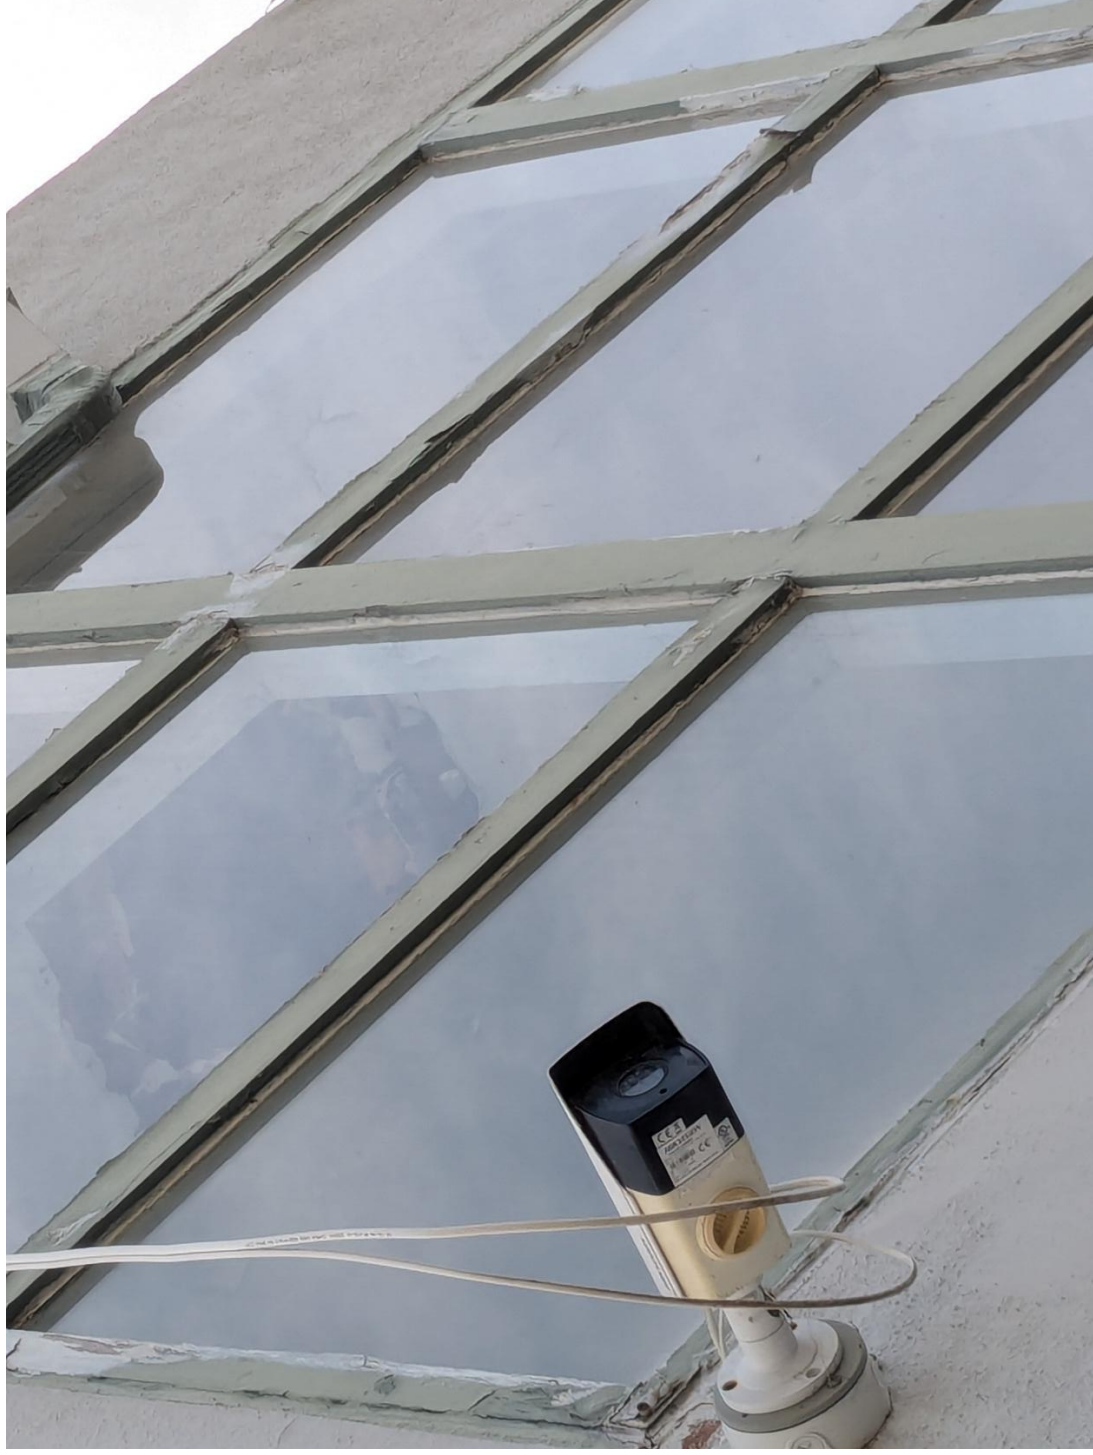
3. Deterioration around window frame, 02-03-2025

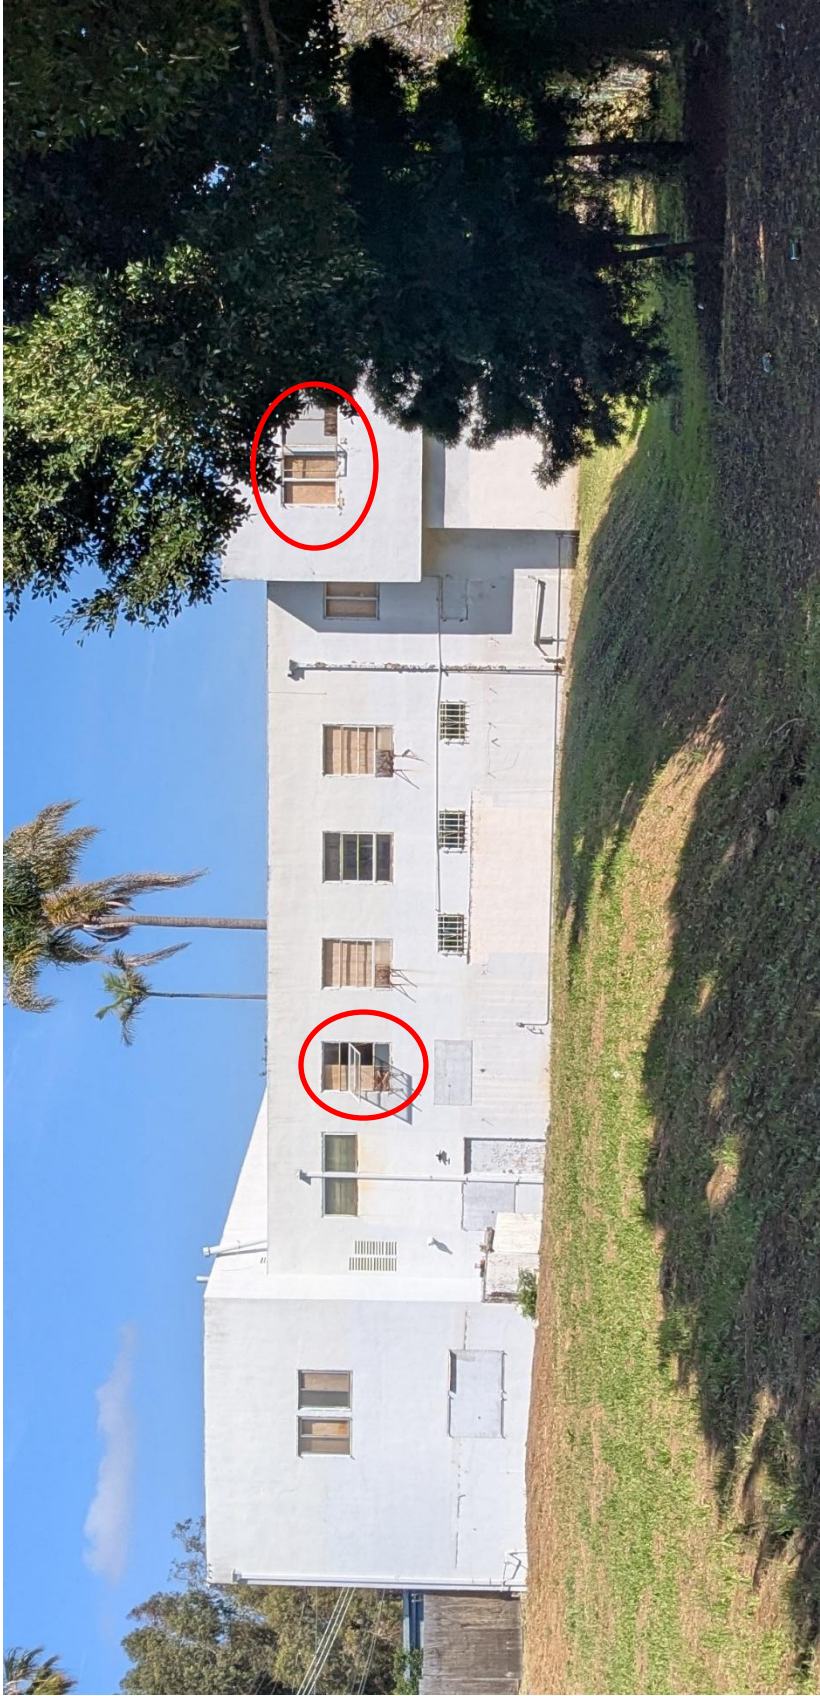
4. West Side showing open windows, 03-10-2026 (Circled in red; one year later from Photo 1)

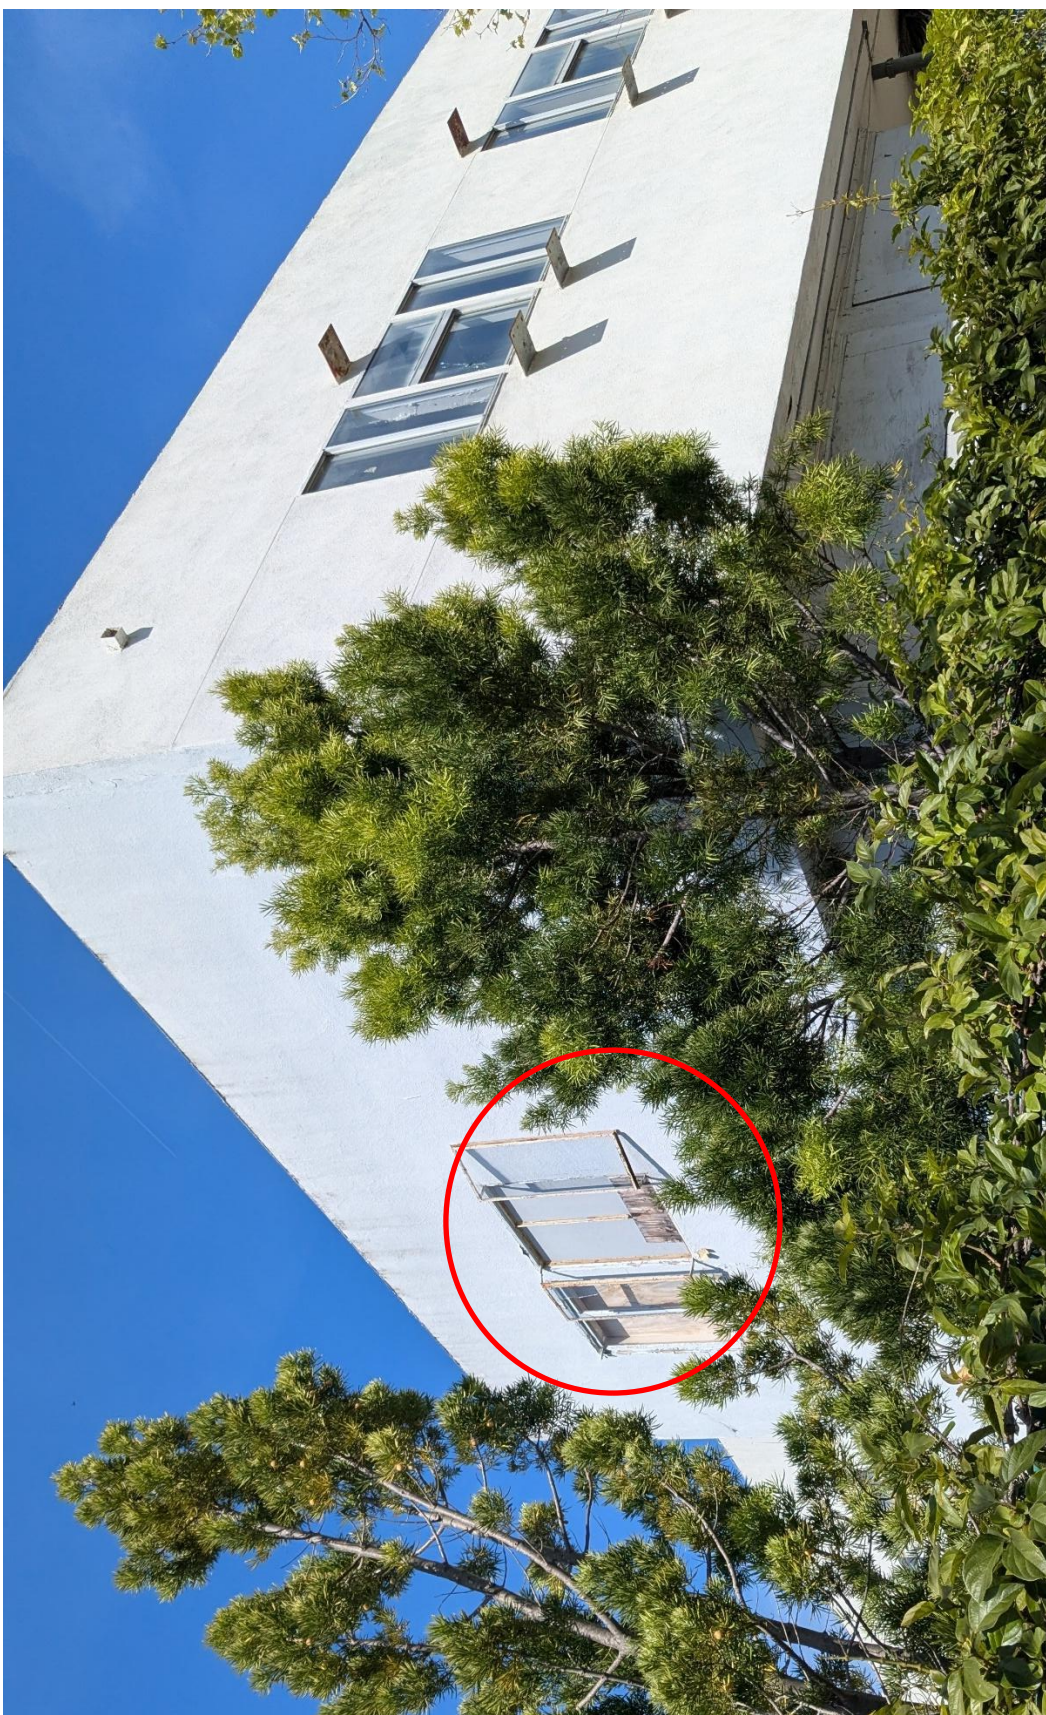
5. West Side of South Wing showing Open Windows, 03-10-2026 (Circled in red)

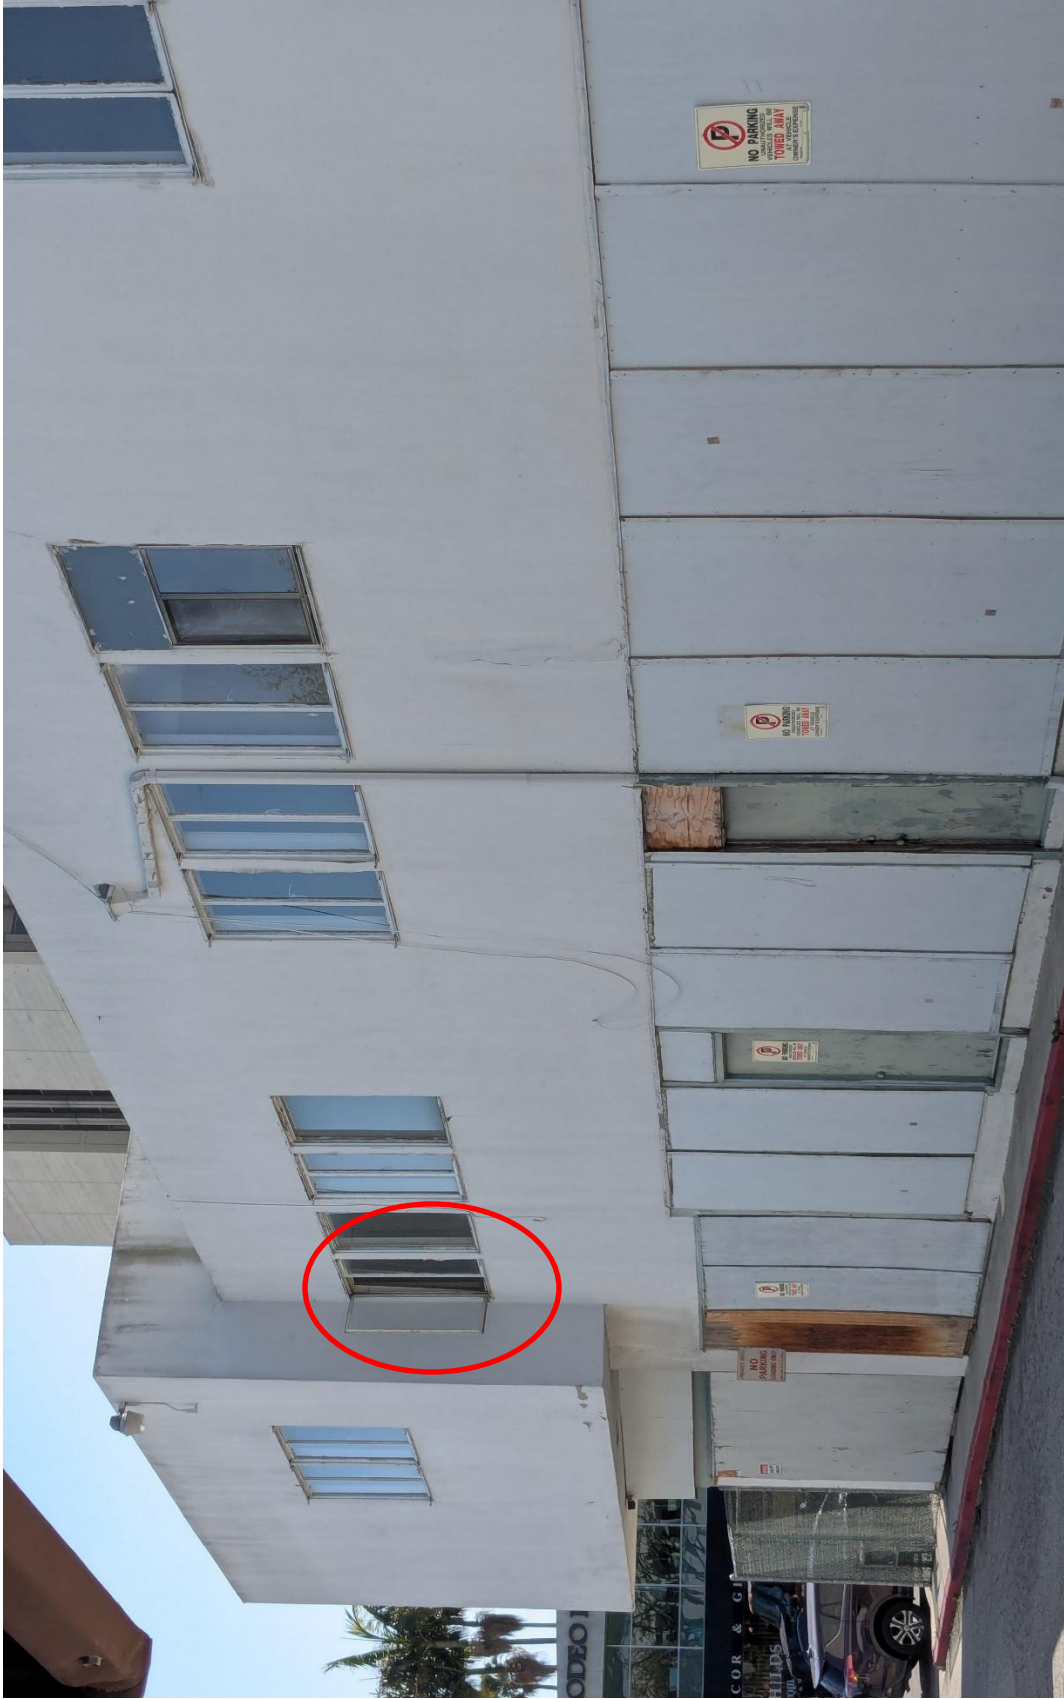
6. East Side\_ Showing open Windows, 03-10-2026 (Circled in red)

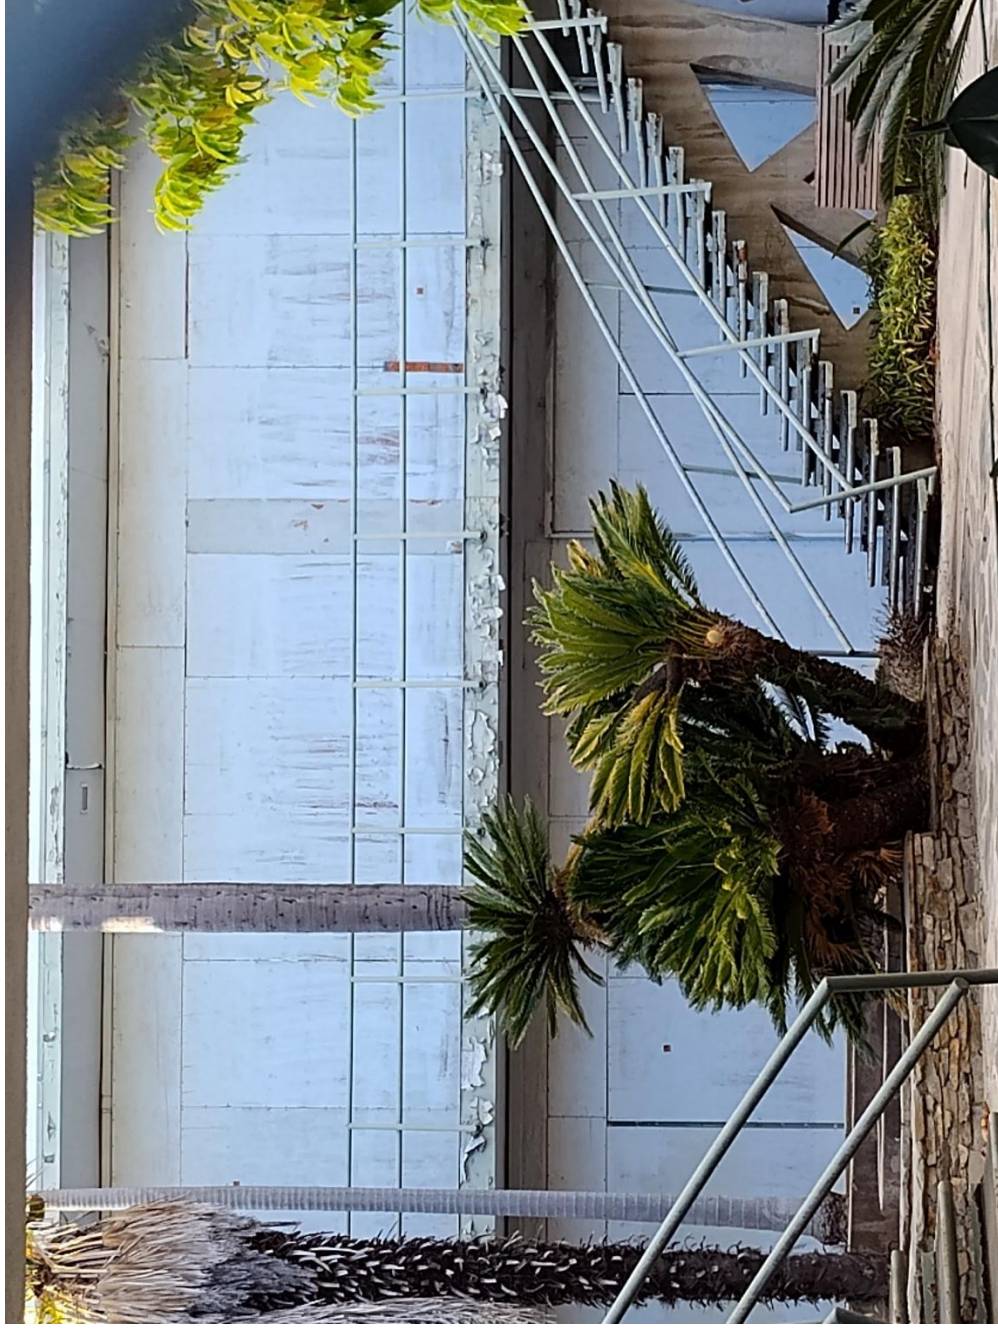
accelerating internal decay. Furthermore, photos clearly document flaking and peeling paint on both wood and metal surfaces, leaving underlying materials vulnerable. **(Attachment B)**

**1. Court Yard showing flaking paint and deteriorated conditions, 04-13-2026**

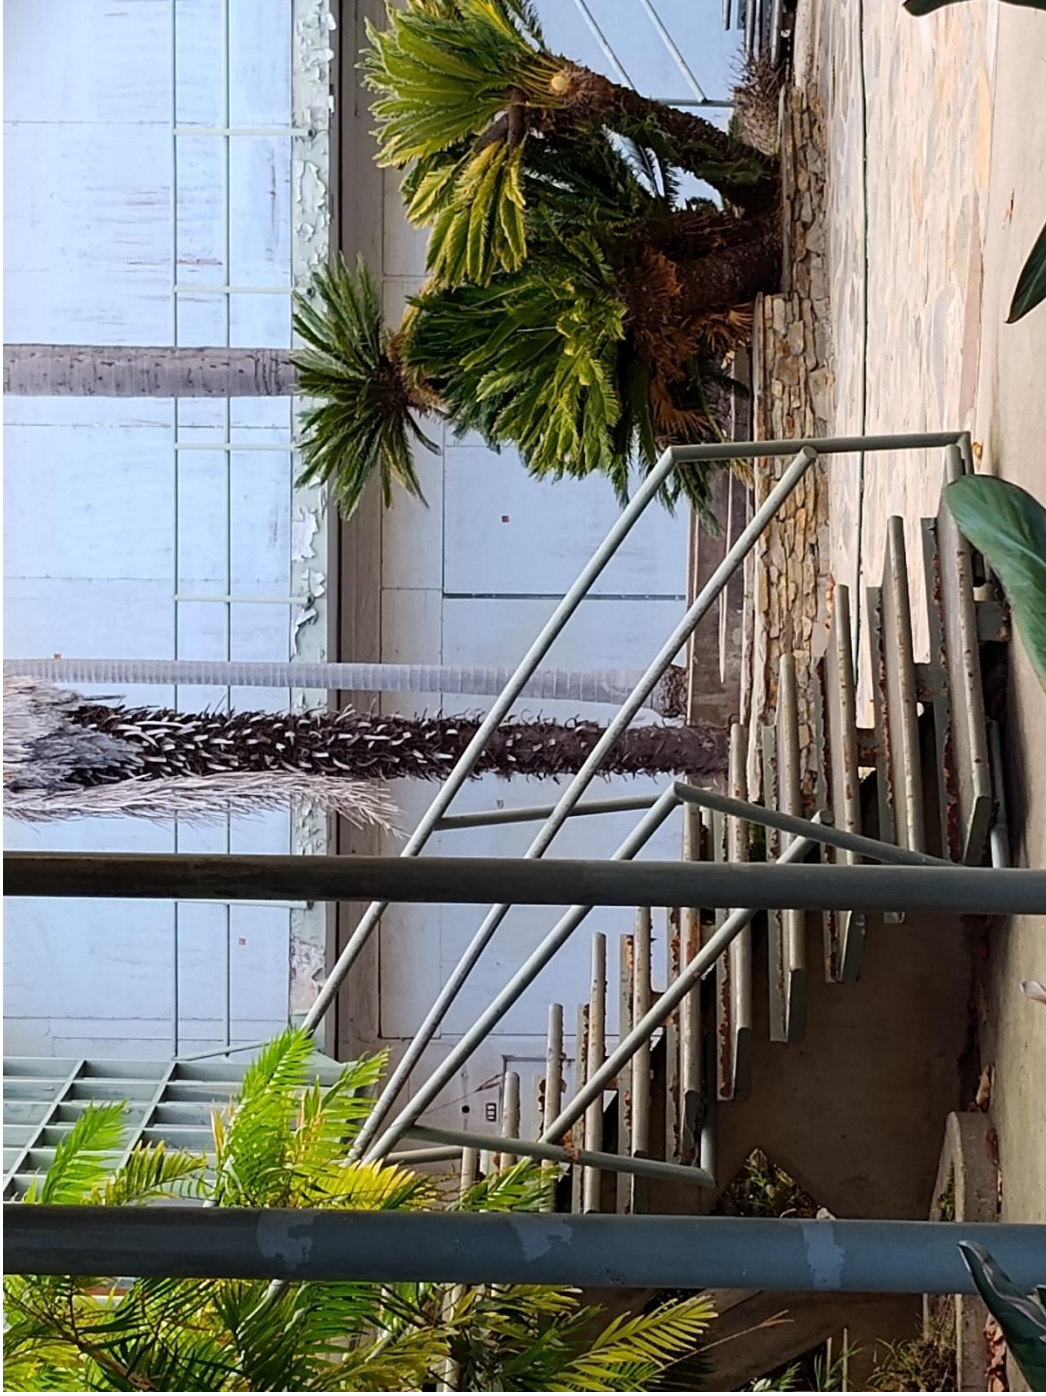
2. Court Yard showing deteriorating staircase and walkway, 04-13-2026

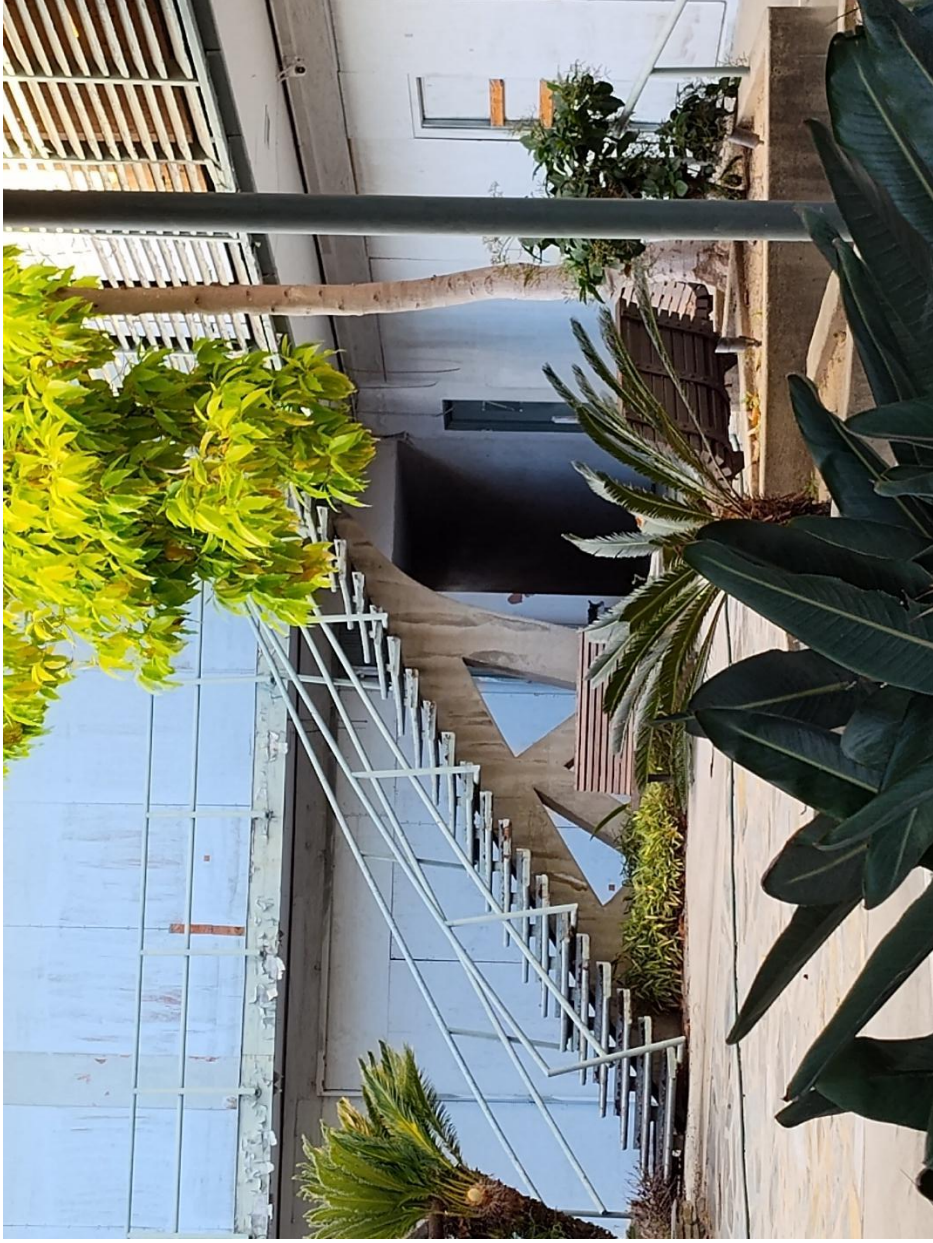
3. Court Yard showing deteriorating staircase and walkway, 04-13-2026

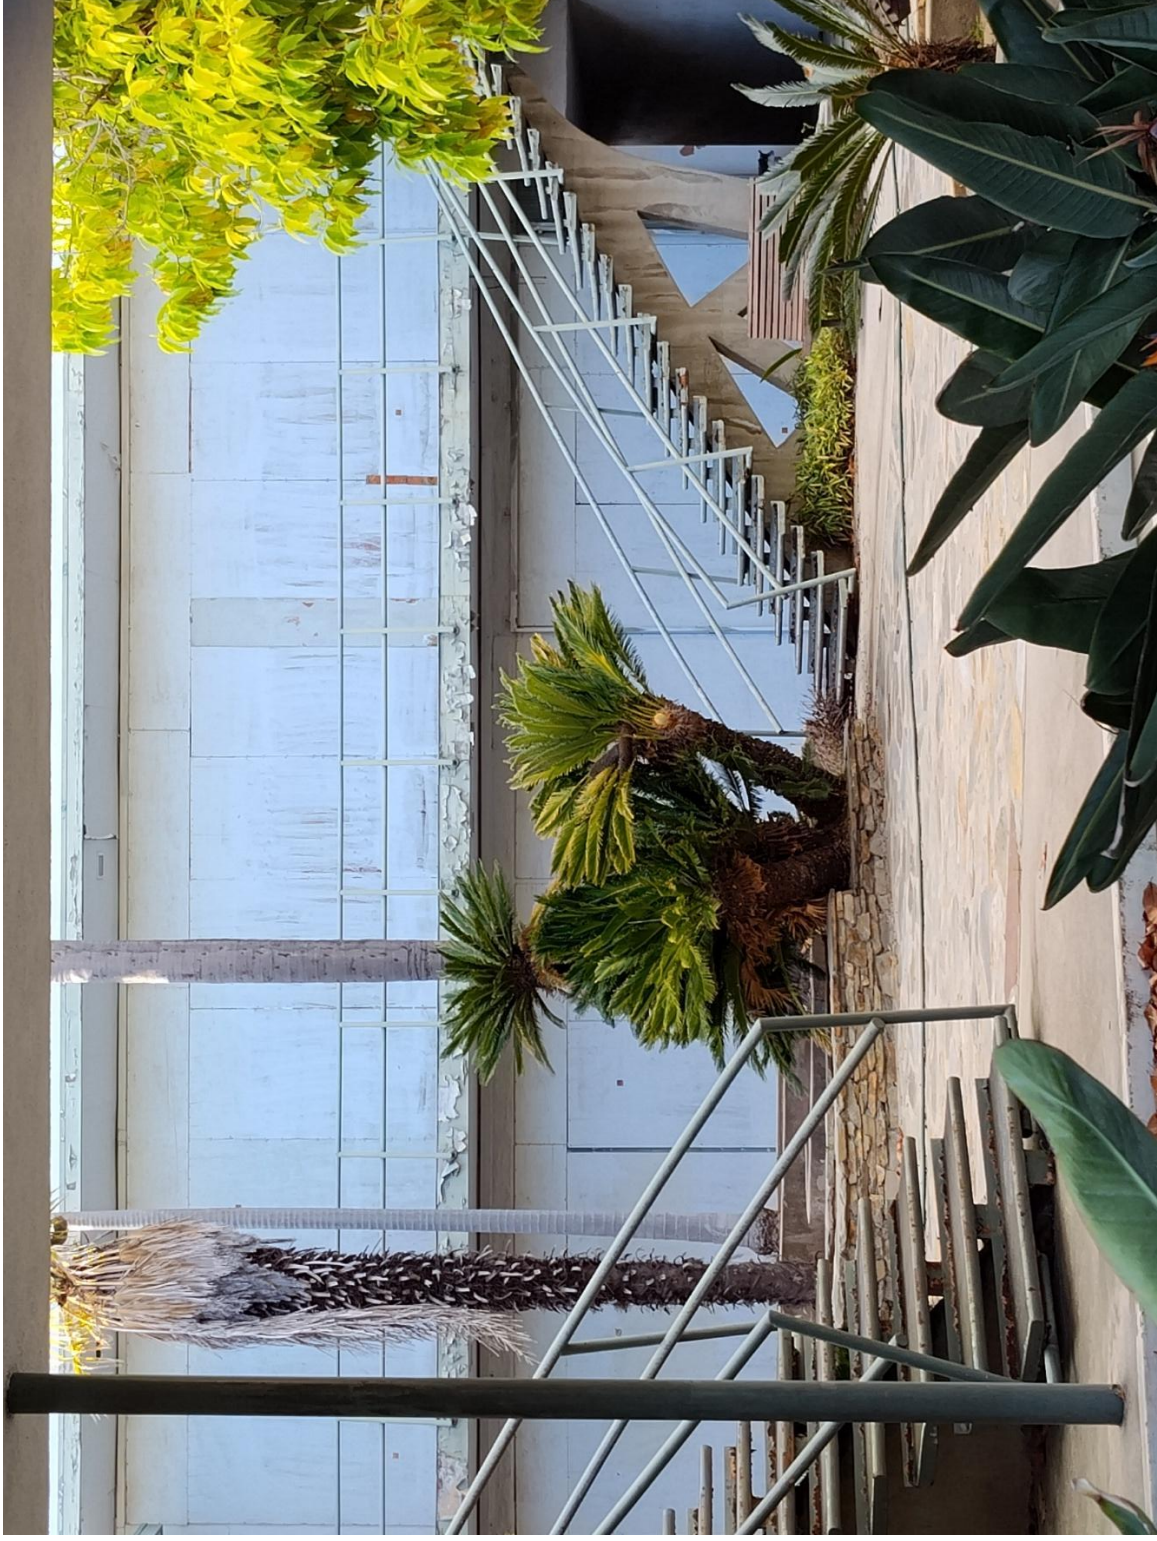
4. Court Yard showing both deteriorating staircases, 04-13-2026

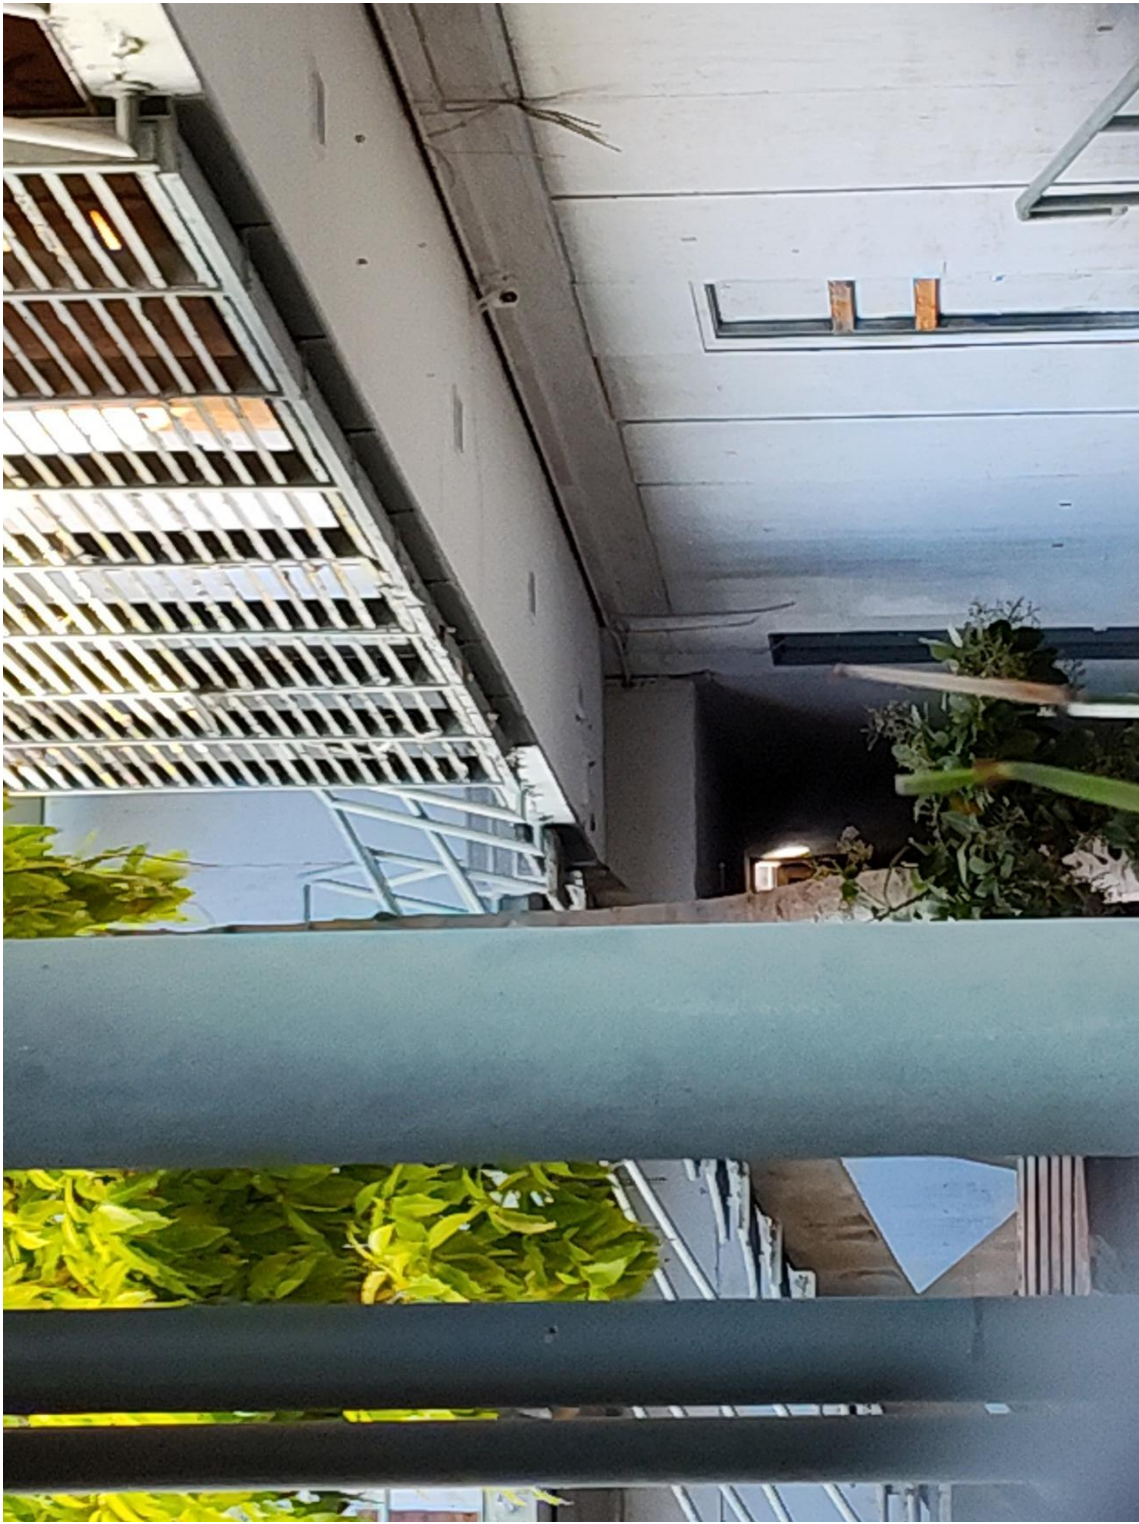
5. Court Yard showing deteriorating louvers, 04-13-2026

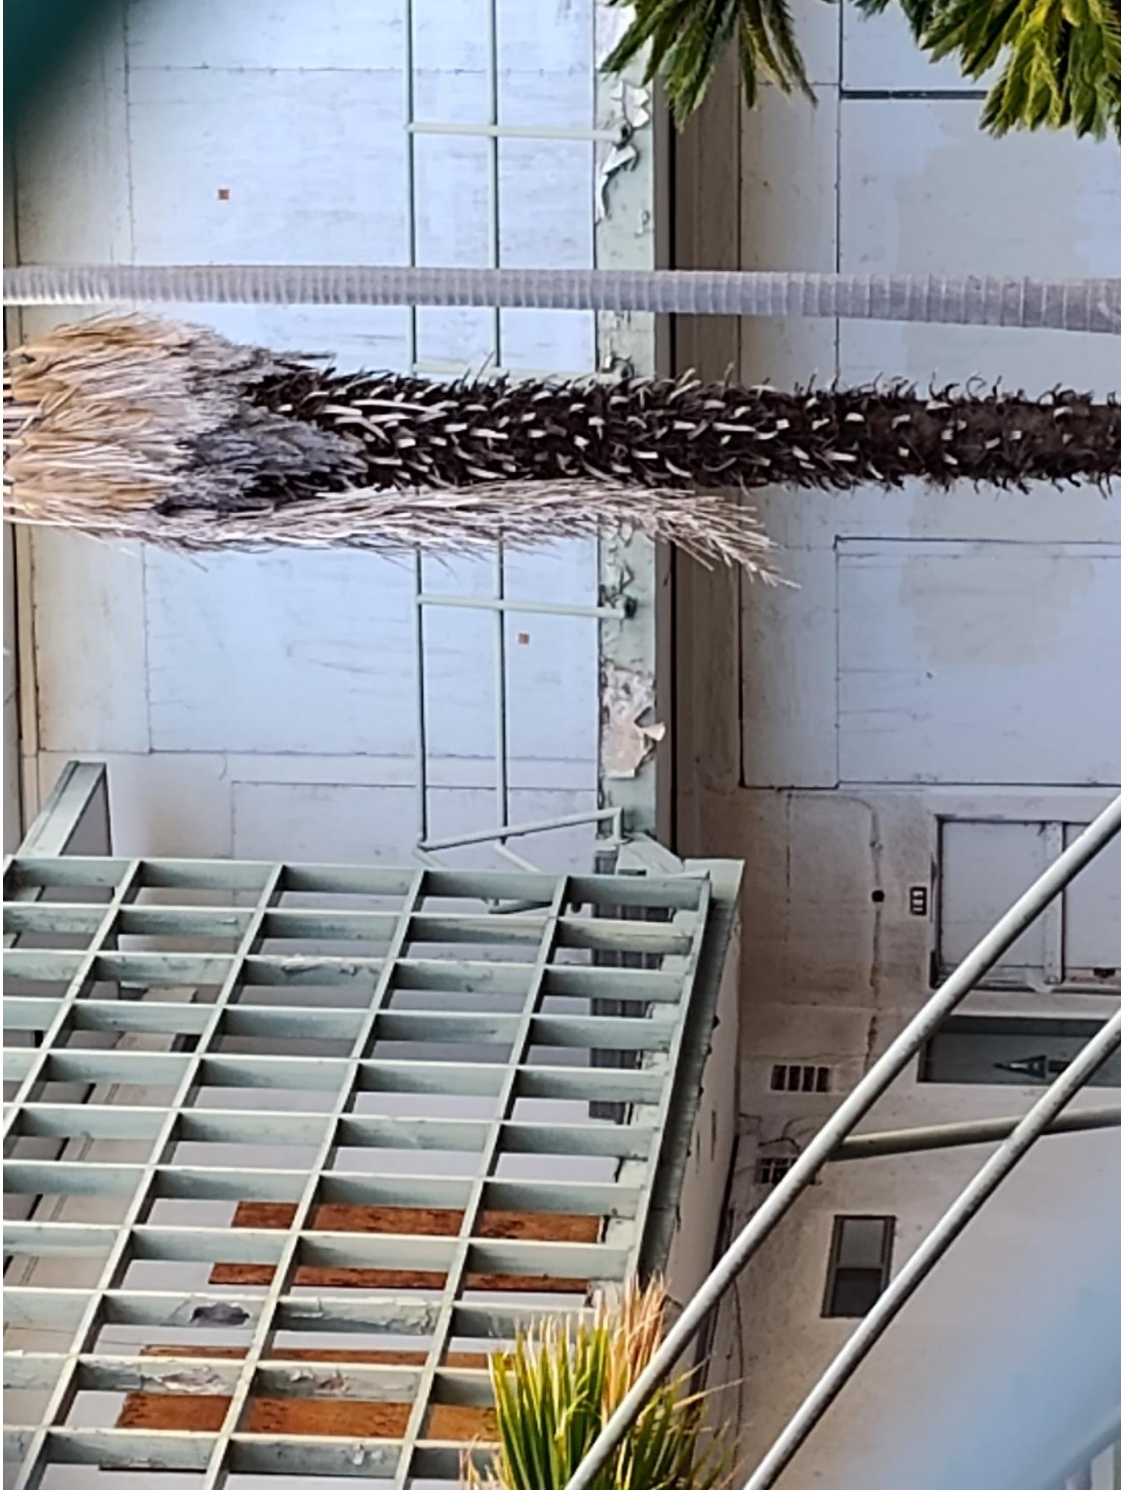
6. Court Yard showing flaking paint, 04-13-2026

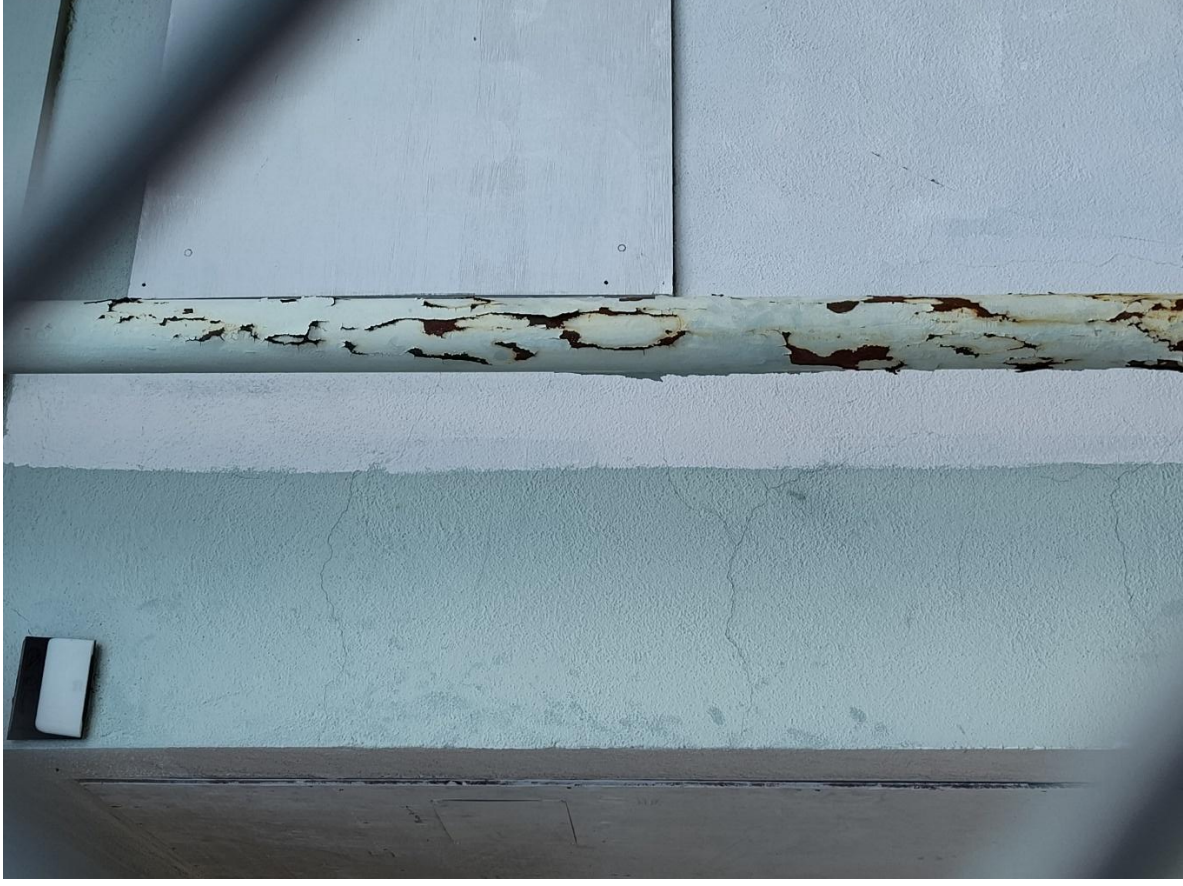
**7. Flaking and Rusting steel column, 04-13-2026**
