## Arborist Report

2170-2172 Stanley Hills Drive  
Los Angeles, California

RE: **ARBORIST REPORT** – 2170-2172 Stanley Hills Drive, Los Angeles, California  
Proposed Lot Line Adjustment; Construction of 2 New Single Family Homes  
City of Los Angeles Tree Ordinance No. 186873

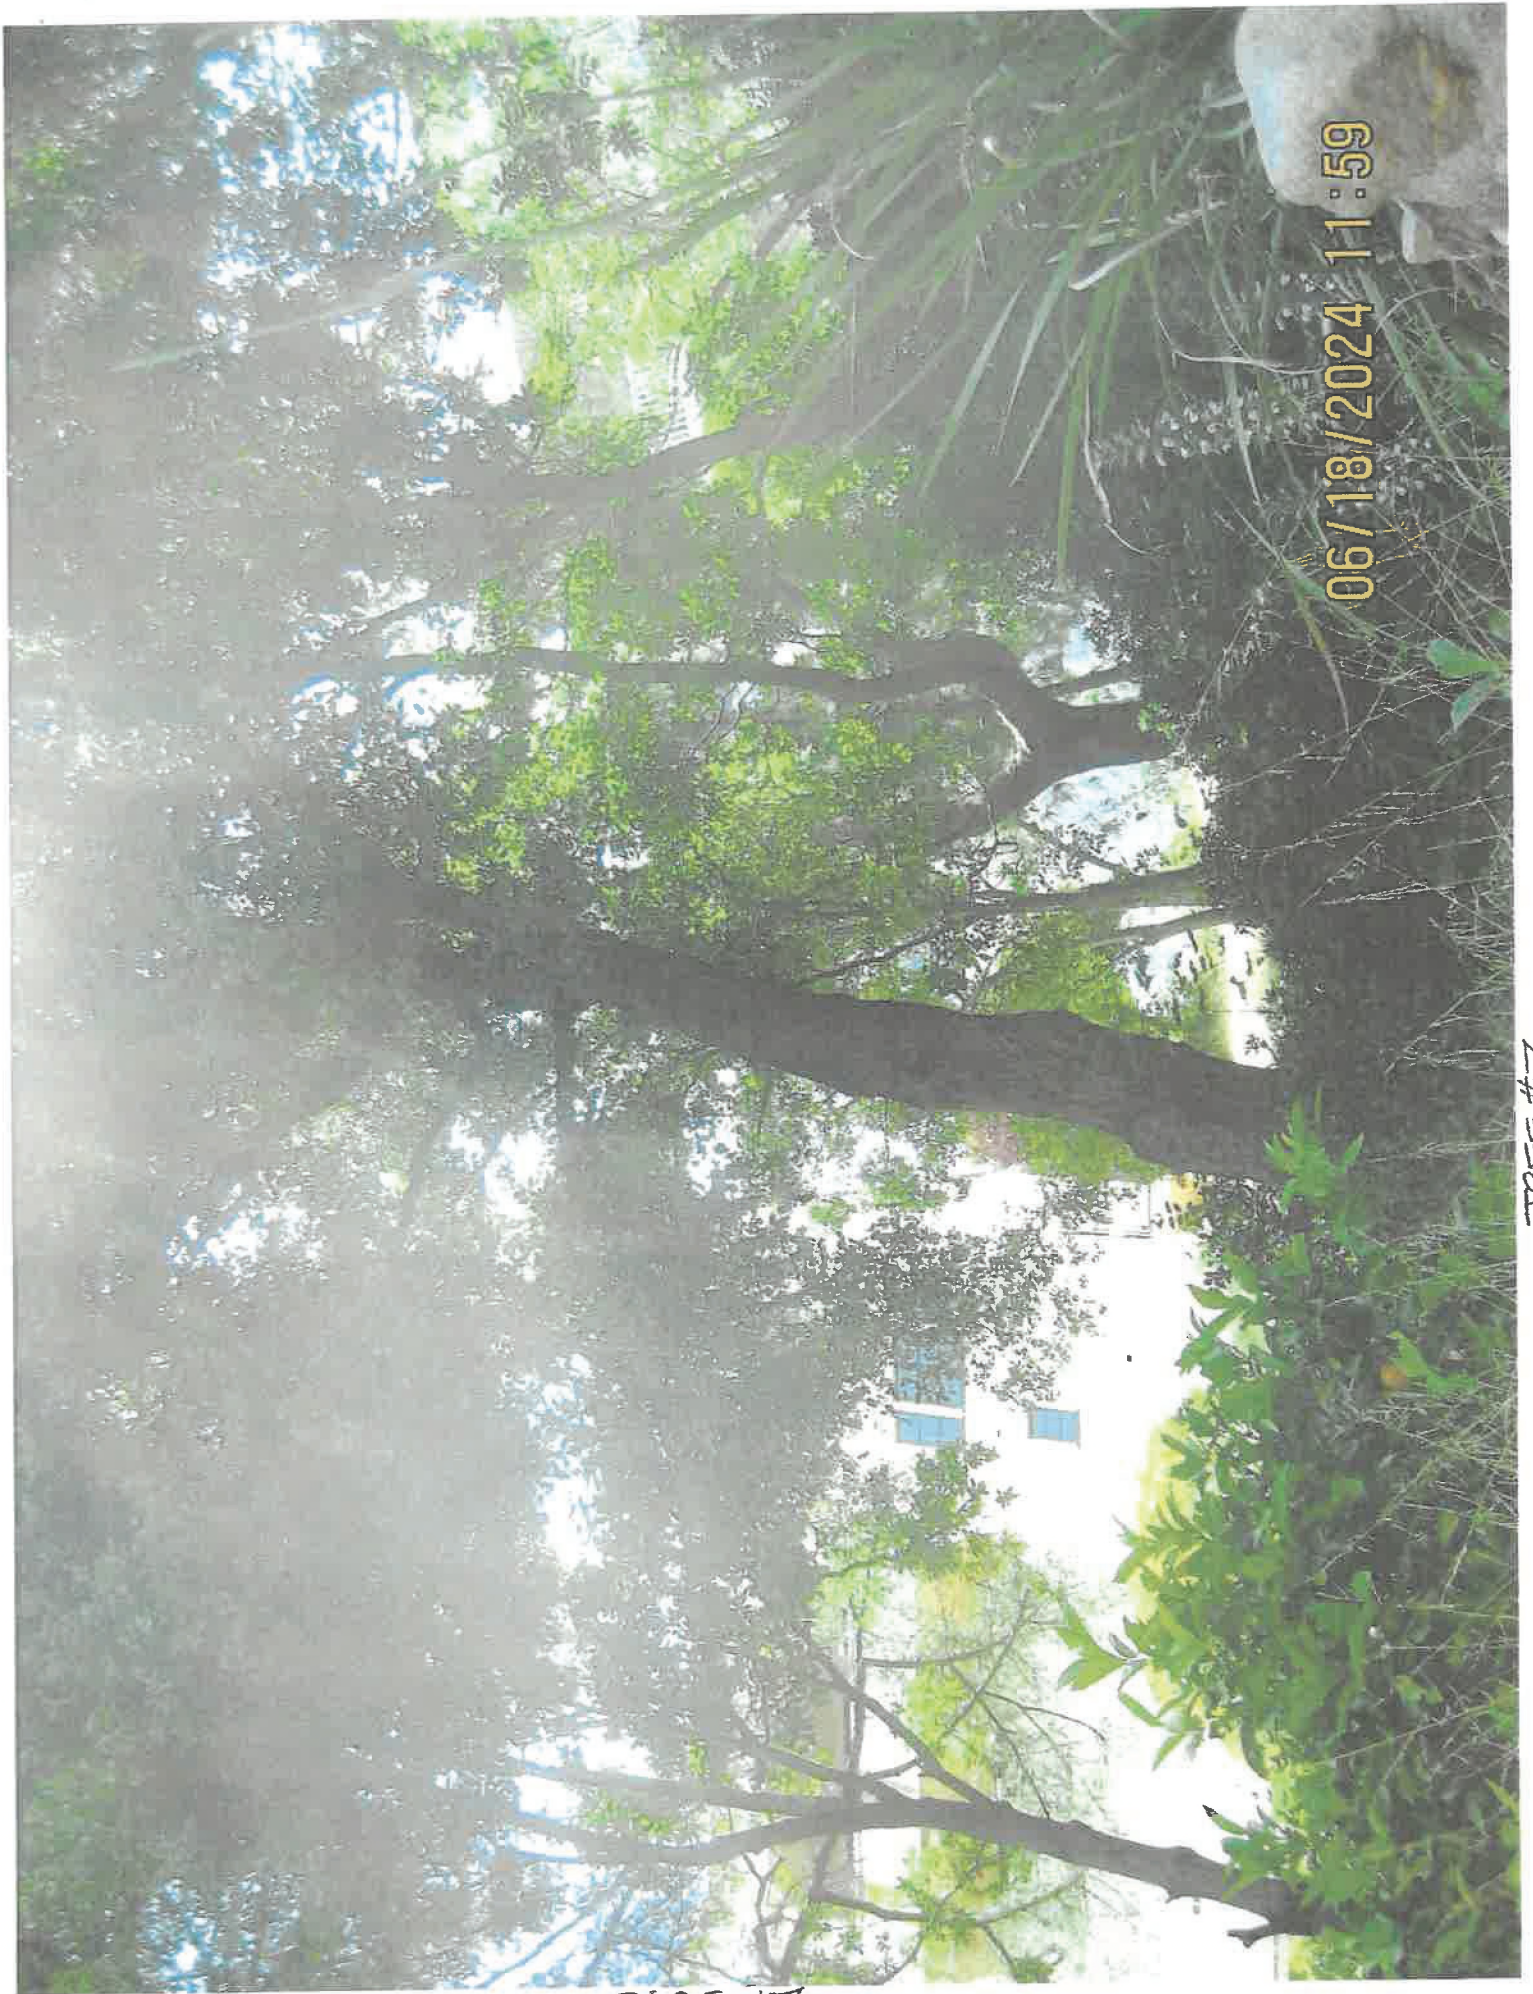
TREE #7

**Tree #7** is a Quercus agrifolia or Coast Live Oak. The tree measures 20 inches in diameter at D.B.H. The tree has a dripline which measures 20 feet south from the tree trunk and it has a 35 foot spread. It is estimated to be roughly 40 feet tall. The tree is located downhill, southwest of Tree #6 on a Poison Oak covered slope. The crown has been pruned and raised. The tree leans slightly south. It is unbalanced. It is crowded by other trees. The foliage size and color appear normal. The density is normal. The tree is in below average health and condition. Rating: B-

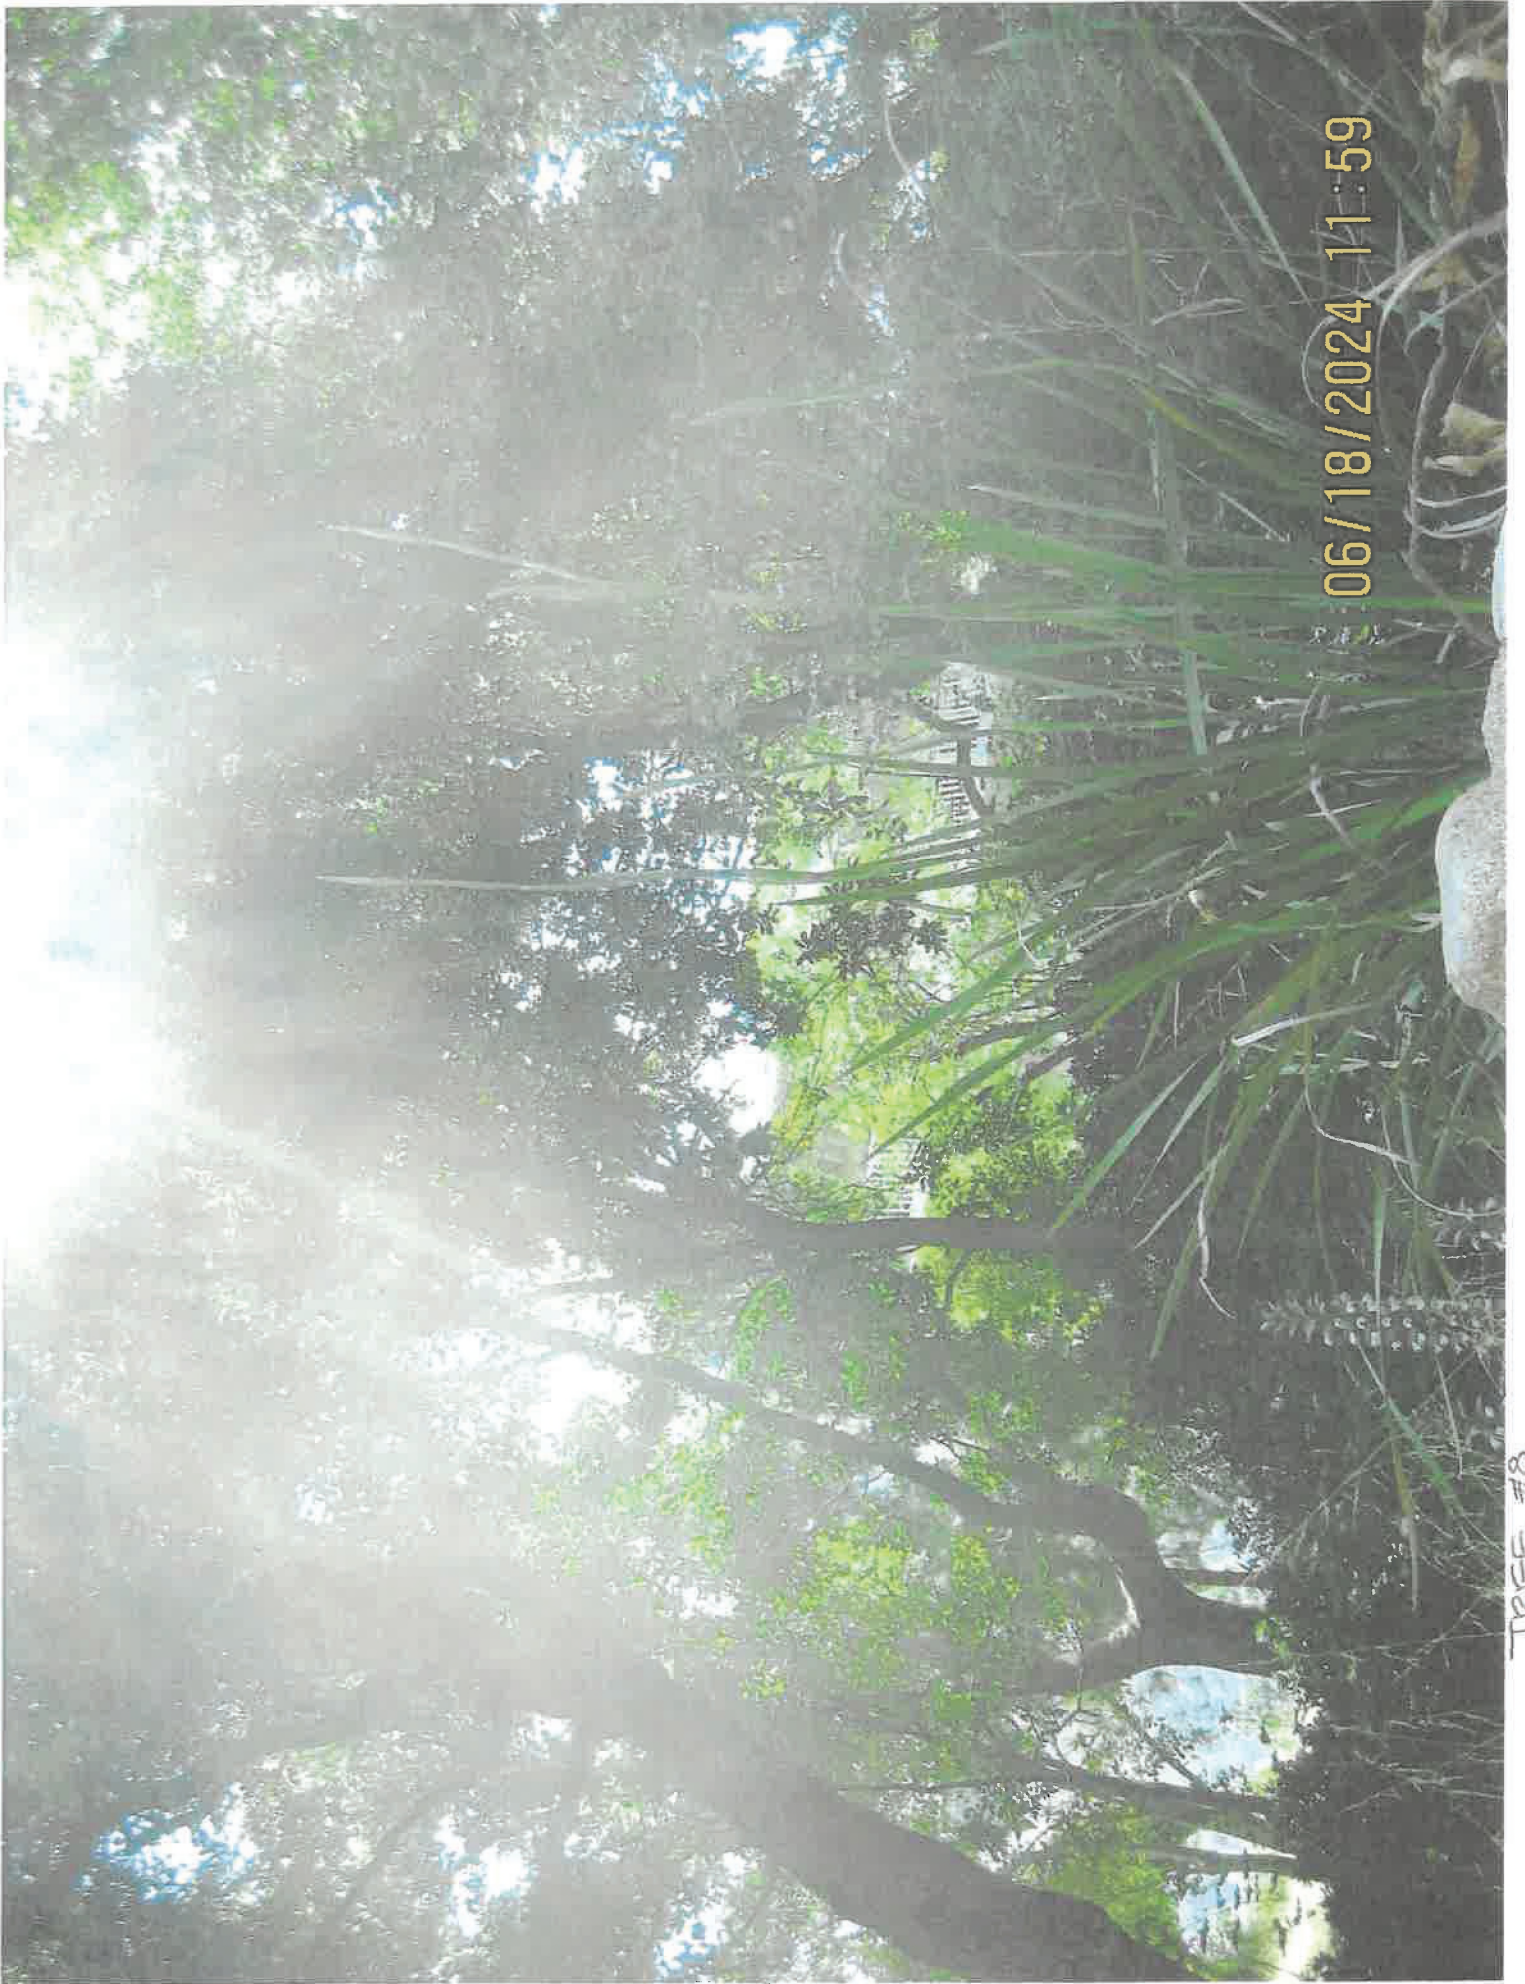
TREE #8

**Tree #8** is a Pittosporum undulatum or Victorian Box. The tree measures 10 inches in diameter at D.B.H. The tree has a dripline which measures 12 feet from the tree trunk and it has a 24 foot spread. It is estimated to be roughly 40 feet tall. The tree is located uphill, southeast of Tree #7 on a Poison Oak covered slope. The crown has been pruned and raised. It is balanced. The foliage size and color appear normal. The density is fair. The tree is in slightly below average health and condition. Rating: C-

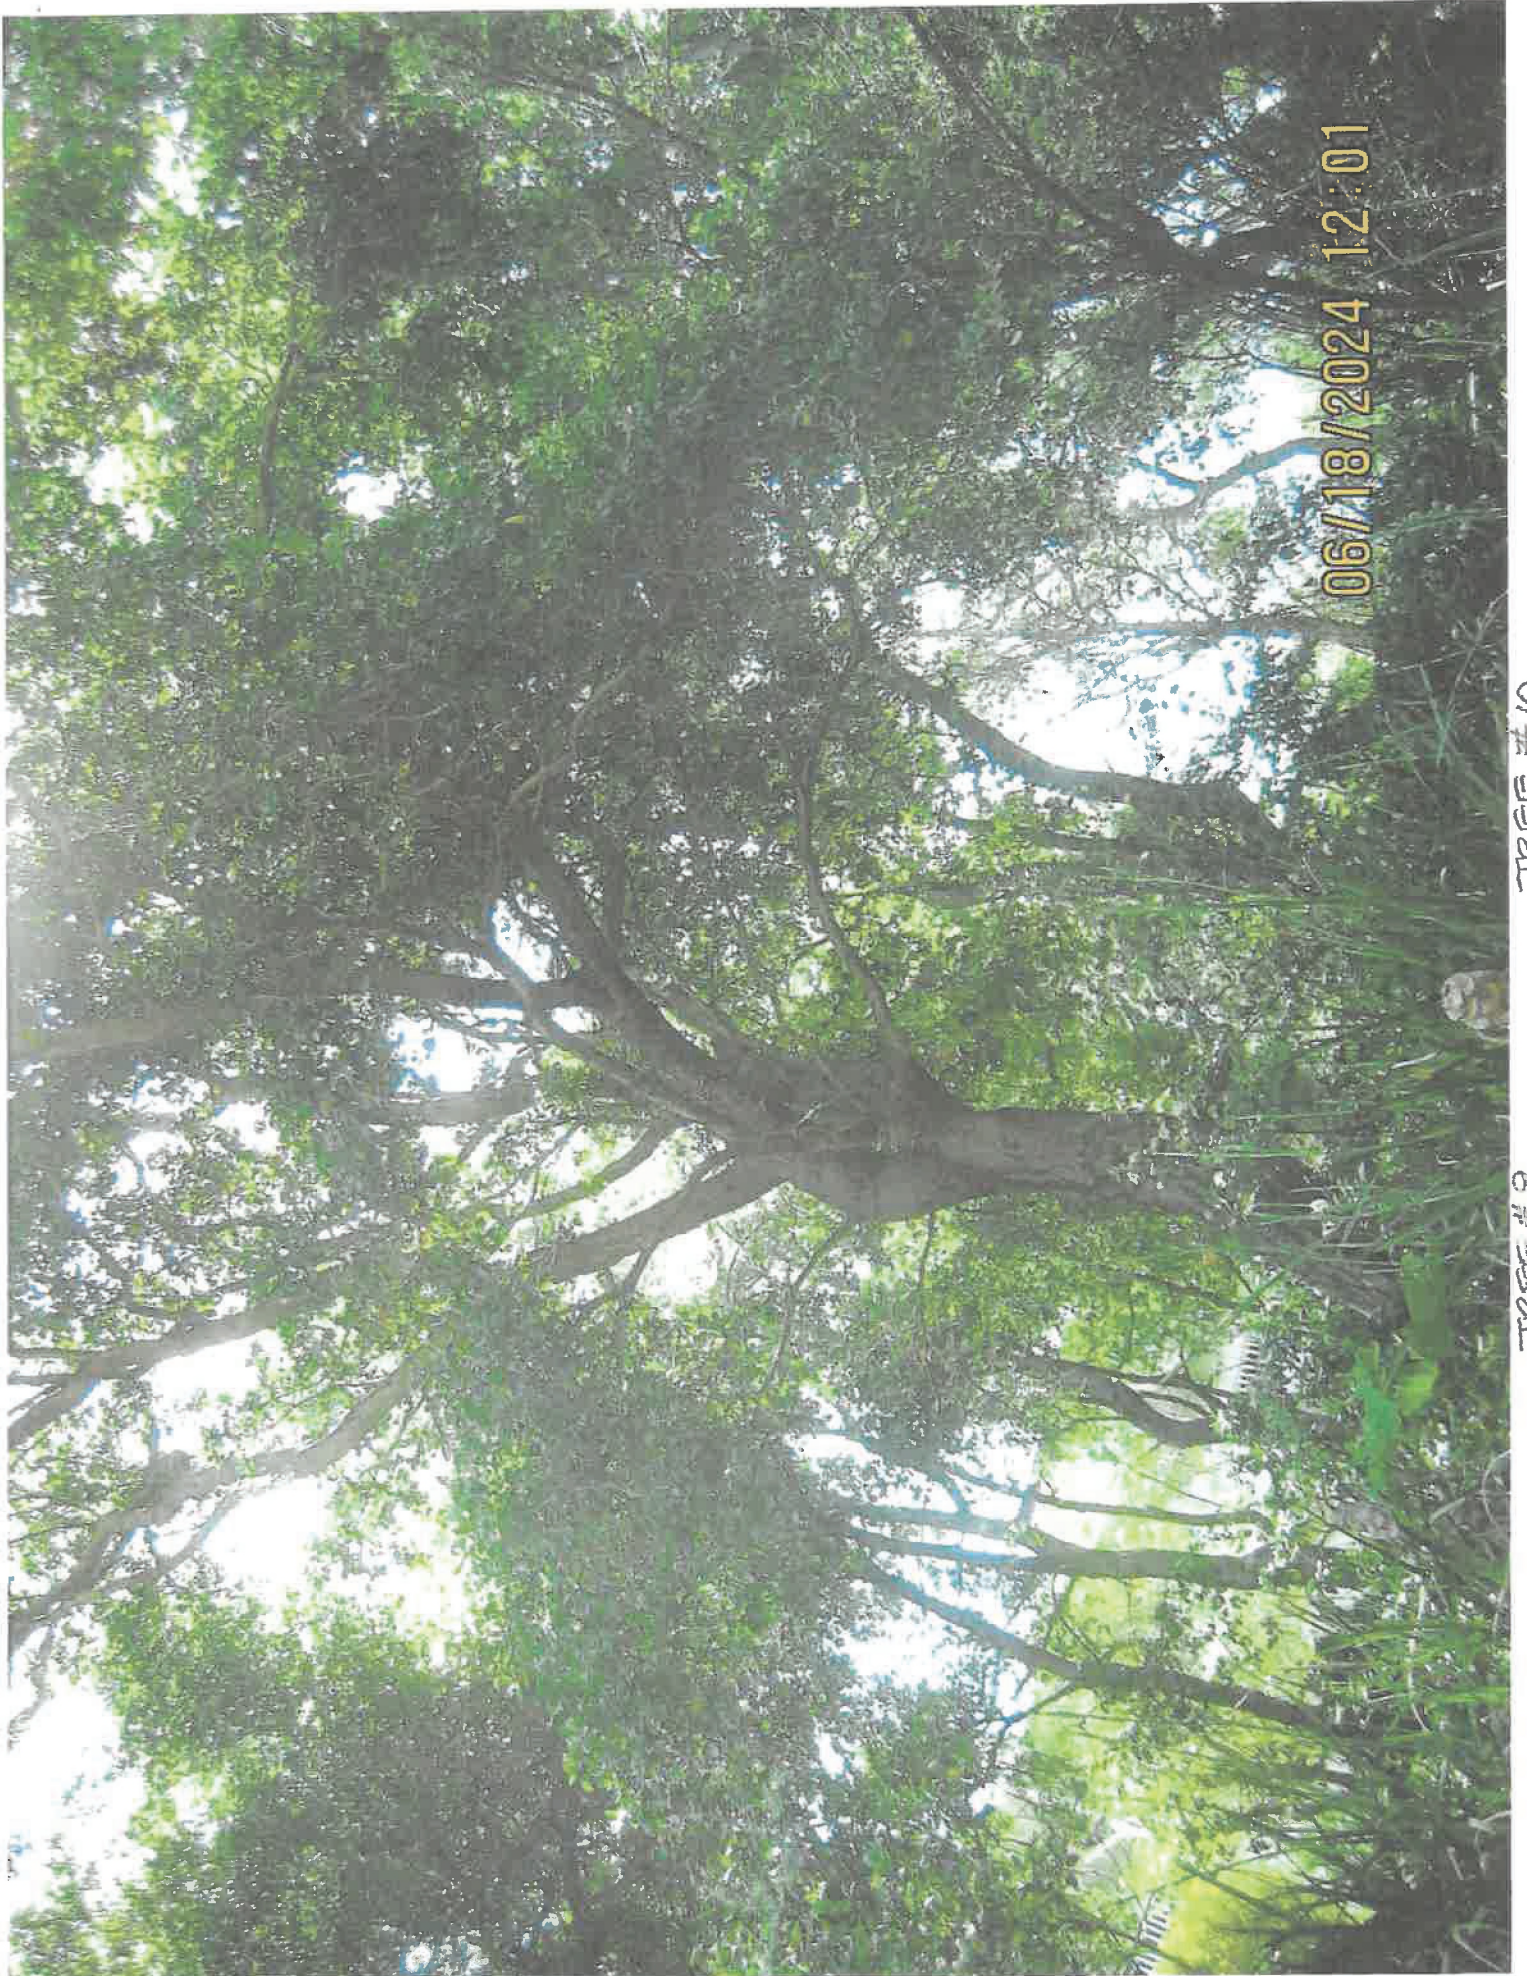
TREE #9

**Tree #9** is a Quercus agrifolia or Coast Live Oak. The tree measures 12 inches in diameter at D.B.H. The tree has a dripline which measures 12 feet from the tree trunk and it has a 24 foot spread. It is estimated to be roughly 30 feet tall. The tree is located downhill, southwest of Tree #8 on a Poison Oak covered slope. The crown has been pruned and raised. The tree is balanced. It is crowded by other trees. The foliage size and color appear normal. The density is normal. The tree is in below average health and condition. Rating: B-

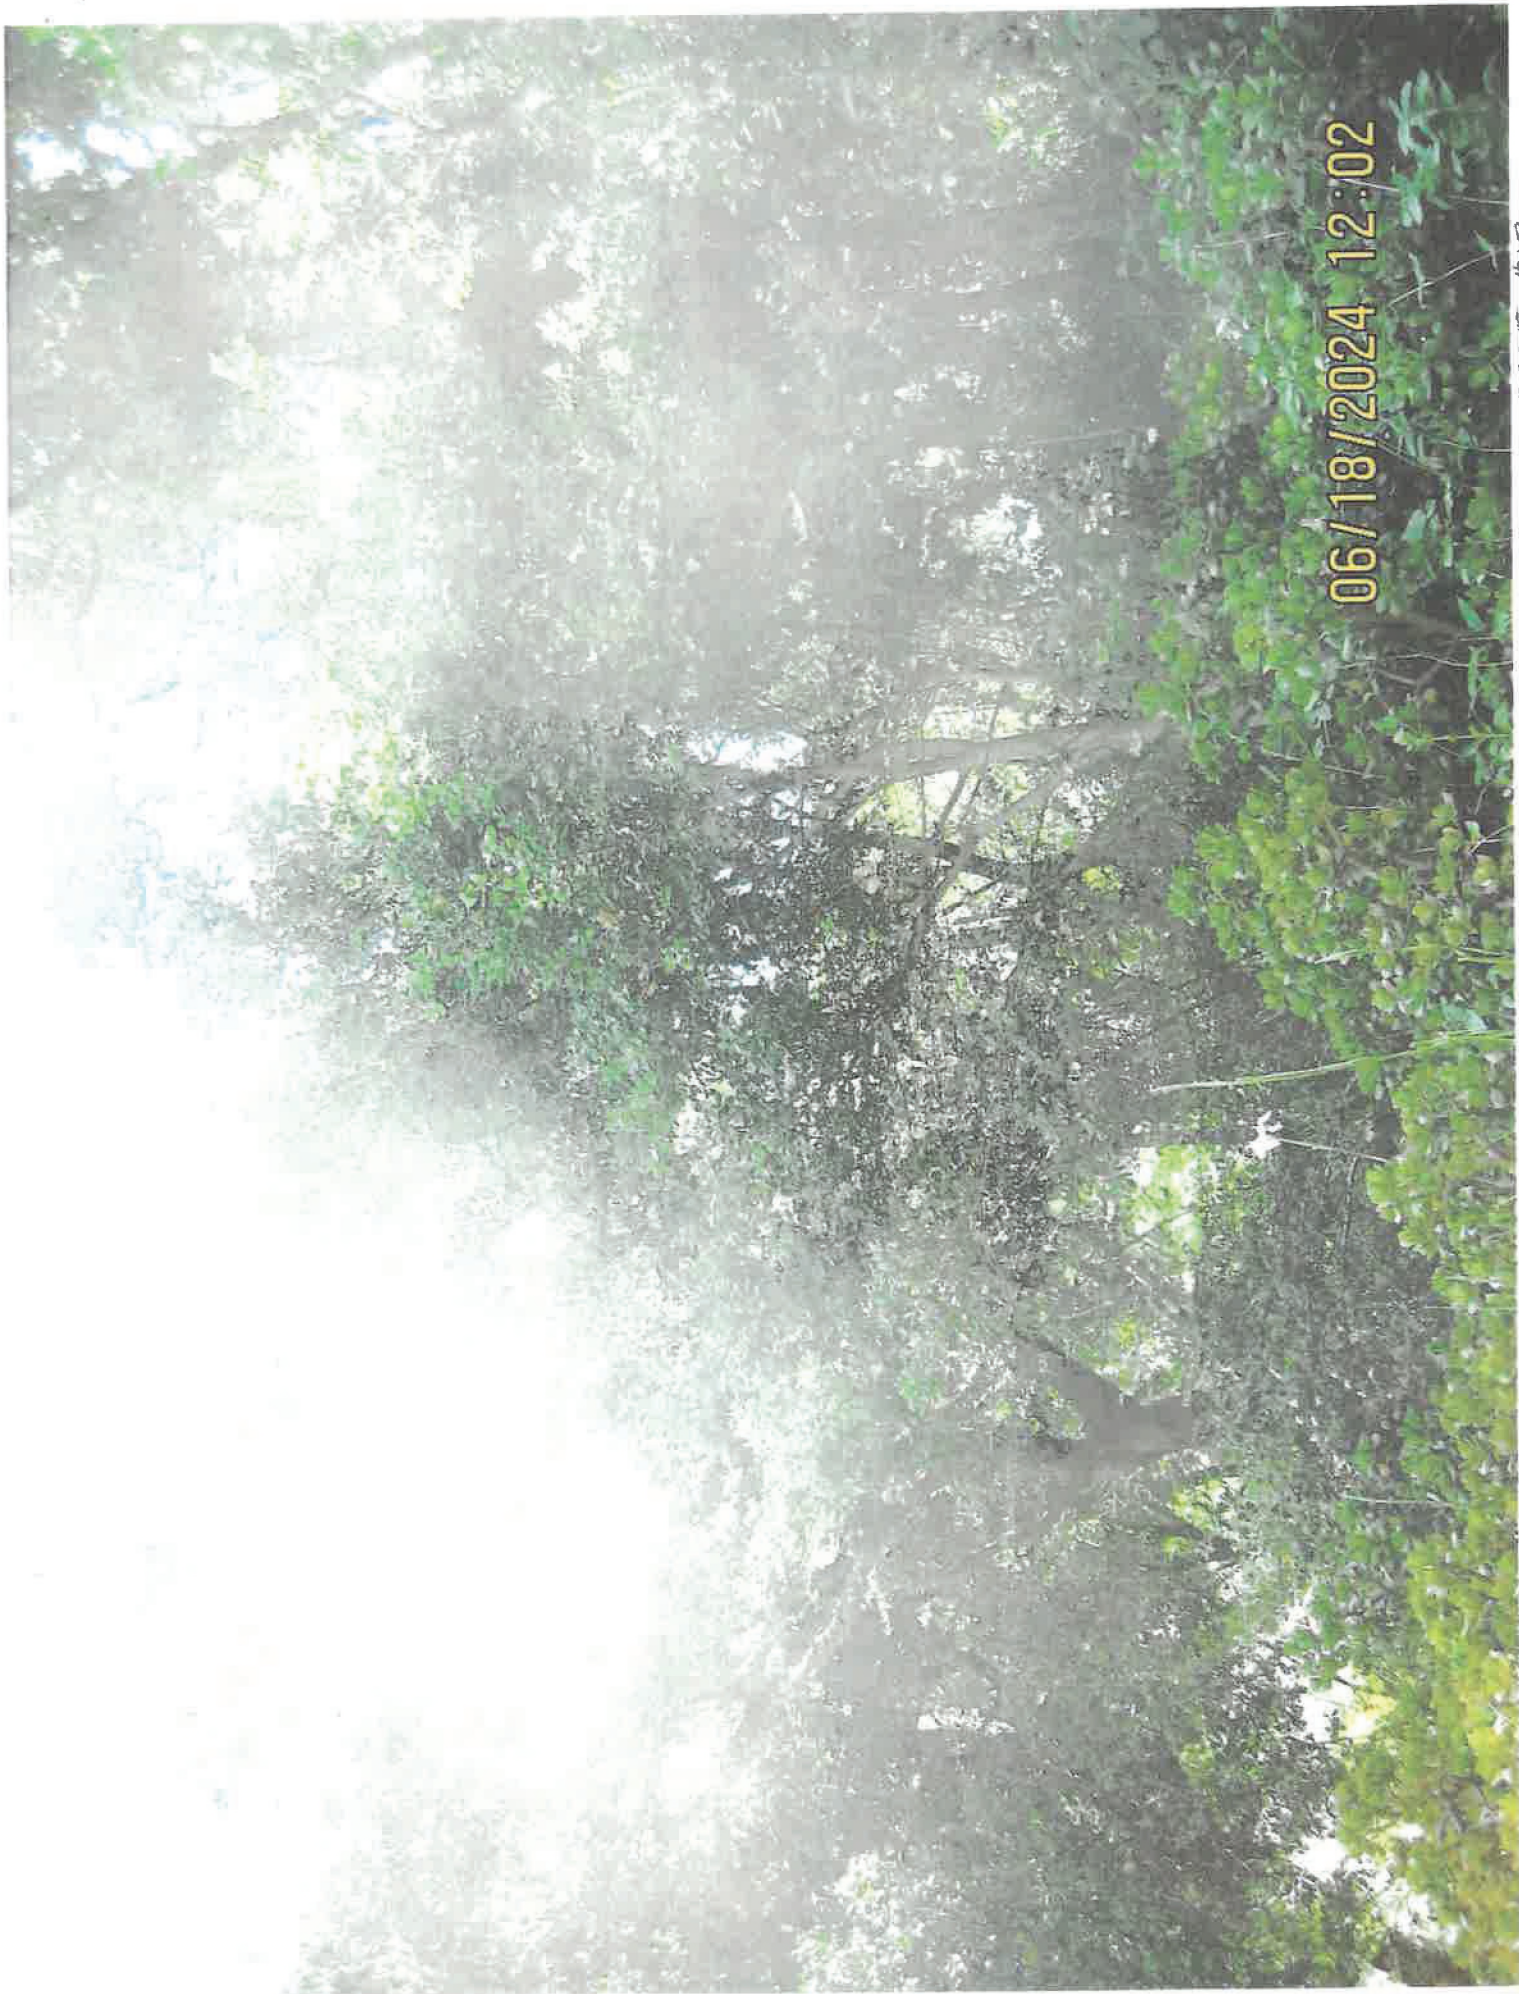
TREE #12

**Tree #12** is a Quercus agrifolia or Coast Live Oak. The tree measures 12 inches in diameter at D.B.H. The tree has a dripline which measures 15 feet from the tree trunk and it has a 30 foot spread. It is estimated to be roughly 15 feet tall. The tree is located uphill, southeast of Tree #11 on a Poison Oak covered slope. The crown has been pruned and raised. The tree is balanced. It is crowded by other trees. The foliage size and color appear normal. The density is normal. The tree is in good health and condition. Rating: B

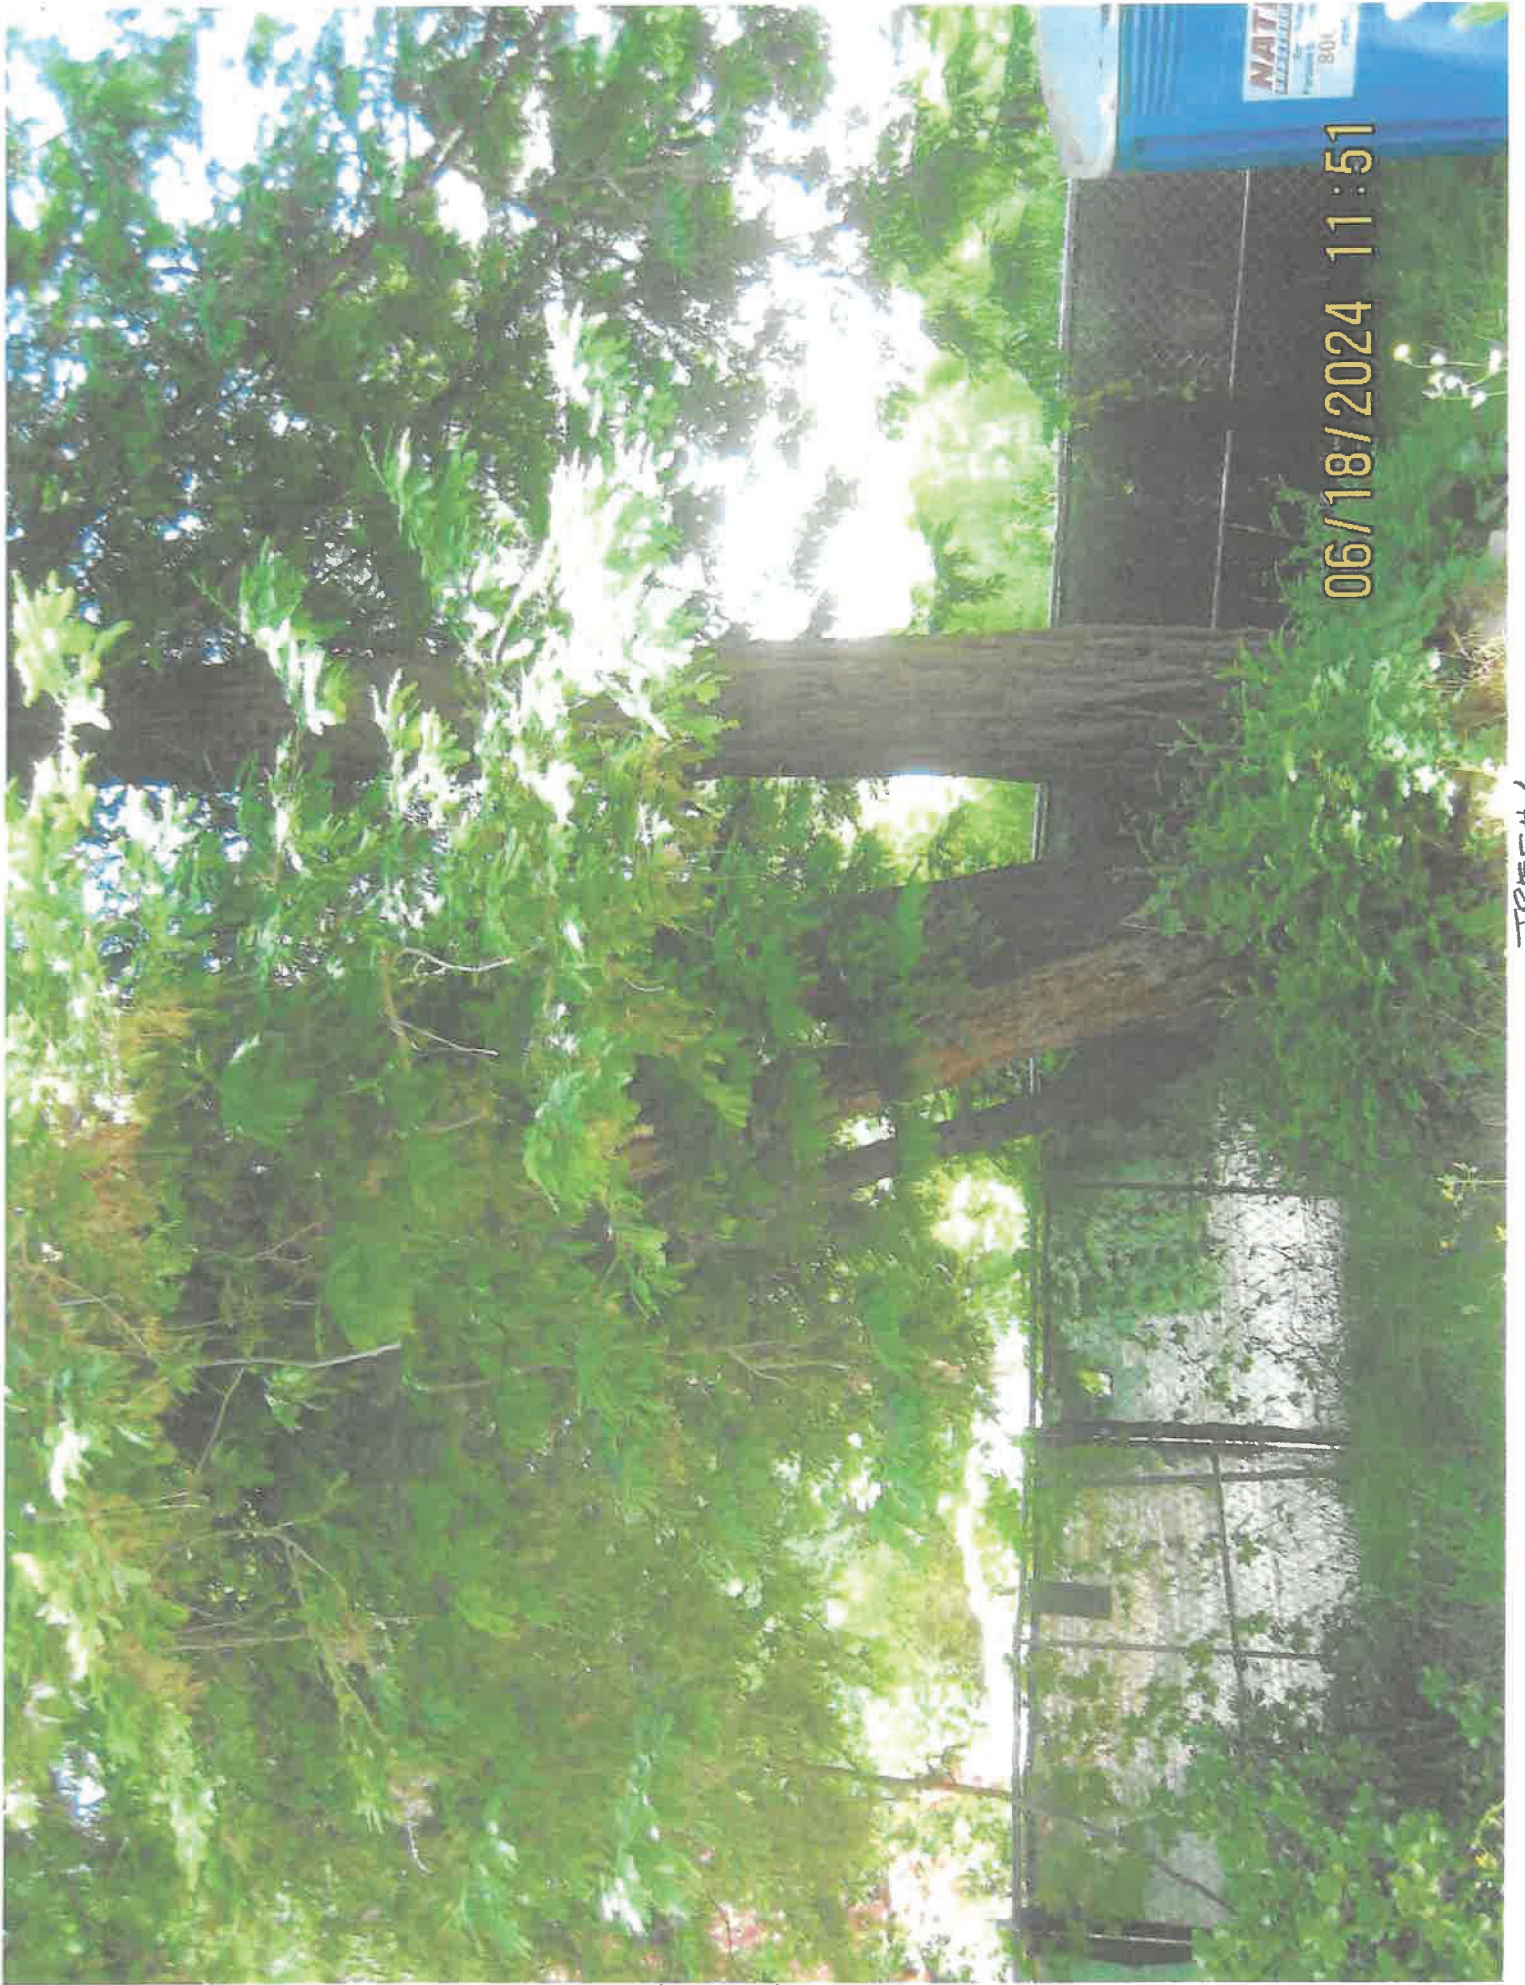
TREE#1

**Tree #1** is a *Sequoia sempervirens* or Coast Redwood. The tree measures 8,5,9,15,19 inches in diameter at D.B.H. (Diameter Breast Height) or 4.5 feet above the ground. The tree has a dripline which measures 14 feet from the tree trunk and it has a 28 foot spread. It is estimated to be roughly 70 feet tall. The tree is located northwest of an existing 2-story building on the site. It is a multi-trunk tree. There are epicormics at the base. The crown is raised. The foliage size and color appear normal. The crown density is normal. The tree is in good health and condition. Rating: B

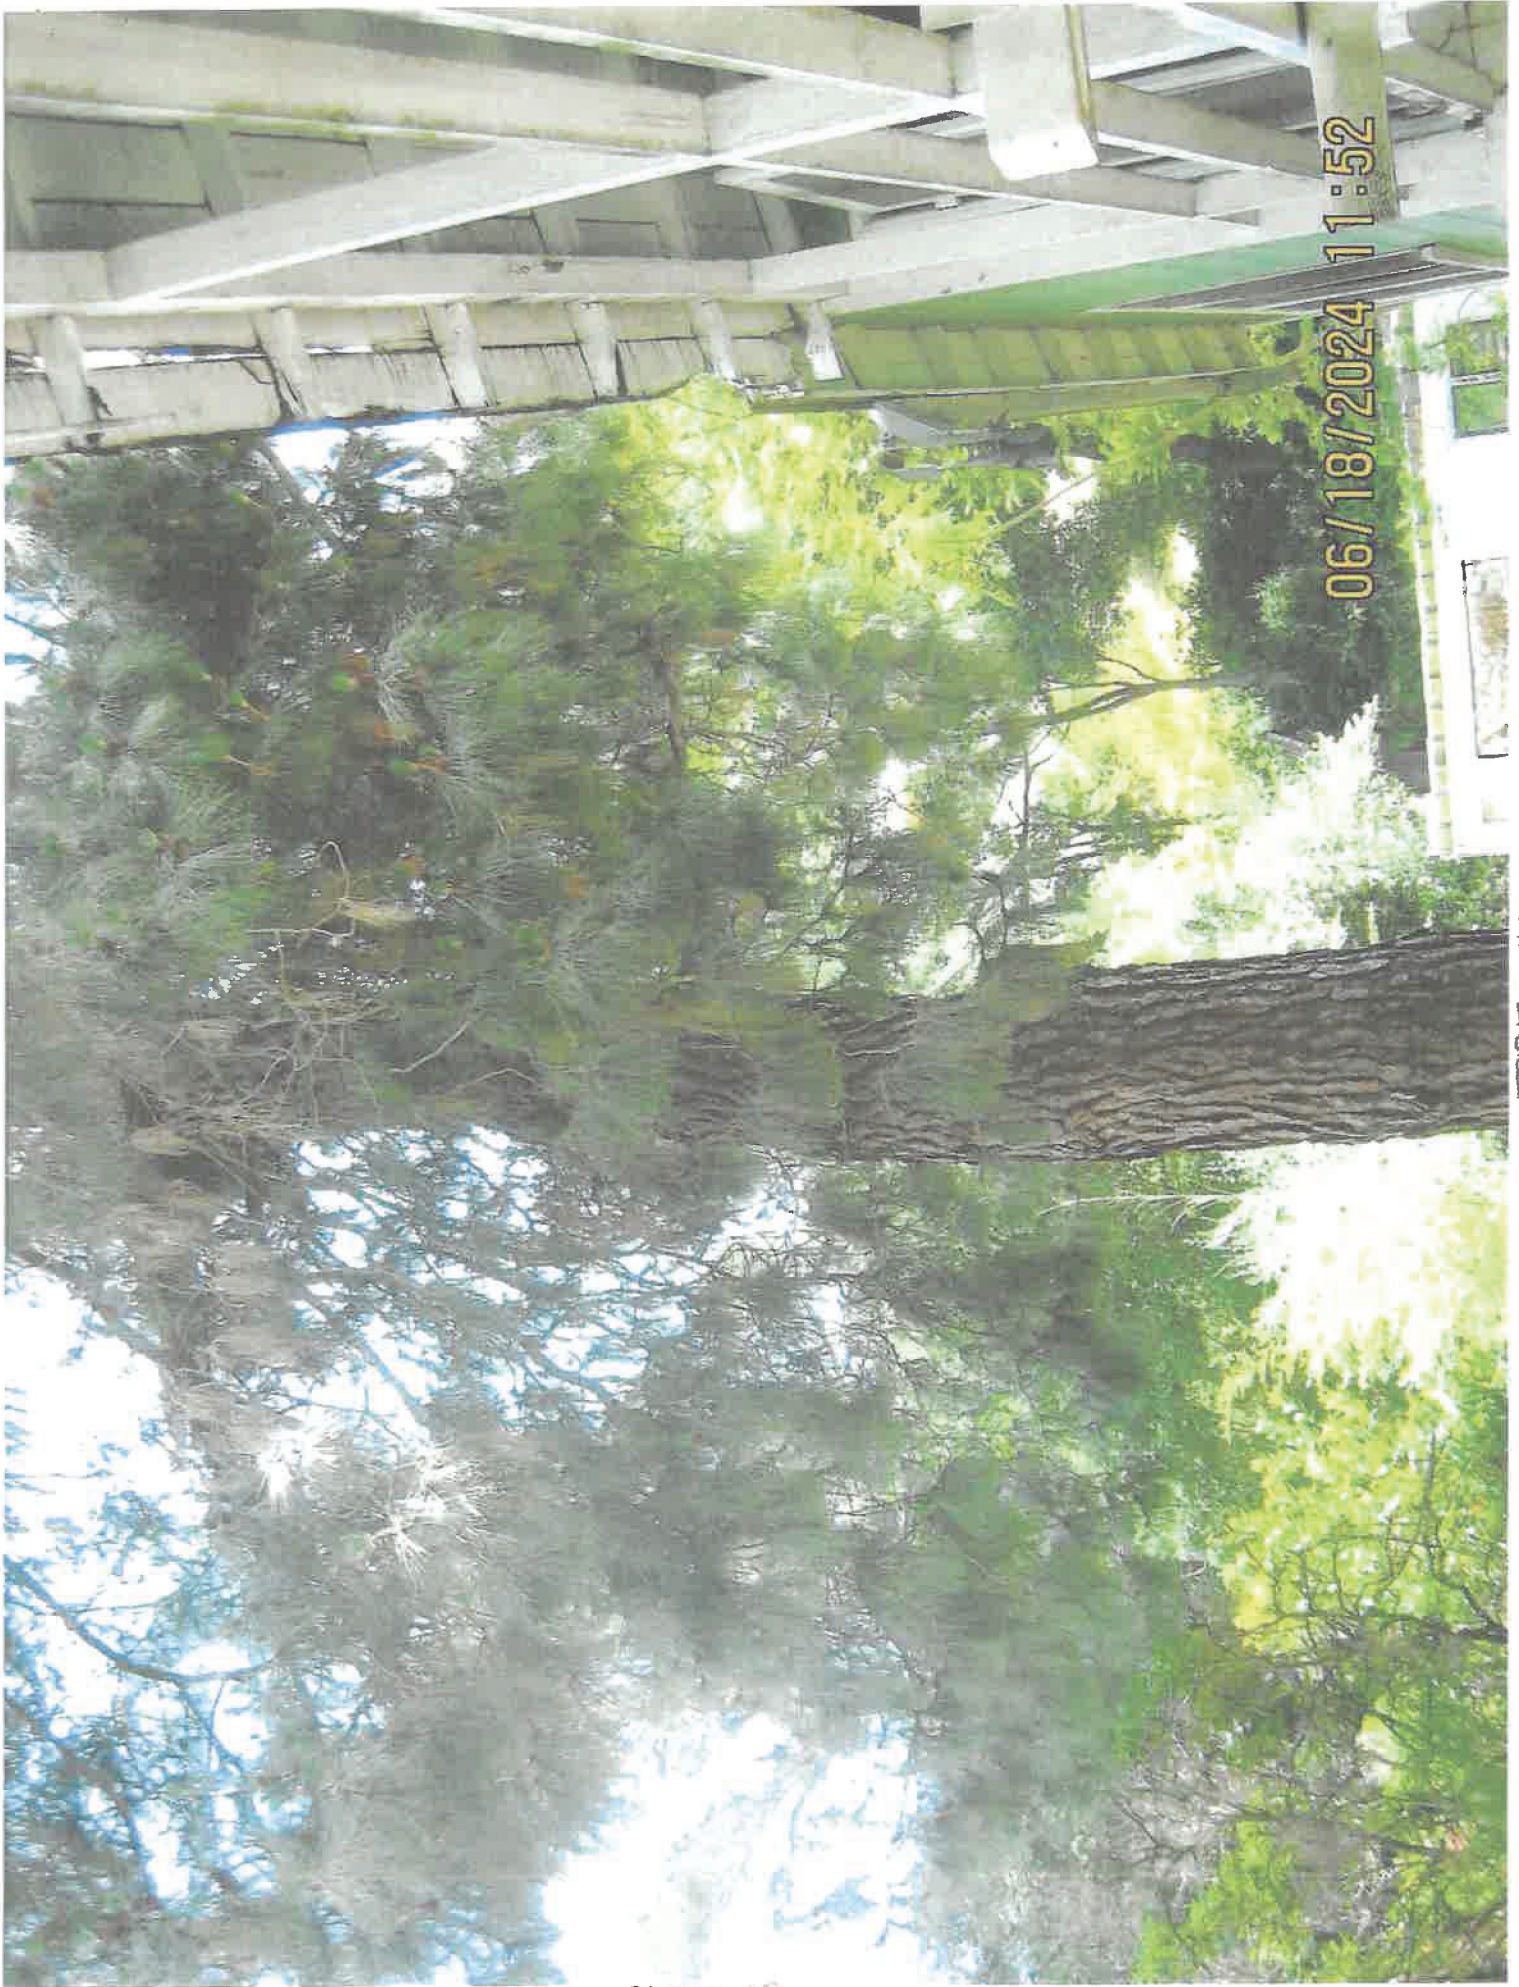
TREE #2

**Tree #2** is a *Pinus canariensis* or Canary Island Pine. The tree measures 32 inches in diameter at D.B.H. The tree has a dripline which measures 12 feet from the tree trunk and it has a 24 foot spread. It is estimated to be roughly 70 feet tall. The tree is located east of Tree #1 and north of the existing 2-story building. The crown has been pruned and raised. It is balanced. The foliage size and color appear normal. The density is normal. The tree is in above average health and condition. Rating: B-

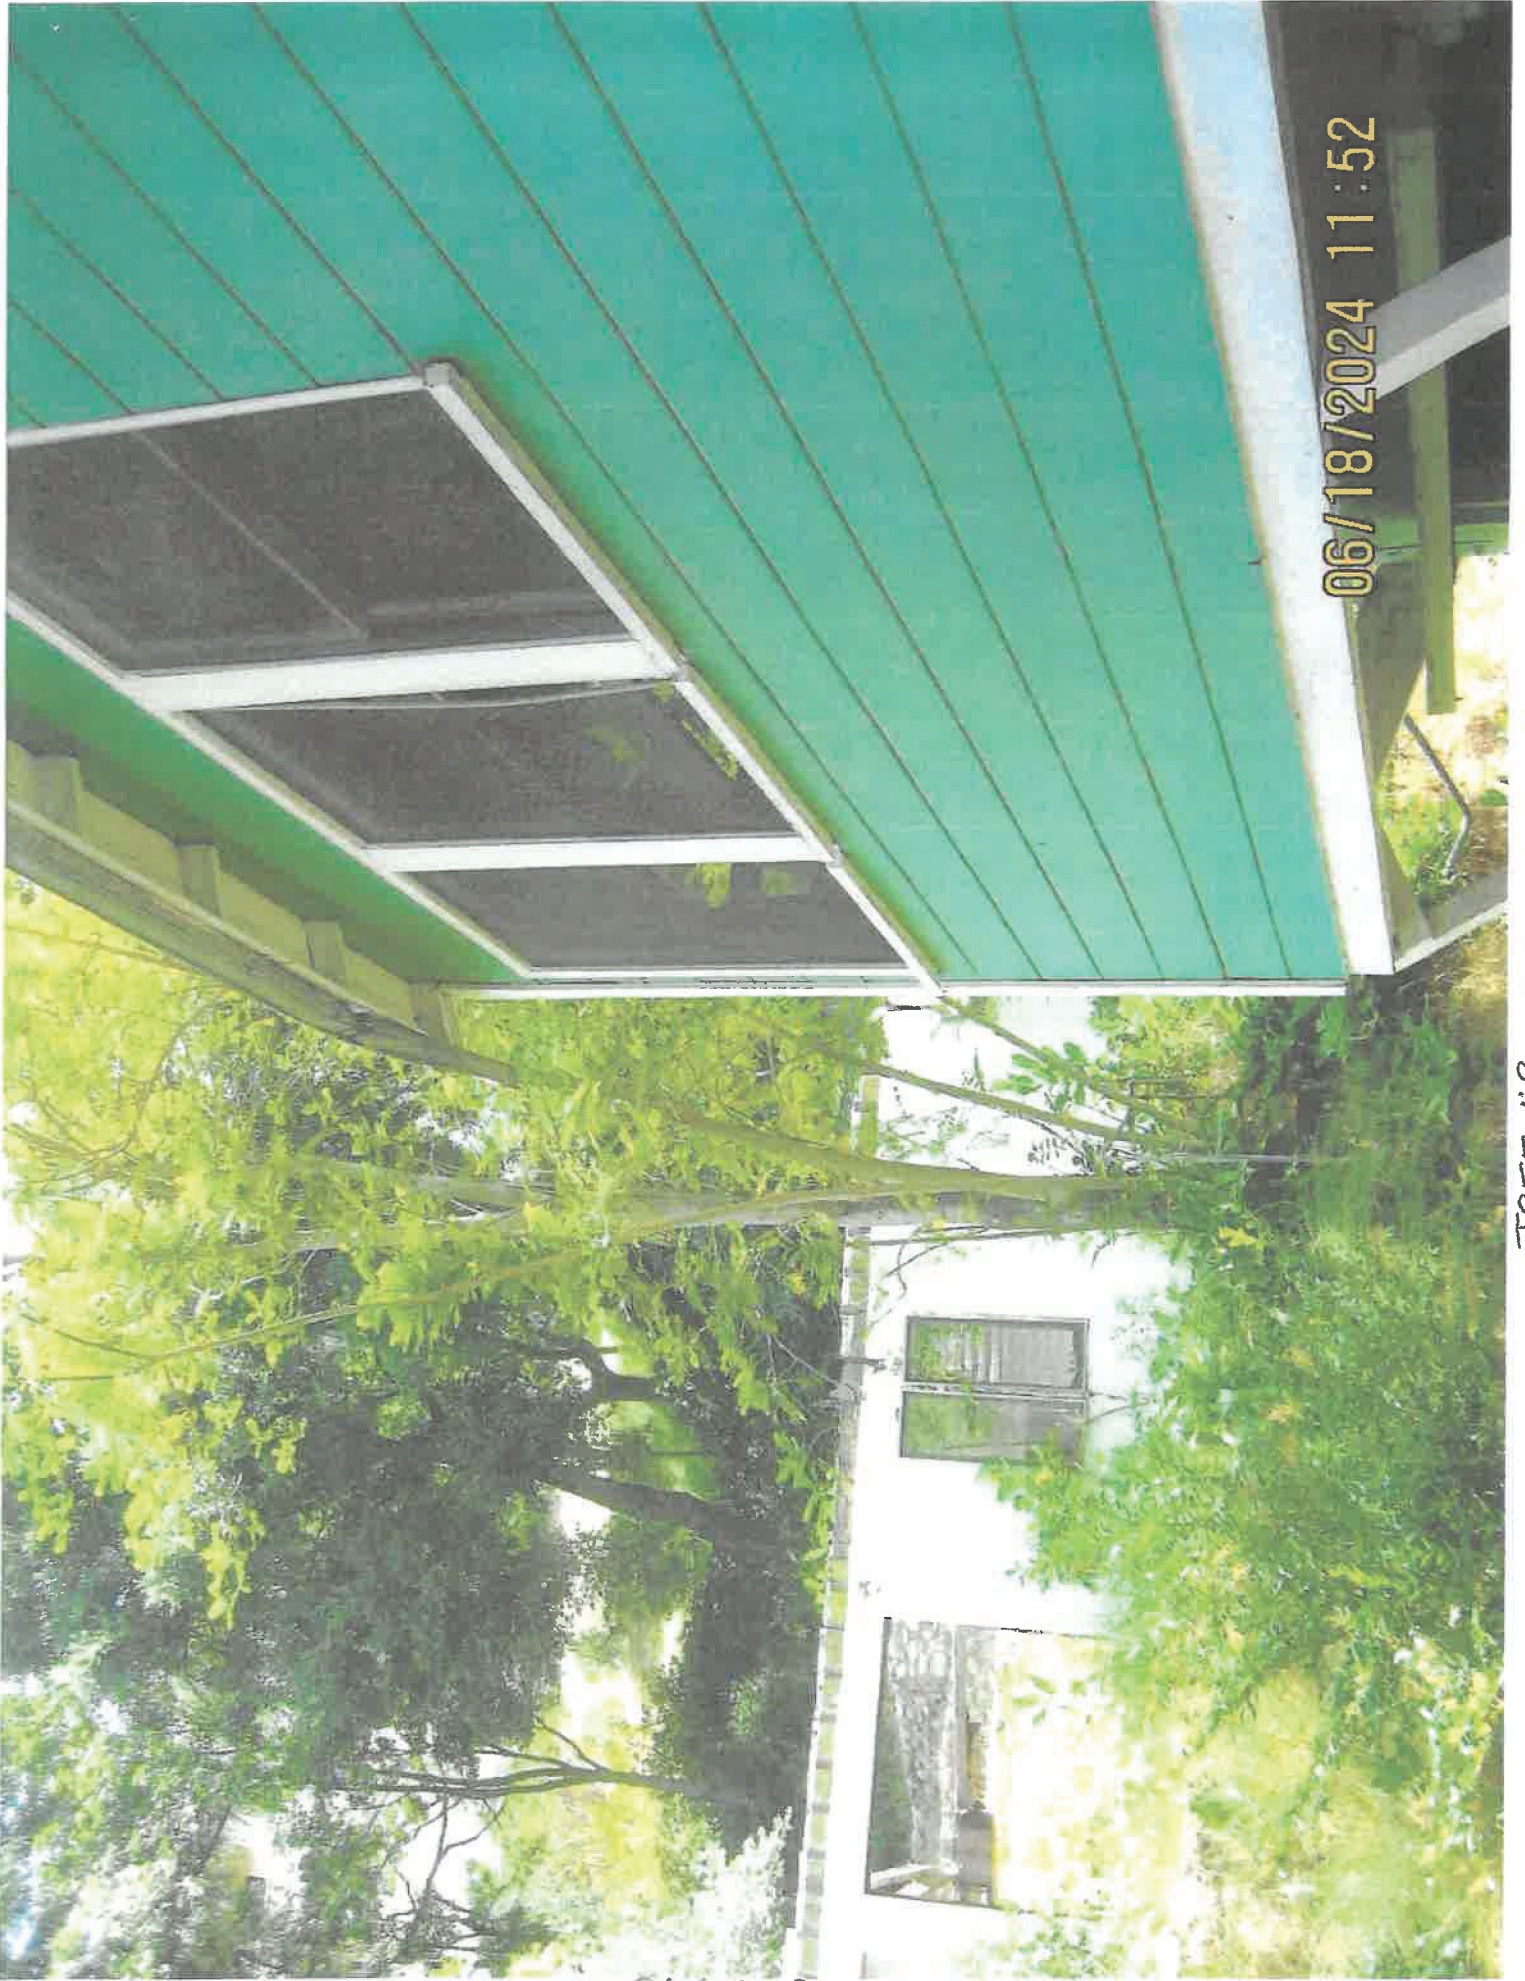
TREE #3

**Tree #3** is a *Jacaranda acutifolia* or Jacaranda. The tree measures 2,2,2,5,10 inches in diameter at D.B.H. The tree has a dripline which measures 15 feet from the tree south side of the trunk and it has a 22 foot spread. It is estimated to be roughly 30 feet tall. The tree is located east of the northeast corner of the existing 2-story building. It is a multi-trunk tree. There are epicormics. The crown has been pruned and raised. It is unbalanced. The foliage size and color appear normal. The crown density is fair. The tree is in slightly below average condition. Rating: C-
