## Arborist Report

2170-2172 Stanley Hills Drive  
Los Angeles, California

RE: **ARBORIST REPORT** – 2170-2172 Stanley Hills Drive, Los Angeles, California  
Proposed Lot Line Adjustment; Construction of 2 New Single Family Homes  
City of Los Angeles Tree Ordinance No. 186873

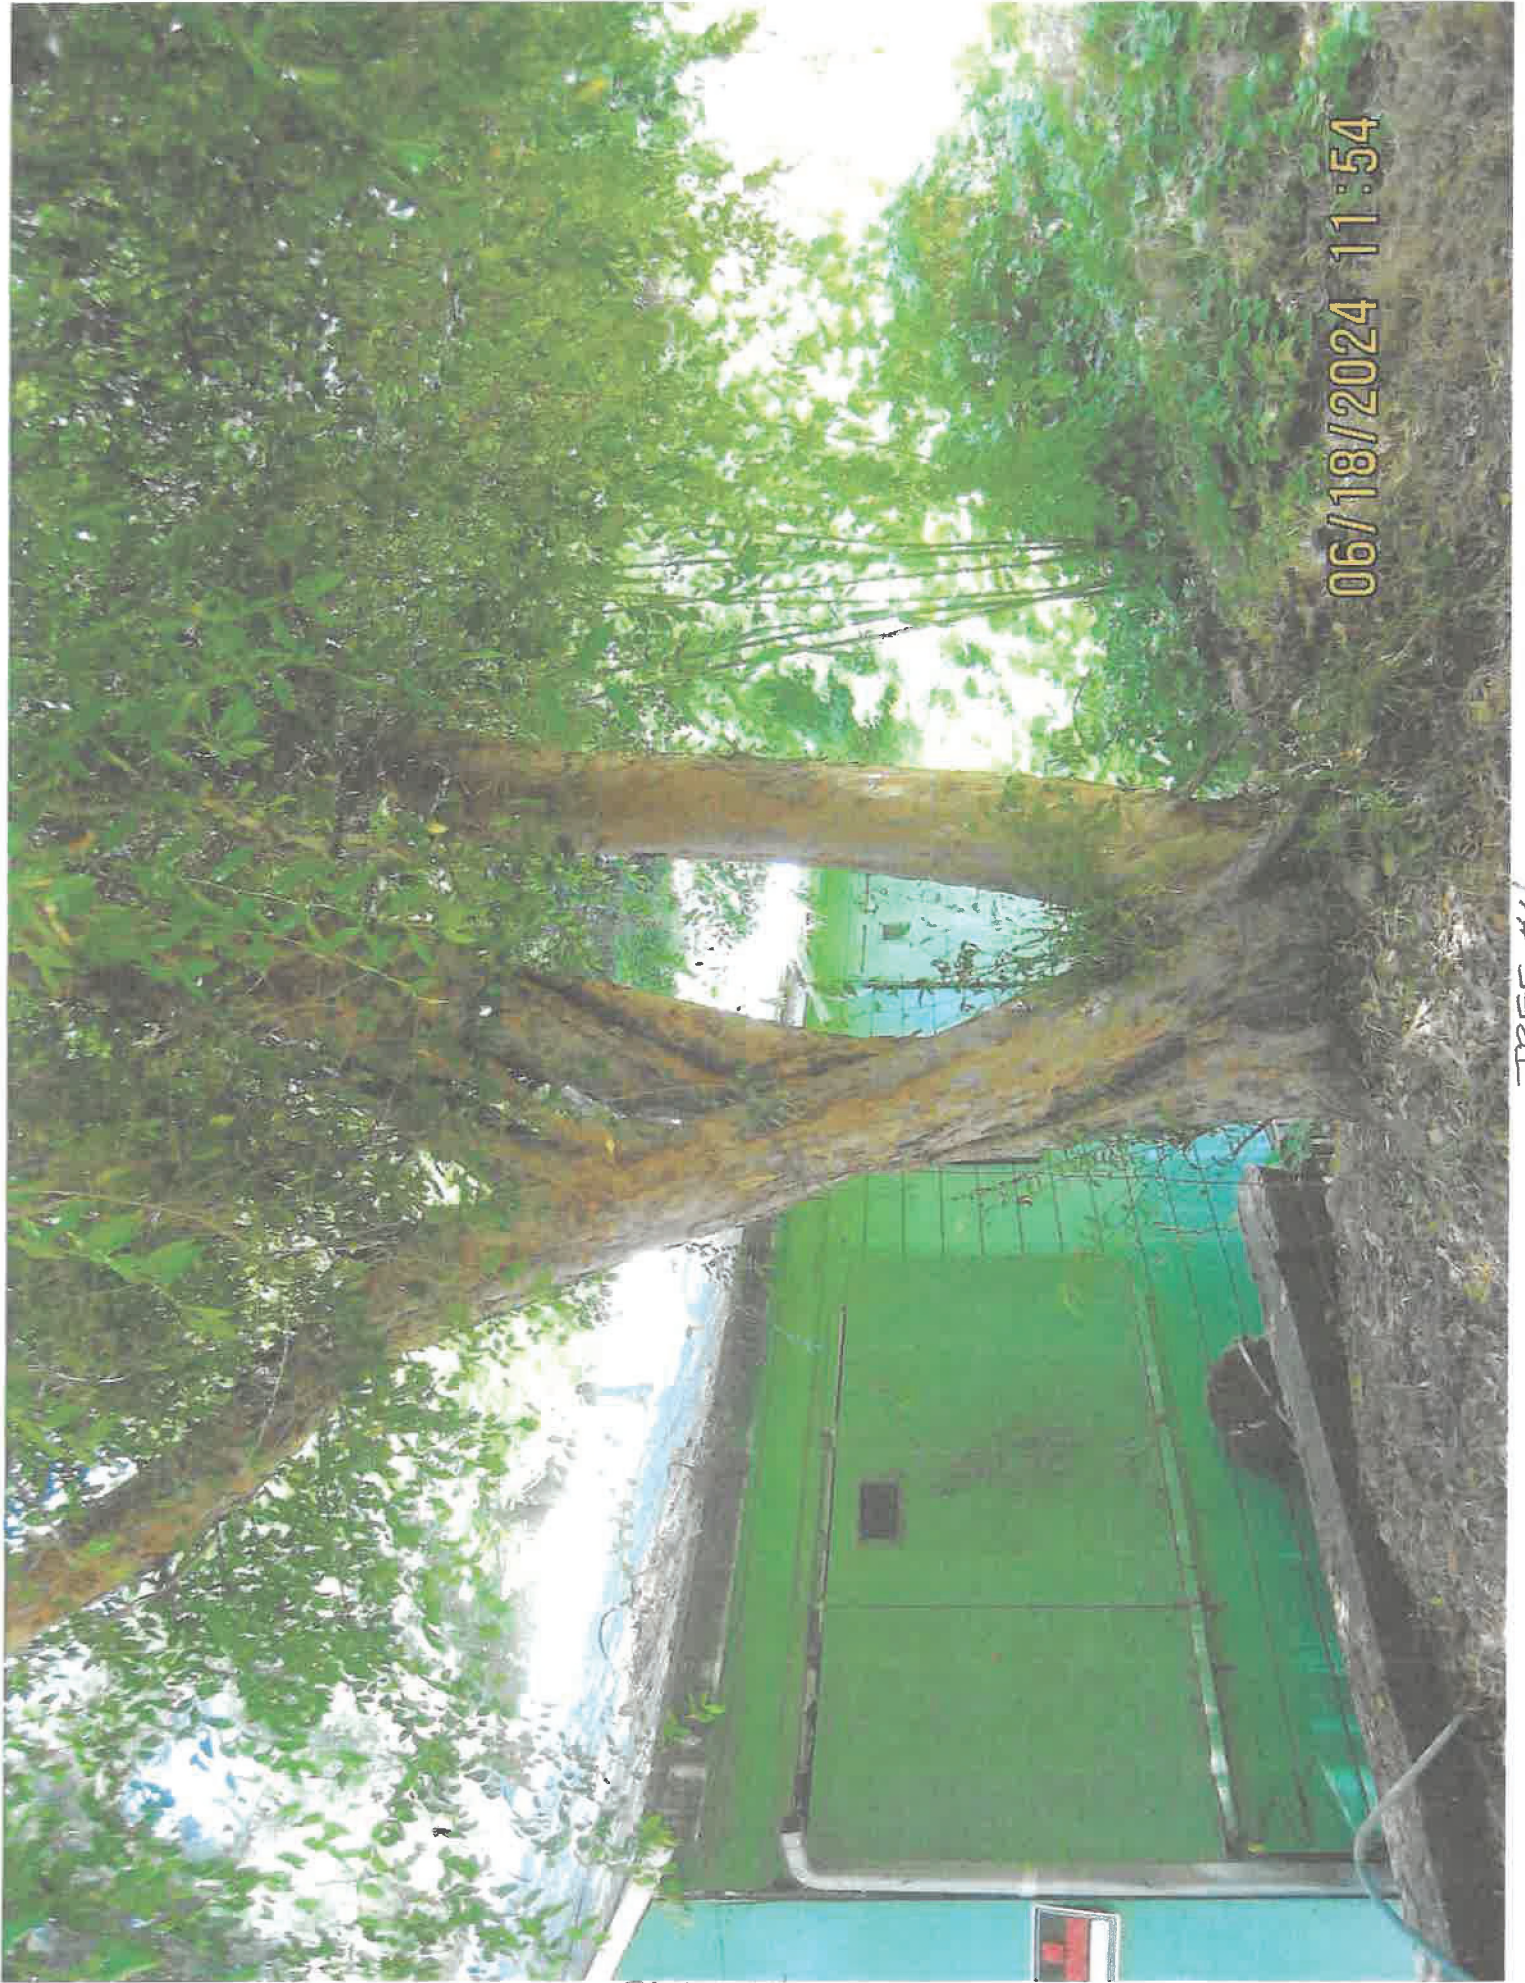
TREE #4

**Tree #4** is a *Ulmus parvifolia* or Chinese Elm. The tree measures 10,17 inches in diameter at D.B.H. The tree has a dripline which measures 18 feet from the trunk and it has a 18 foot spread. It is estimated to be roughly 30 feet tall. The tree is located south of the southwest corner of the existing 2-story building. It is a multi-trunk tree. The crown has been pruned and raised. The area around the tree has been disturbed. The roots have been cut near the trunk. The trunks are fused together. There is included bark tissue. The foliage size and color appear normal. The crown density is normal. The tree is in slightly below average health and condition. Rating: C-

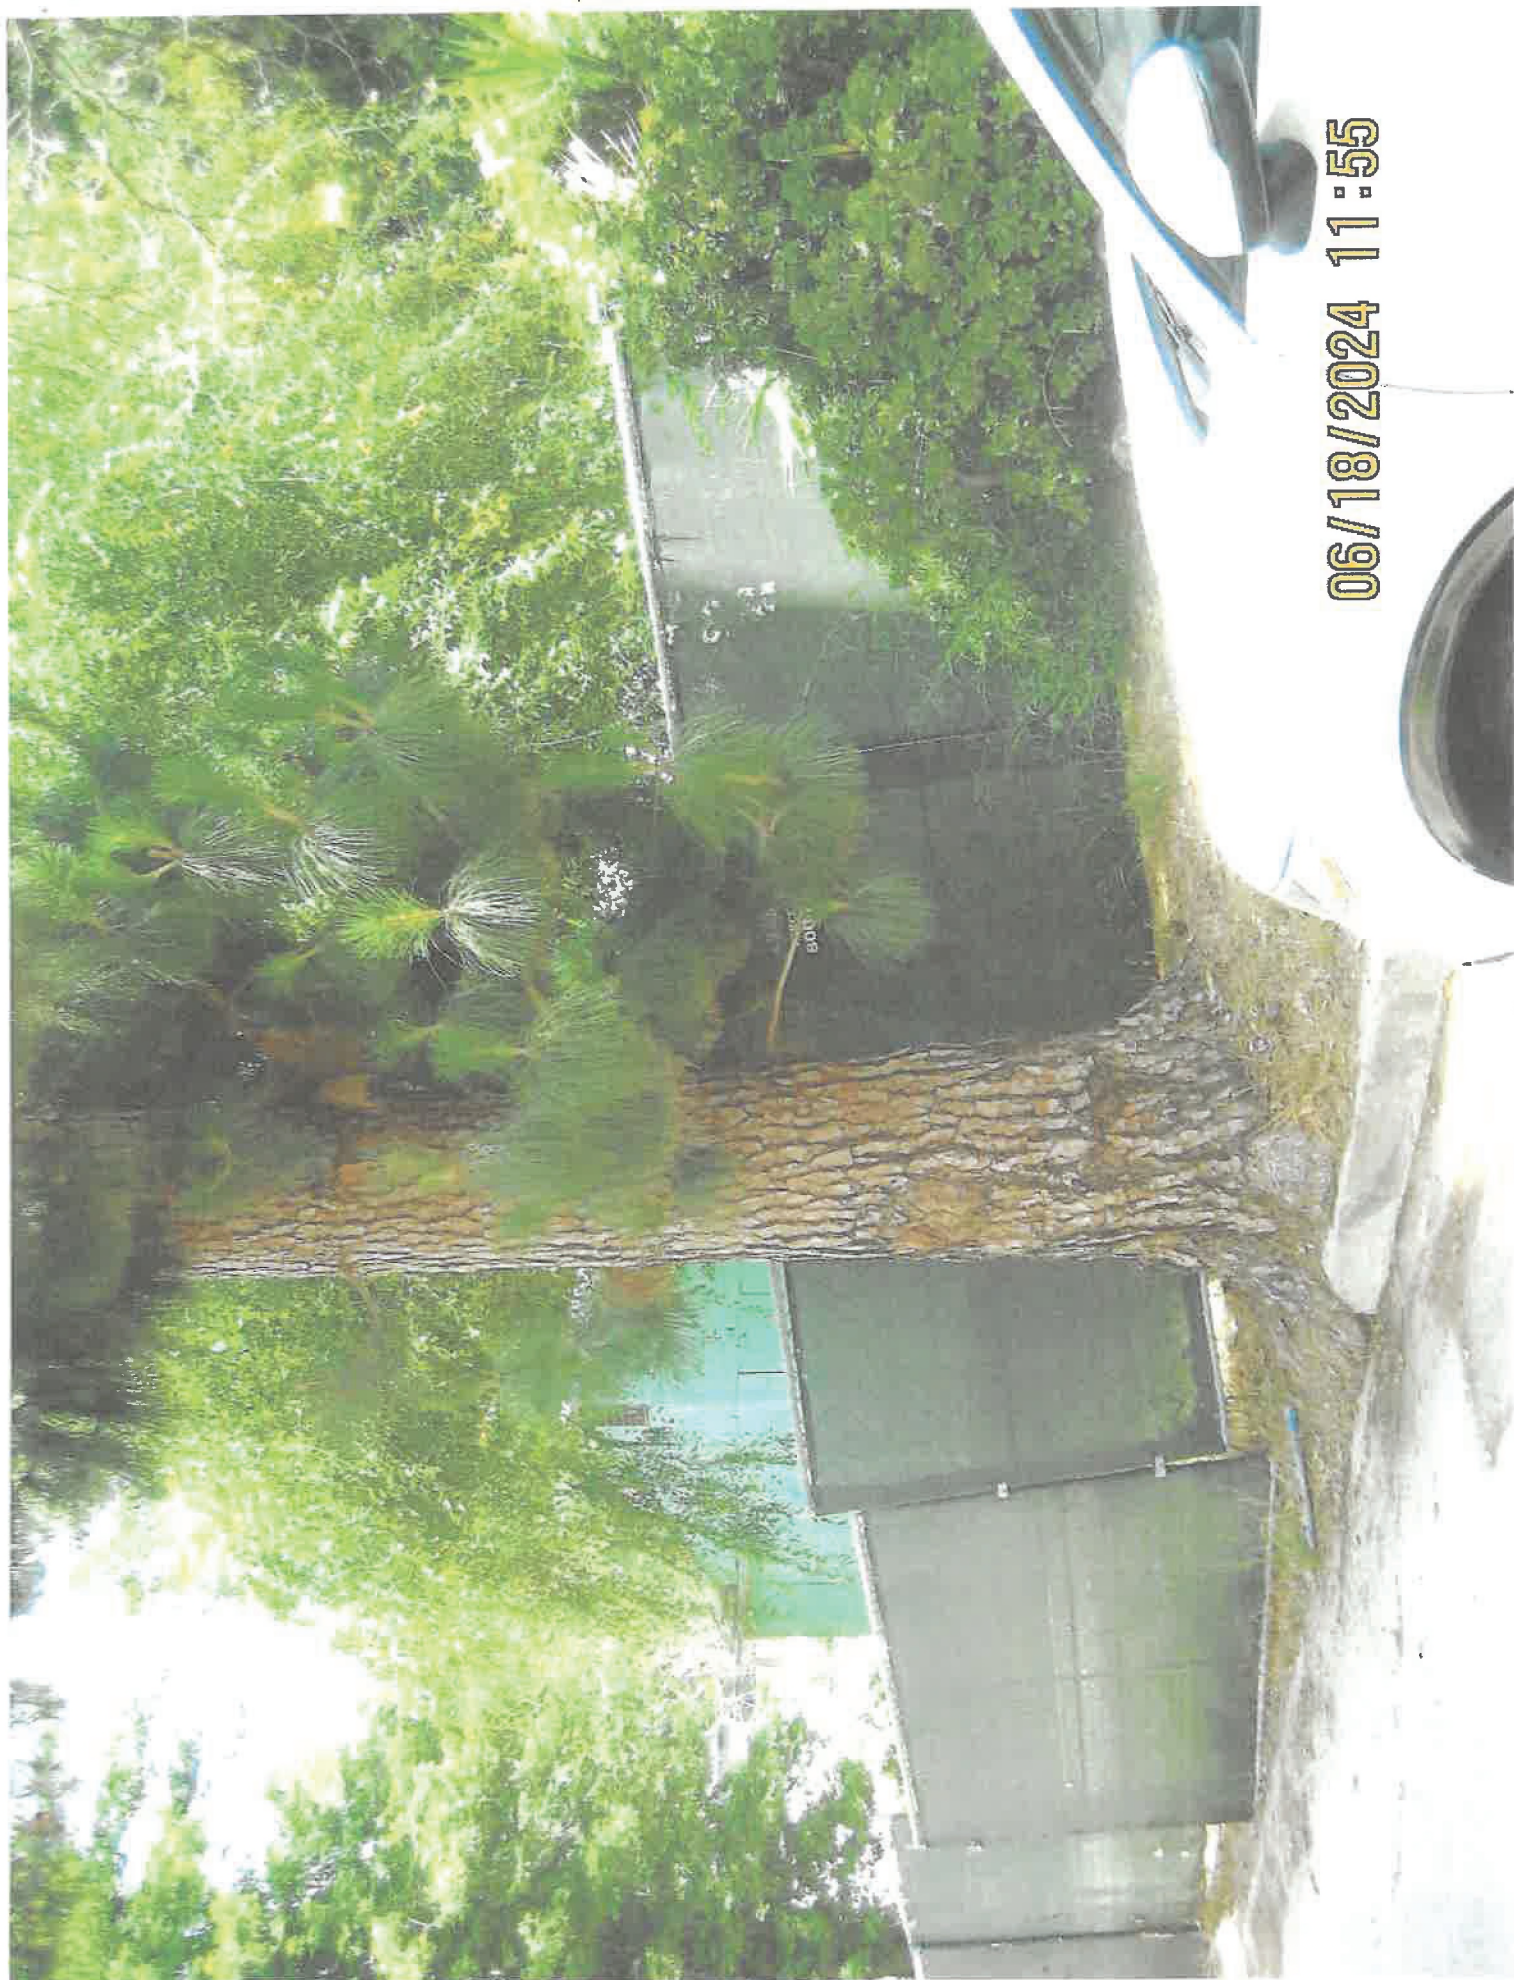
TREE #5

**Tree #5** is a *Pinus canariensis* or Canary Island Pine. The tree measures 26 inches in diameter at D.B.H. The tree has a dripline which measures 17 feet from the tree trunk and it has a 34 foot spread. It is estimated to be roughly 70 feet tall. The tree is located at the street curb at the southern boundary of the subject property. It appears to be a City Street Tree. The crown has been pruned and raised. It is balanced. The foliage size and color appear normal. The density is normal. The tree is in above average health and condition. Rating: B-

There are 6 protected Coast Live Oaks growing on the subject property. The proposed grading and construction will not encroach within the dripline of the Oaks. There is one Street Tree identified as Tree #5 which must be preserved. The following tree protection measures should be followed:

- 1) I would recommend that a 4 foot high orange plastic tree protection fence be placed at the dripline of the Oak trees and Street Tree. Photographs should be taken and must be included at the end of this Arborist Report. The placement of the tree protection fencing should be inspected by a Certified Arborist prior to the commencement of construction.

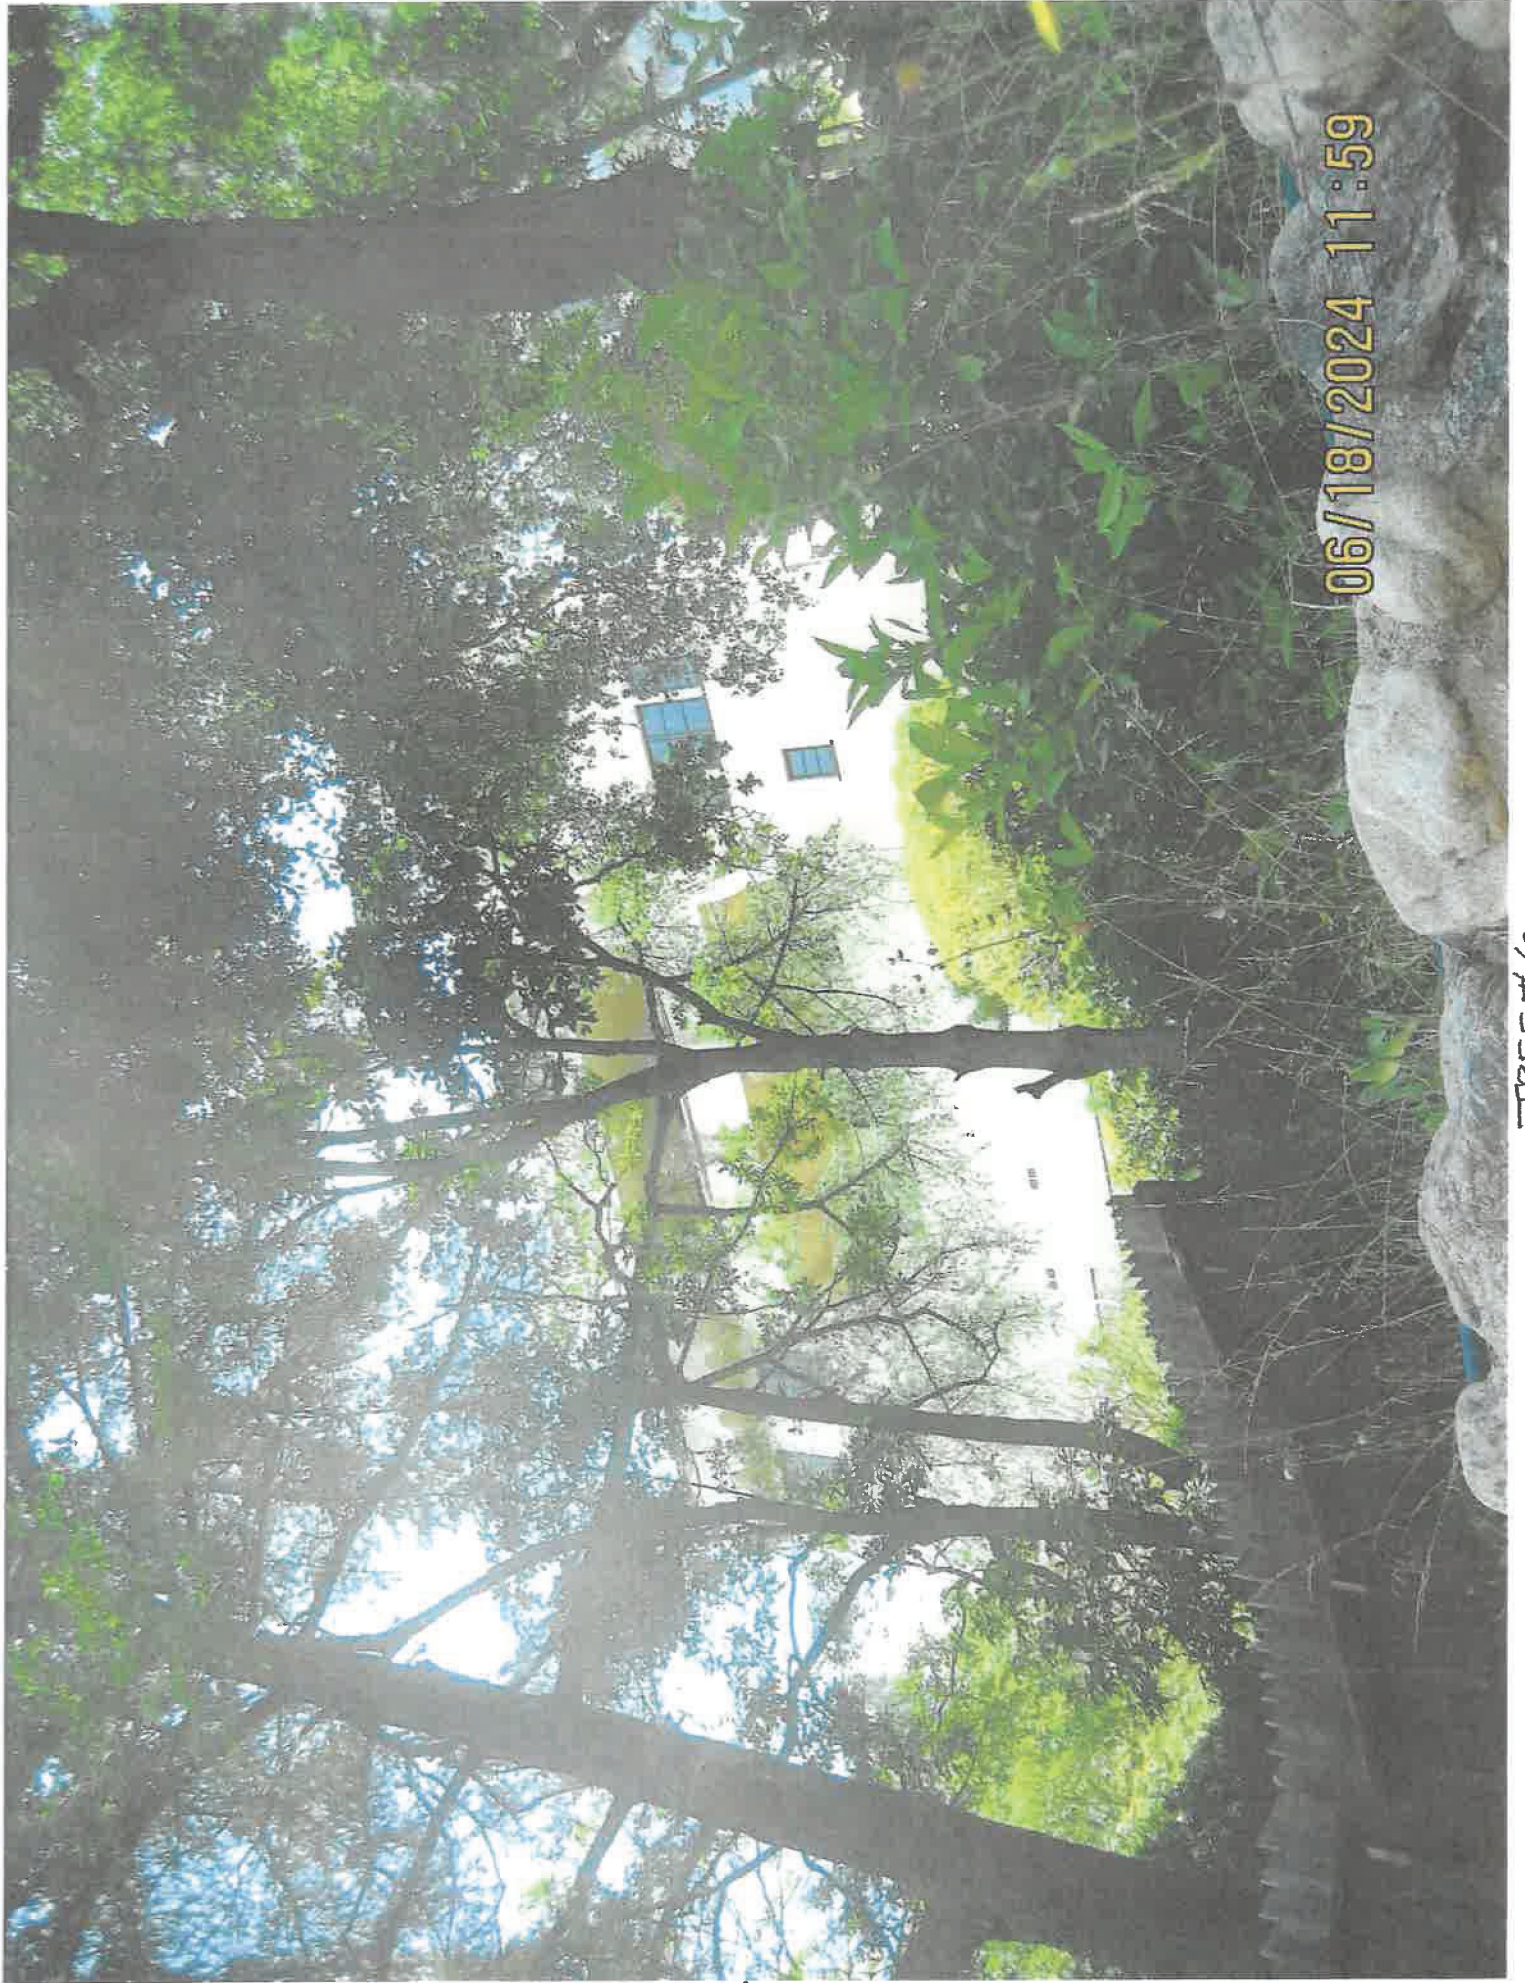
TREE #6

**Tree #6** is a *Pittosporum undulatum* or Victorian Box. The tree measures 8 inches in diameter at D.B.H. The tree has a dripline which measures 10 feet from the tree trunk and it has a 20 foot spread. It is estimated to be roughly 40 feet tall. The tree is located on an uphill slope near the northeast boundary of the subject property. Jade Plant and Poison Oak surround the tree. The crown has been pruned and raised. It is balanced. The foliage size and color appear normal. The density is fair. The tree is in slightly below average health and condition. Rating: C-
