### **Tree Report**

**CRENSHAW CROSSING TREE REPORT  
EXPOSITION AND CRENSHAW BOULEVARDS  
LOS ANGELES, CALIFORNIA 90016**

**SEPTEMBER 2, 2019**

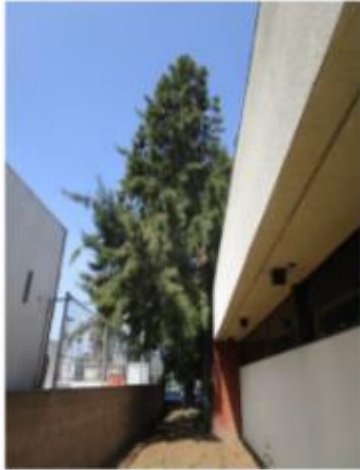
Tree 1

| Tree # | Common Name | Botanical Name | Diameter at 4.5 feet (dbh) (inches) | Adjusted Dbh (inches) | Height (feet) | Health | Structure | Canopy Spread N/E/SW | Disposition | Protected or Significant? | Comments |
|---|---|---|---|---|---|---|---|---|---|---|---|
| 1 | horsetail tree | <i>Casuarina cunninghamiana</i> | 19.4 | N/A | 40 | B | B | 7/15/15/12 | Remove | Significant | trunk engulfing structure |

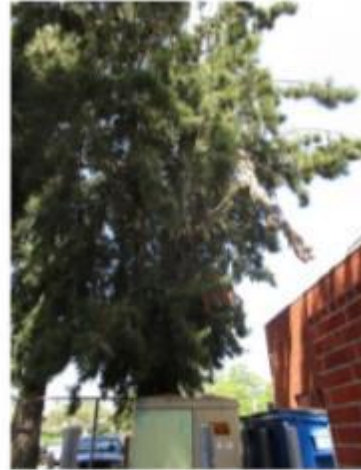
Tree 2

| Tree # | Common Name | Botanical Name | Diameter at 4.5 feet (dbh) (inches) | Adjusted Dbh (inches) | Height (feet) | Health | Structure | Canopy Spread N/E/SW | Disposition | Protected or Significant? | Comments |
|---|---|---|---|---|---|---|---|---|---|---|---|
| 2 | horsetail tree | <i>Casuarina cunninghamiana</i> | 15.2, 17.2 | 23 | 40 | B- | B | 16/18/15/10 | Remove | Significant | 2 trunks, next to electrical generator |

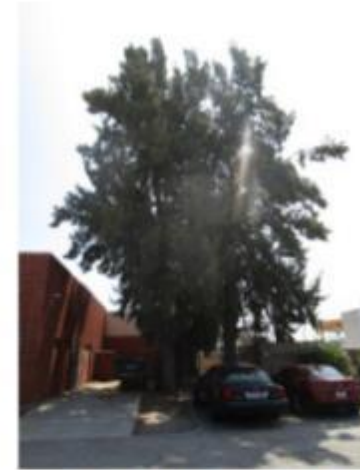
Tree 3(L) - 4(R)

| Tree # | Common Name | Botanical Name | Diameter at 4.5 feet (dbh) (inches) | Adjusted Dbh (inches) | Height (feet) | Health | Structure | Canopy Spread N/E/SW | Disposition | Protected or Significant? | Comments |
|---|---|---|---|---|---|---|---|---|---|---|---|
| 3 | horsetail tree | <i>Casuarina cunninghamiana</i> | 21.6 | N/A | 50 | B | B | 15/6/6/20 | Remove | Significant | exposed roots |
| 4 | horsetail tree | <i>Casuarina cunninghamiana</i> | 23.2 | N/A | 50 | B | B | 10/10/18/20 | Remove | Significant | exposed roots |

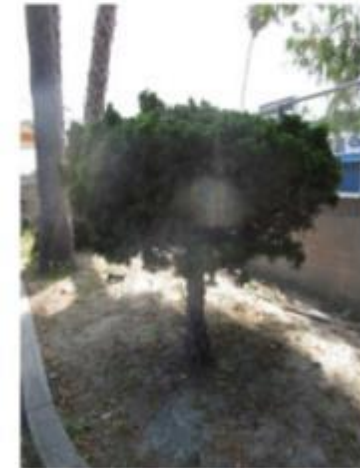
Tree 8

| Tree # | Common Name | Botanical Name | Diameter at 4.5 feet (dbh) (inches) | Adjusted Dbh (inches) | Height (feet) | Health | Structure | Canopy Spread N/E/SW | Disposition | Protected or Significant? | Comments |
|---|---|---|---|---|---|---|---|---|---|---|---|
| 8 | Hollywood juniper | <i>Juniperus chinensis 'Torulosa'</i> | 4.2 | N/A | 6 | A | B- | 3/3/3/3 | Remove | No | topped and shaped |

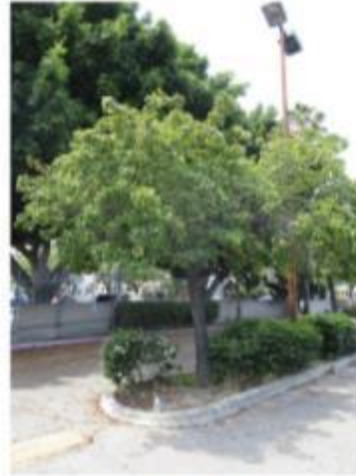
Tree 10

| Tree # | Common Name | Botanical Name | Diameter at 4.5 feet (dbh) (inches) | Adjusted Dbh (inches) | Height (feet) | Health | Structure | Canopy Spread N/E/SW | Disposition | Protected or Significant? | Comments |
|---|---|---|---|---|---|---|---|---|---|---|---|
| 10 | evergreen pear | <i>Pyrus kawakamii</i> | 8.9 | N/A | 13 | B | B | 10/12/9/10 | Remove | Significant | multiple branch attachments, interior deadwood, fireblight, water stress |

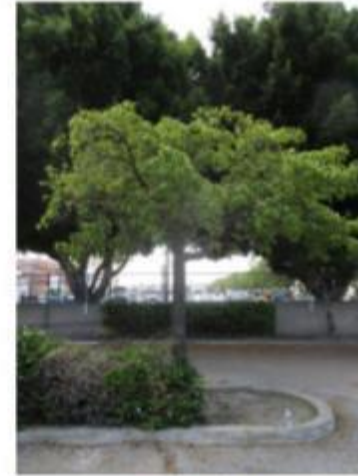
Tree 11

| Tree # | Common Name | Botanical Name | Diameter at 4.5 feet (dbh) (inches) | Adjusted Dbh (inches) | Height (feet) | Health | Structure | Canopy Spread N/E/SW | Disposition | Protected or Significant? | Comments |
|---|---|---|---|---|---|---|---|---|---|---|---|
| 11 | evergreen pear | <i>Pyrus kawakamii</i> | 7.3 | N/A | 13 | B- | B | 4/7/8/10 | Remove | No | history of breakage, interior deadwood, fireblight, damaged roots, water stress |

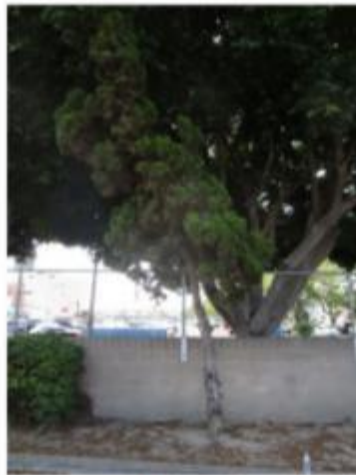
Tree 12

| Tree # | Common Name | Botanical Name | Diameter at 4.5 feet (dbh) (inches) | Adjusted Dbh (inches) | Height (feet) | Health | Structure | Canopy Spread N/E/SW | Disposition | Protected or Significant? | Comments |
|---|---|---|---|---|---|---|---|---|---|---|---|
| 12 | Hollywood juniper | <i>Juniperus chinensis 'Torulosa'</i> | 6.6 | N/A | 15 | B | B | 5/7/4/3 | Remove | No | leans east, shaded out |

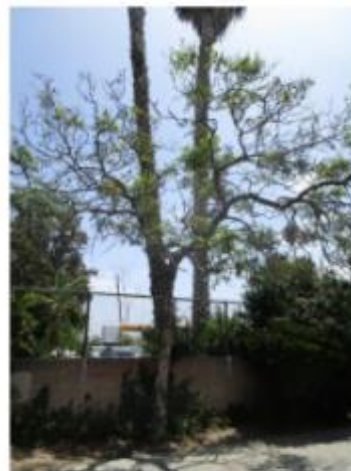
Tree 19

| Tree # | Common Name | Botanical Name | Diameter at 4.5 feet (dbh) (inches) | Adjusted Dbh (inches) | Height (feet) | Health | Structure | Canopy Spread N/E/SW | Disposition | Protected or Significant? | Comments |
|---|---|---|---|---|---|---|---|---|---|---|---|
| 19 | Jacaranda | <i>Jacaranda mimosifolia</i> | 9.4 | N/A | 15 | C | C | 10/5/10/15 | Remove | Significant | significant dieback |

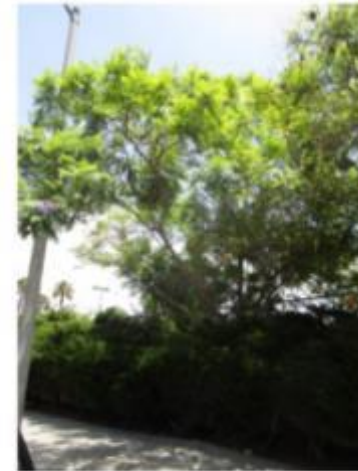
Tree 20

| Tree # | Common Name | Botanical Name | Diameter at 4.5 feet (dbh) (inches) | Adjusted Dbh (inches) | Height (feet) | Health | Structure | Canopy Spread N/E/SW | Disposition | Protected or Significant? | Comments |
|---|---|---|---|---|---|---|---|---|---|---|---|
| 20 | Jacaranda | <i>Jacaranda mimosifolia</i> | ~12 | N/A | 18 | B | C | 15/9/15/15 | Remove | Significant | multiple branch attachments at 5', sidewalk uplift |

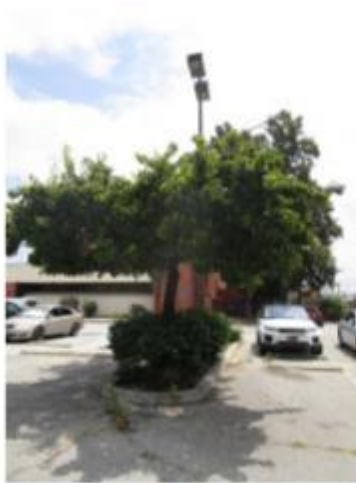
Tree 21

| Tree # | Common Name | Botanical Name | Diameter at 4.5 feet (dbh) (inches) | Adjusted Dbh (inches) | Height (feet) | Health | Structure | Canopy Spread N/E/SW | Disposition | Protected or Significant? | Comments |
|---|---|---|---|---|---|---|---|---|---|---|---|
| 21 | evergreen pear | <i>Pyrus kawakamii</i> | 9.7 | N/A | 15 | B | B | 10/10/12/12 | Remove | Significant | interior deadwood |

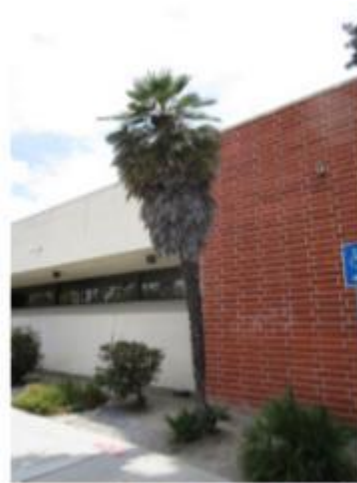
Tree 22

| Tree # | Common Name | Botanical Name | Diameter at 4.5 feet (dbh) (inches) | Adjusted Dbh (inches) | Height (feet) | Health | Structure | Canopy Spread N/E/SW | Disposition | Protected or Significant? | Comments |
|---|---|---|---|---|---|---|---|---|---|---|---|
| 22 | Chinese windmill palm | <i>Trachycarpus fortunei</i> | BT 12' | N/A | 15 | B | B- | 3/3/3/3 | Remove | No | leans west |

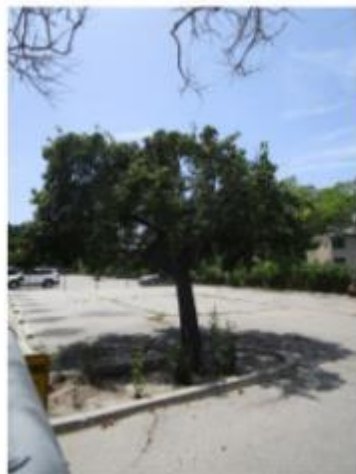
Tree 24

| Tree # | Common Name | Botanical Name | Diameter at 4.5 feet (dbh) (inches) | Adjusted Dbh (inches) | Height (feet) | Health | Structure | Canopy Spread N/E/SW | Disposition | Protected or Significant? | Comments |
|---|---|---|---|---|---|---|---|---|---|---|---|
| 24 | evergreen pear | <i>Pyrus kawakamii</i> | ~12 | N/A | 15 | B | C- | 1/10/16/12 | Remove | Significant | no access, heavy lean SW, epicormic, exposed roots |

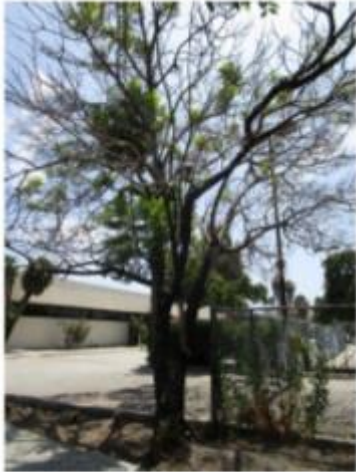
Tree 31

| Tree # | Common Name | Botanical Name | Diameter at 4.5 feet (dbh) (inches) | Adjusted Dbh (inches) | Height (feet) | Health | Structure | Canopy Spread N/E/SW | Disposition | Protected or Significant? | Comments |
|---|---|---|---|---|---|---|---|---|---|---|---|
| 31 | Jacaranda | <i>Jacaranda mimosifolia</i> | 8.4, 10 | 13 | 20 | D | D | 3/18/16/12 | Remove | Significant | extensive fire damage |

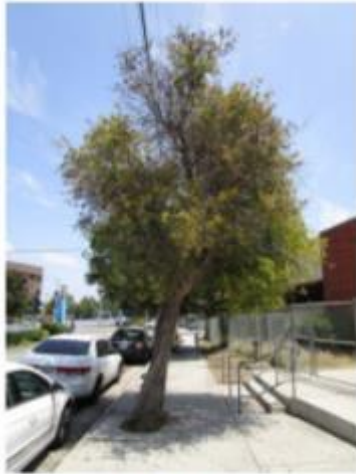
Tree 39

| Tree # | Common Name | Botanical Name | Diameter at 4.5 feet (dbh) (inches) | Adjusted Dbh (inches) | Height (feet) | Health | Structure | Canopy Spread N/E/SW | Disposition | Protected or Significant? | Comments |
|---|---|---|---|---|---|---|---|---|---|---|---|
| 39 | weeping bottlebrush | <i>Callistemon viminalis</i> | 15.2 | N/A | 20 | C | B- | 7/9/10/6 | Remove | Significant | moderate dieback |

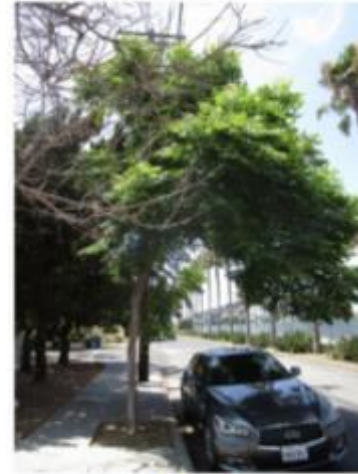
Tree 41

| Tree # | Common Name | Botanical Name | Diameter at 4.5 feet (dbh) (inches) | Adjusted Dbh (inches) | Height (feet) | Health | Structure | Canopy Spread N/E/SW | Disposition | Protected or Significant? | Comments |
|---|---|---|---|---|---|---|---|---|---|---|---|
| 41 | Chinese flame tree | <i>Koelreuteria bipinnata</i> | 6.1 | N/A | 20 | A | B | 13/9/5/12 | Remove | No | canopy lean north |

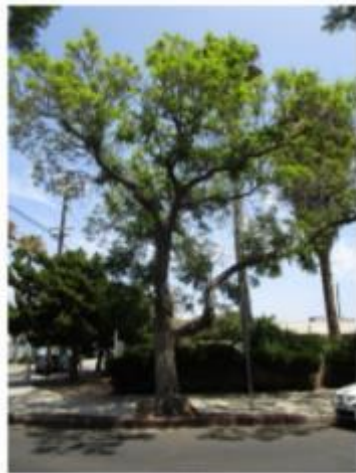
Tree ST-42

| Tree # | Common Name | Botanical Name | Diameter at 4.5 feet (dbh) (inches) | Adjusted Dbh (inches) | Height (feet) | Health | Structure | Canopy Spread N/E/SW | Disposition | Protected or Significant? | Comments |
|---|---|---|---|---|---|---|---|---|---|---|---|
| ST42 | Jacaranda | <i>Jacaranda mimosifolia</i> | 21 | N/A | 25 | B | B- | 15/20/20/15 | Remove | Protected, City ROW tree | sidewalk and curb displacement |

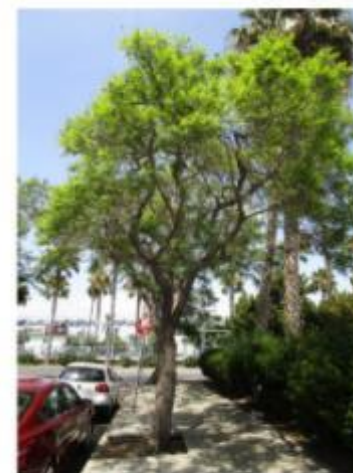
Tree ST-43

| Tree # | Common Name | Botanical Name | Diameter at 4.5 feet (dbh) (inches) | Adjusted Dbh (inches) | Height (feet) | Health | Structure | Canopy Spread N/E/SW | Disposition | Protected or Significant? | Comments |
|---|---|---|---|---|---|---|---|---|---|---|---|
| ST43 | Jacaranda | <i>Jacaranda mimosifolia</i> | 14 | N/A | 20 | B | B | 10/12/12/10 | Preserve | Protected, City ROW tree | sidewalk damage |

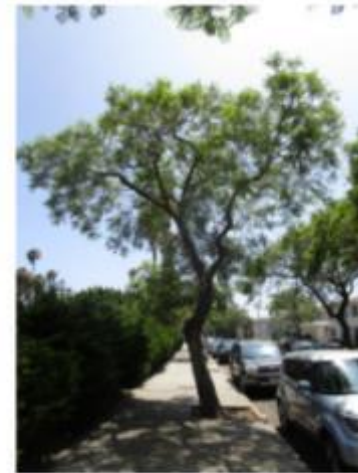
Tree ST-44

| Tree # | Common Name | Botanical Name | Diameter at 4.5 feet (dbh) (inches) | Adjusted Dbh (inches) | Height (feet) | Health | Structure | Canopy Spread N/E/SW | Disposition | Protected or Significant? | Comments |
|---|---|---|---|---|---|---|---|---|---|---|---|
| ST44 | Jacaranda | <i>Jacaranda mimosifolia</i> | 14.3 | N/A | 25 | B | B- | 10/12/10/10 | Preserve | Protected, City ROW tree | history of breakage, sidewalk uplift |

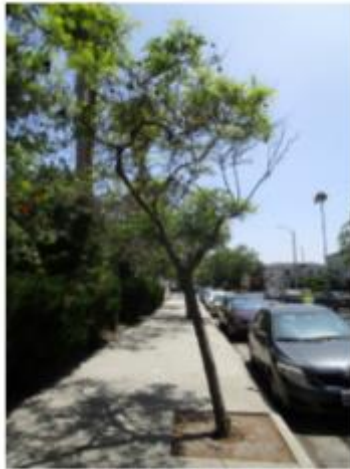
Tree ST-45

| Tree # | Common Name | Botanical Name | Diameter at 4.5 feet (dbh) (inches) | Adjusted Dbh (inches) | Height (feet) | Health | Structure | Canopy Spread N/E/SW | Disposition | Protected or Significant? | Comments |
|---|---|---|---|---|---|---|---|---|---|---|---|
| ST45 | Jacaranda | <i>Jacaranda mimosifolia</i> | 5.2 | N/A | 13 | B- | B- | 4/8/8/3 | Preserve | Protected, City ROW tree | water stress, deadwood |

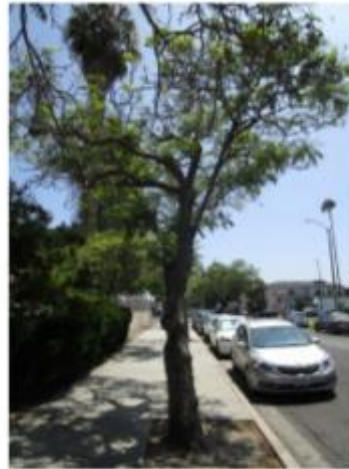
Tree ST-46

| Tree # | Common Name | Botanical Name | Diameter at 4.5 feet (dbh) (inches) | Adjusted Dbh (inches) | Height (feet) | Health | Structure | Canopy Spread N/E/SW | Disposition | Protected or Significant? | Comments |
|---|---|---|---|---|---|---|---|---|---|---|---|
| ST46 | Jacaranda | <i>Jacaranda mimosifolia</i> | 11 | N/A | 15 | B- | B- | 6/10/12/8 | Preserve | Protected, City ROW tree | water stress, deadwood |

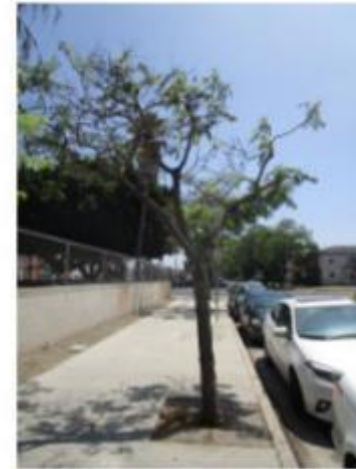
Tree ST-47

| Tree # | Common Name | Botanical Name | Diameter at 4.5 feet (dbh) (inches) | Adjusted Dbh (inches) | Height (feet) | Health | Structure | Canopy Spread N/E/SW | Disposition | Protected or Significant? | Comments |
|---|---|---|---|---|---|---|---|---|---|---|---|
| ST47 | Jacaranda | <i>Jacaranda mimosifolia</i> | 7 | N/A | 13 | C | B- | 4/10/8/5 | Preserve | Protected, City ROW tree | water stress, deadwood |

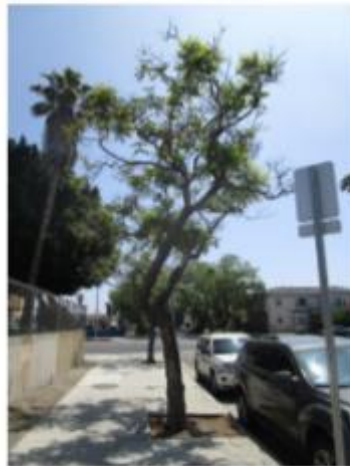
Tree ST-48

| Tree # | Common Name | Botanical Name | Diameter at 4.5 feet (dbh) (inches) | Adjusted Dbh (inches) | Height (feet) | Health | Structure | Canopy Spread N/E/SW | Disposition | Protected or Significant? | Comments |
|---|---|---|---|---|---|---|---|---|---|---|---|
| ST48 | Jacaranda | <i>Jacaranda mimosifolia</i> | 10 | N/A | 15 | C | B- | 10/7/12/6 | Preserve | Protected, City ROW tree | water stress, deadwood |

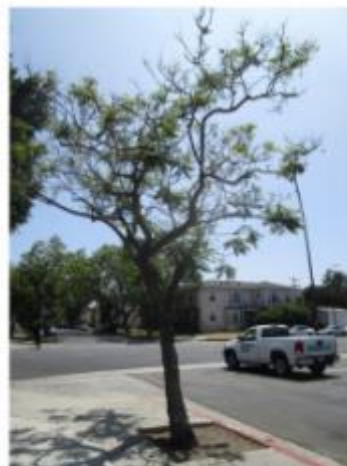
Tree ST-49

| Tree # | Common Name | Botanical Name | Diameter at 4.5 feet (dbh) (inches) | Adjusted Dbh (inches) | Height (feet) | Health | Structure | Canopy Spread N/E/SW | Disposition | Protected or Significant? | Comments |
|---|---|---|---|---|---|---|---|---|---|---|---|
| ST49 | Jacaranda | <i>Jacaranda mimosifolia</i> | 10 | N/A | 15 | C | B- | 10/10/10/5 | Preserve | Protected, City ROW tree | water stress, deadwood, leans south |

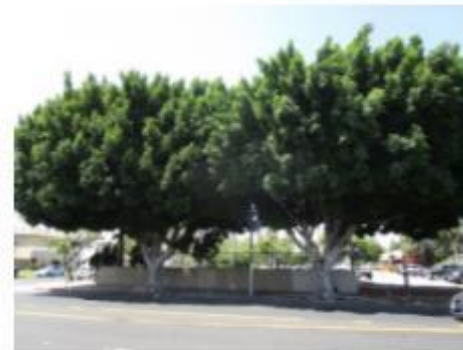
Tree ST-50(L) - 51(R)

| Tree # | Common Name | Botanical Name | Diameter at 4.5 feet (dbh) (inches) | Adjusted Dbh (inches) | Height (feet) | Health | Structure | Canopy Spread N/E/SW | Disposition | Protected or Significant? | Comments |
|---|---|---|---|---|---|---|---|---|---|---|---|
| ST50 | Indian laurel fig | <i>Ficus microcarpa</i> | 32.2 | N/A | 35 | A | A | 27/20/30/33 | Preserve | Protected, City ROW tree | sidewalk and curb displacement |
| ST51 | Indian laurel fig | <i>Ficus microcarpa</i> | 31.4 | N/A | 35 | A | A | 27/33/30/20 | Preserve | Protected, City ROW tree | sidewalk and curb displacement |

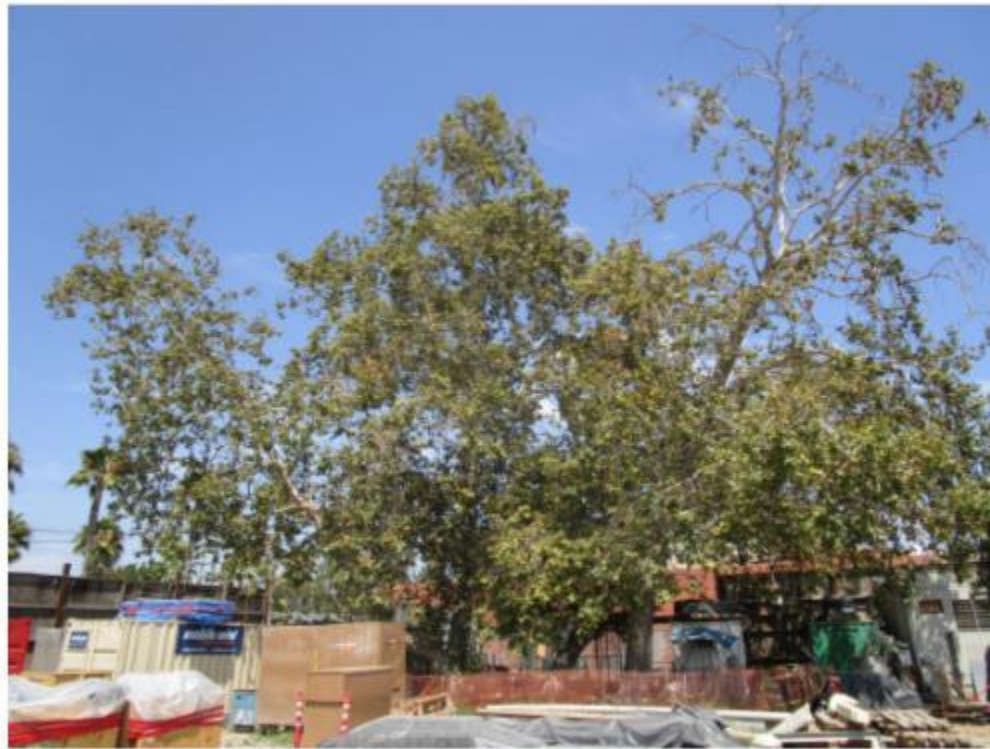
Trees 30(L) - 32(R) at Site B

| Tree # | Common Name | Botanical Name | Diameter at 4.5 feet (dbh) (inches) | Converted Dbh | Height (feet) | Health | Structure | Canopy Spread N/E/S/W | Disposition | Protected or Significant? | Comments |
|---|---|---|---|---|---|---|---|---|---|---|---|
| 30 | California sycamore | <i>Platanus racemosa</i> | 22, 29 | 36.3 | 70 | B- | B | 60' | Remove | Protected | Water stress, sycamore borer presence |
| 31 | California sycamore | <i>Platanus racemosa</i> | 26 | N/A | 35 | B | B- | 50' | Remove | Protected | trunk lean E/SE, sycamore borers up the trunk, trunk bow SE, water stress, sycamore borer presence |
| 32 | California sycamore | <i>Platanus racemosa</i> | 14.5 | N/A | 30 | B- | B | 25' | Remove | Protected | slight trunk lean south, top dieback, water stress, sycamore borer presence |
