PROTECTED TREE REPORT

V & G Development, INC.

2669 N. Bronholly Dr.

October 13, 2021

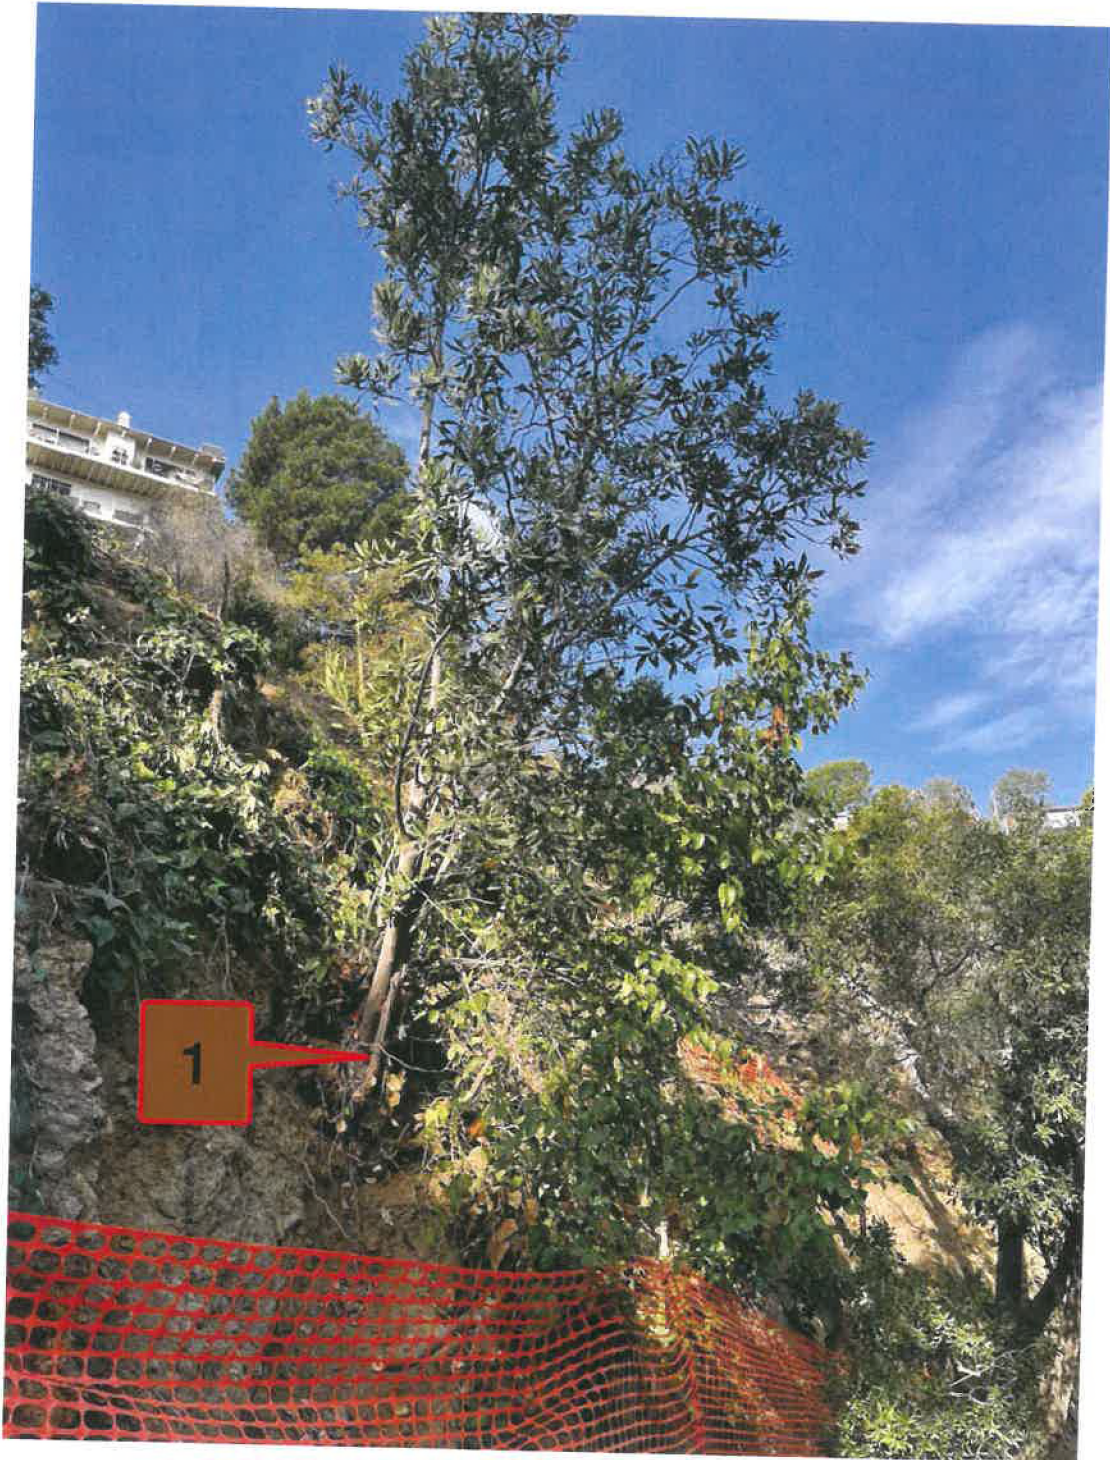
PHOTO 1 - Toyon (*Heteromeles arbutifolia*) shrub/tree #1 located at base of slope, will be impacted by the proposed new development and will be replaced at a 4:1 ratio further up the hillside, with new Toyon in 15 gallon or largest commonly available size (upon completion of construction project).

Toyon (*Heteromeles arbutifolia*) tree #3 located at base of slope, will be impacted by the proposed new development and will be replaced at a 4:1 ratio further up the hillside, with new Toyon in 15 gallon or largest commonly available size (upon completion of construction project).

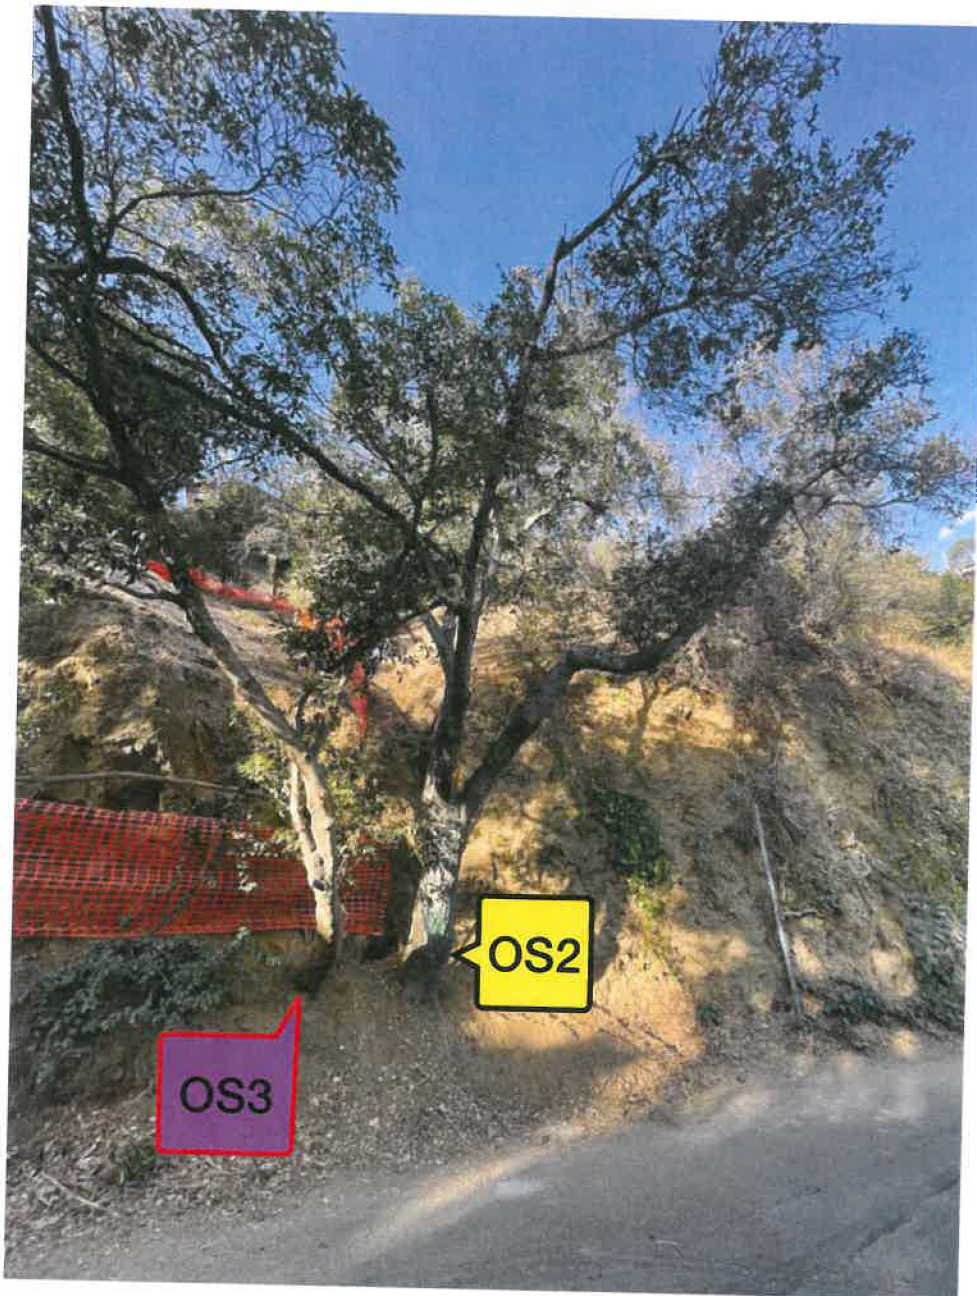
PHOTO 2 - Coast live oak (*Quercus agrifolia*) tree #OS2 is in the public right-of-way will receive minimal impact. Grading will occur approximately 5 feet above the Oak trunk. A 12" wall is proposed to keep out sediment. The road is proposed to be widened with a regular curb to be installed near the base of the tree. If roots are encountered a shallow curb will be installed instead and will be supported by a tube driven into the ground. This tree will be retained and protected in place.

Non-protected significant tree #OS3 located in the city easement will be impacted by the proposed construction and will be removed and replaced at a one-to-one (1:1) ratio, to the satisfaction of the City of Los Angeles if needed.

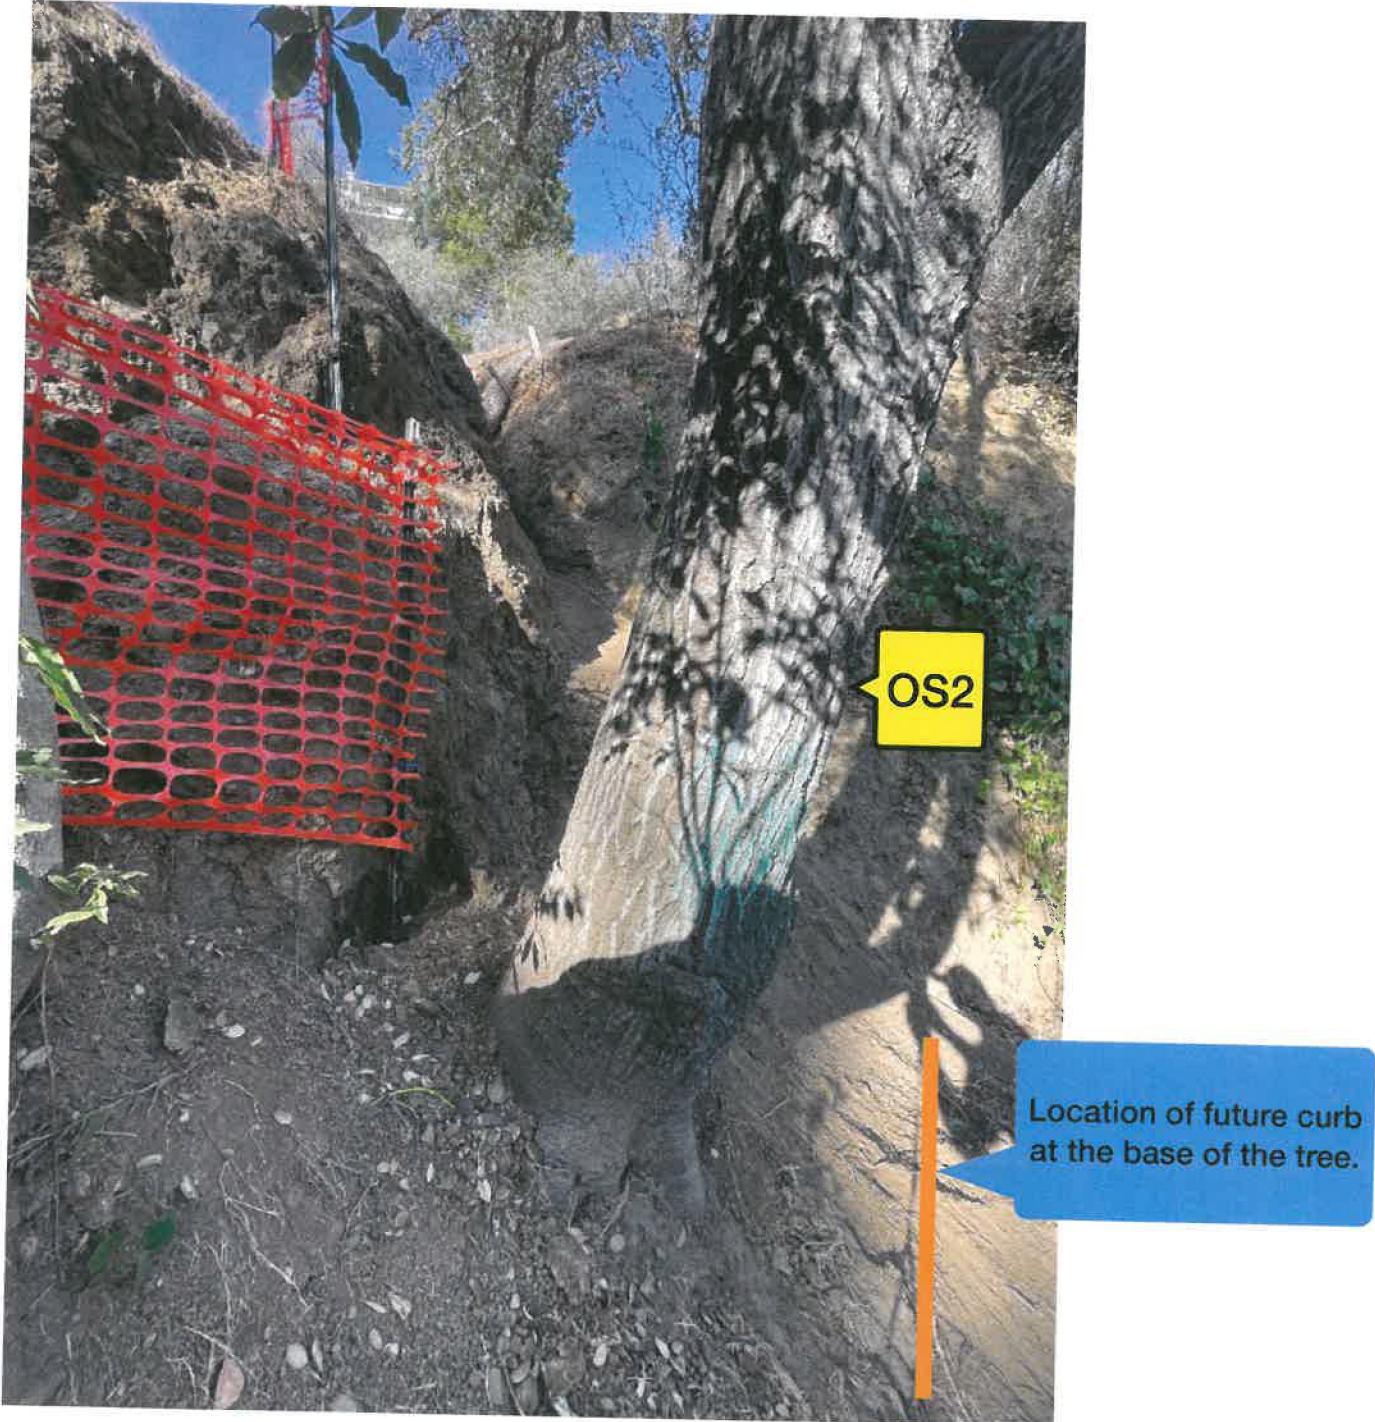
PHOTO 3 - Coast live oak (*Quercus agrifolia*) tree #OS2 is in the public right-of-way will receive minimal impact. Grading will occur approximately 5 feet above the Oak trunk. The road is proposed to be widened with a regular curb to be installed near the base of the tree. If roots are encountered a shallow curb will be installed instead and will be supported by a tube driven into the ground. This tree will be retained and protected in place.

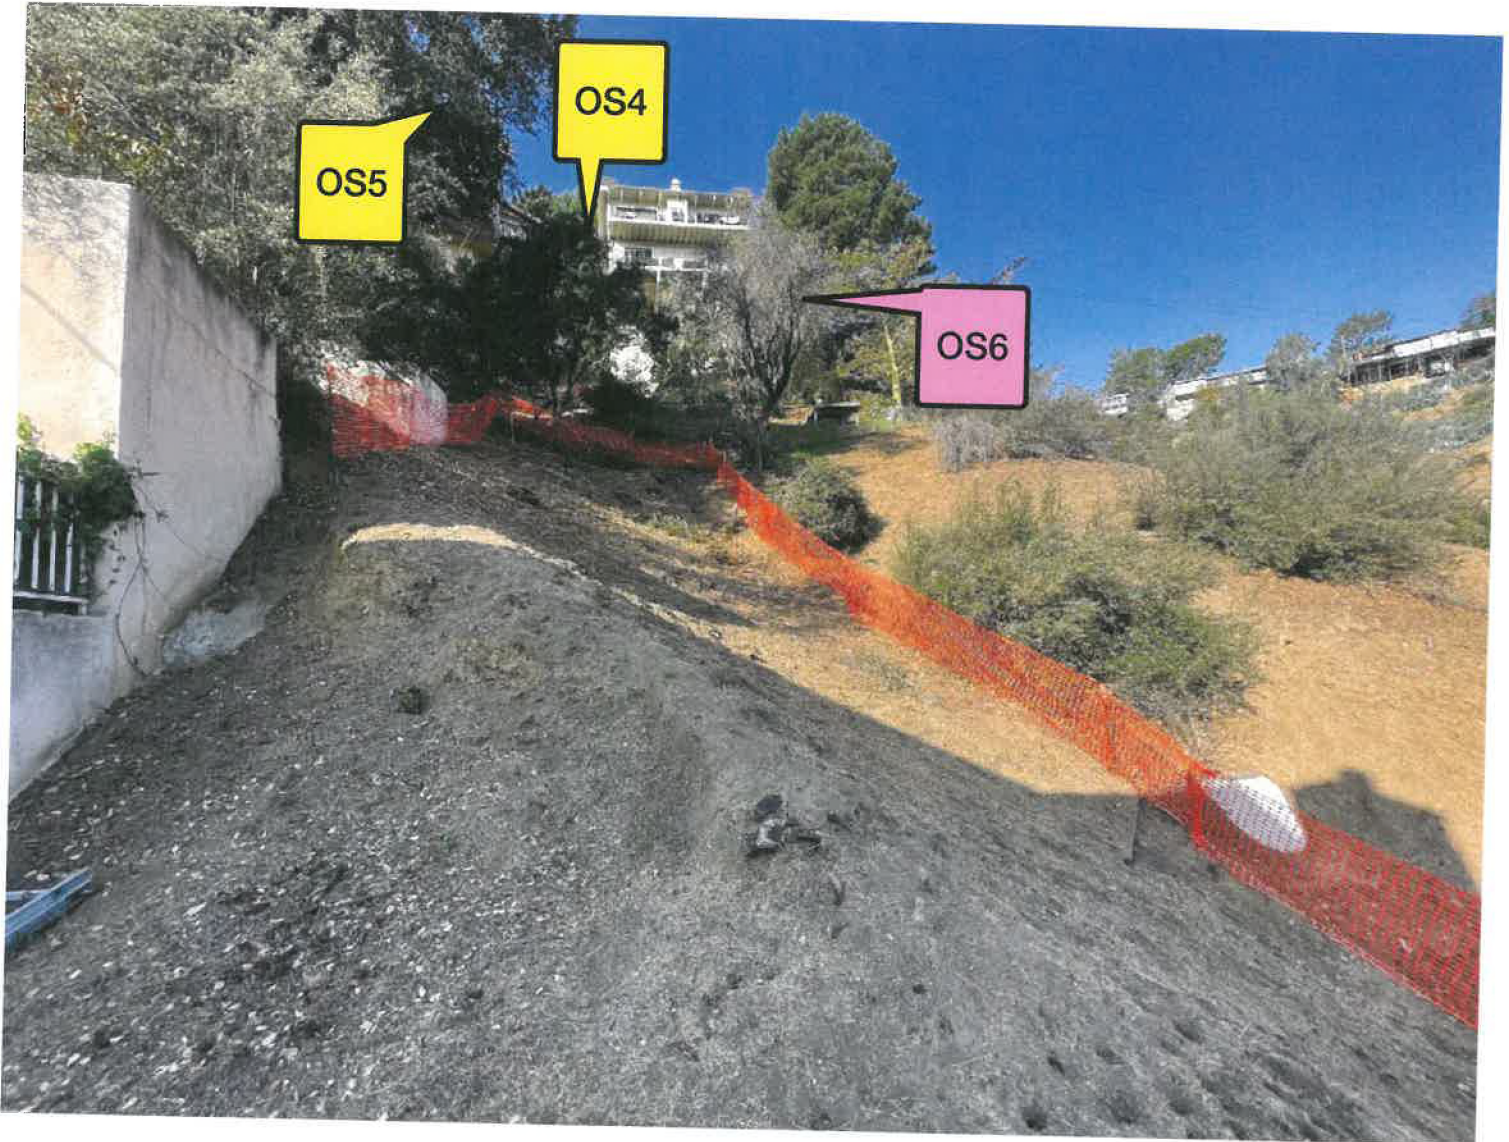
PHOTO 4 - Shows off site trees #OS4, #OS5 and #OS6. These trees will be retained and protected in place. These trees will receive no impact from the proposed new development.

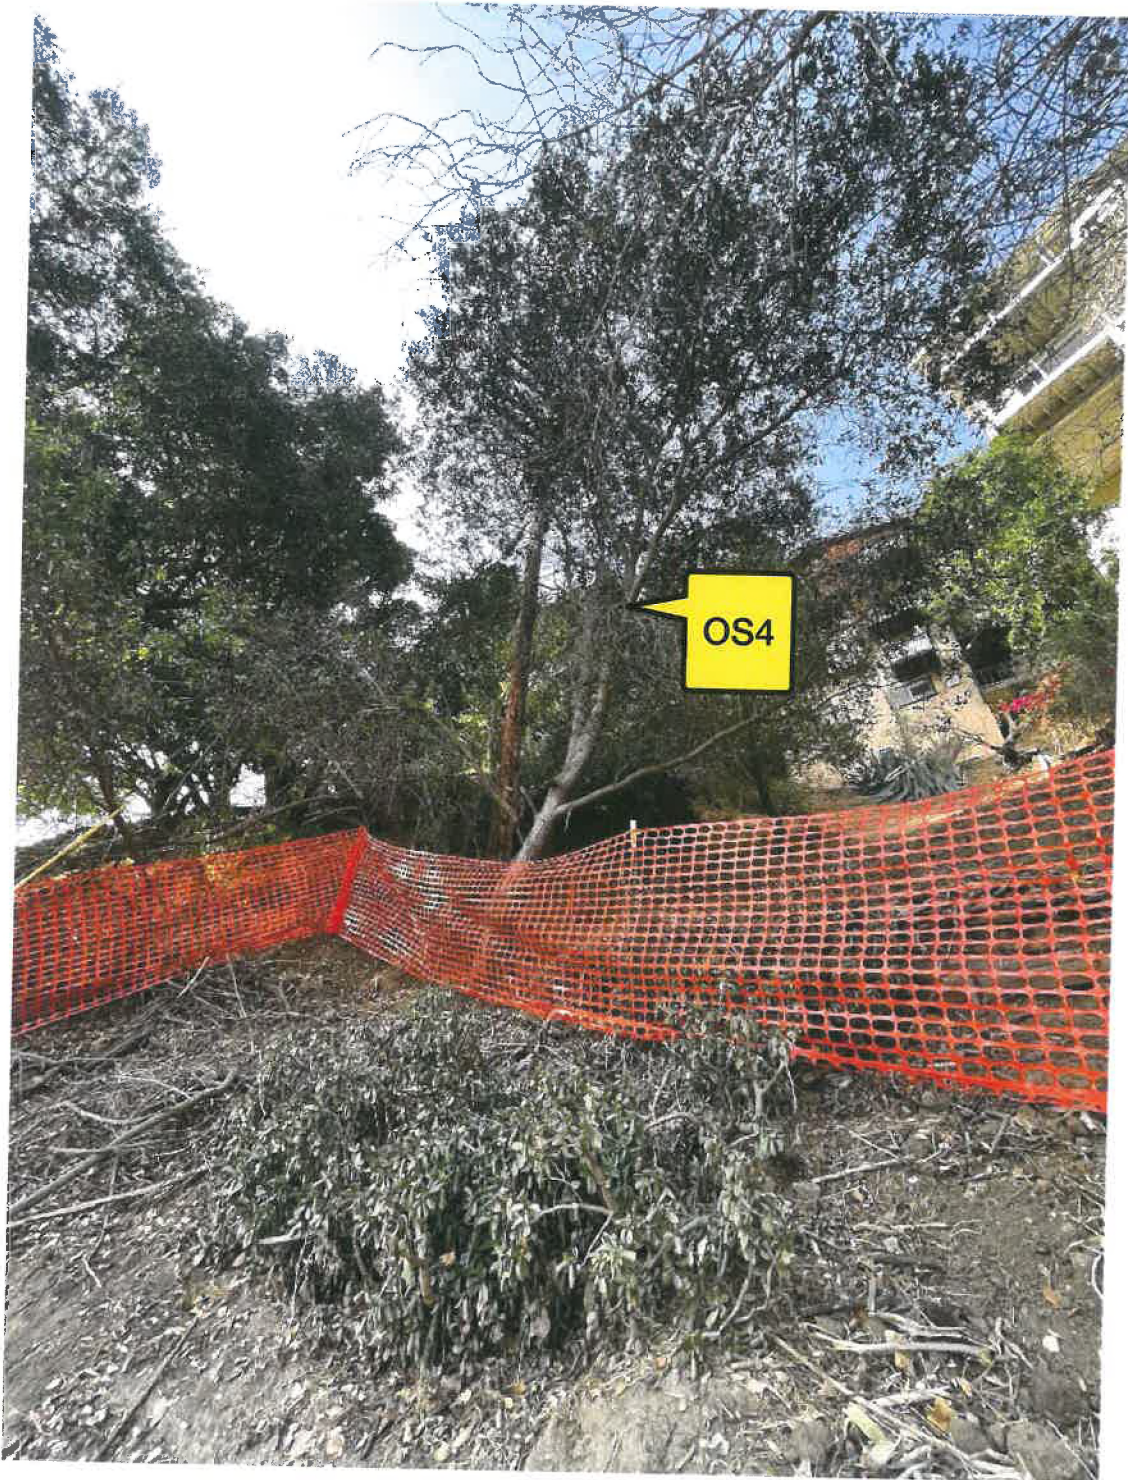
Coast live oak (*Quercus agrifolia*) tree #OS4 will not be impacted. The proposed ADU is sited approximately 6'-10" downhill from the oak trunk. This tree will receive minimal impact and will be retained and protected in place.

PHOTO 5 - Coast live oak (*Quercus agrifolia*) tree #OS4 will not be impacted. The proposed ADU is sited approximately 7' downhill from the oak trunk. This tree will receive no impact and will be retained and protected in place.

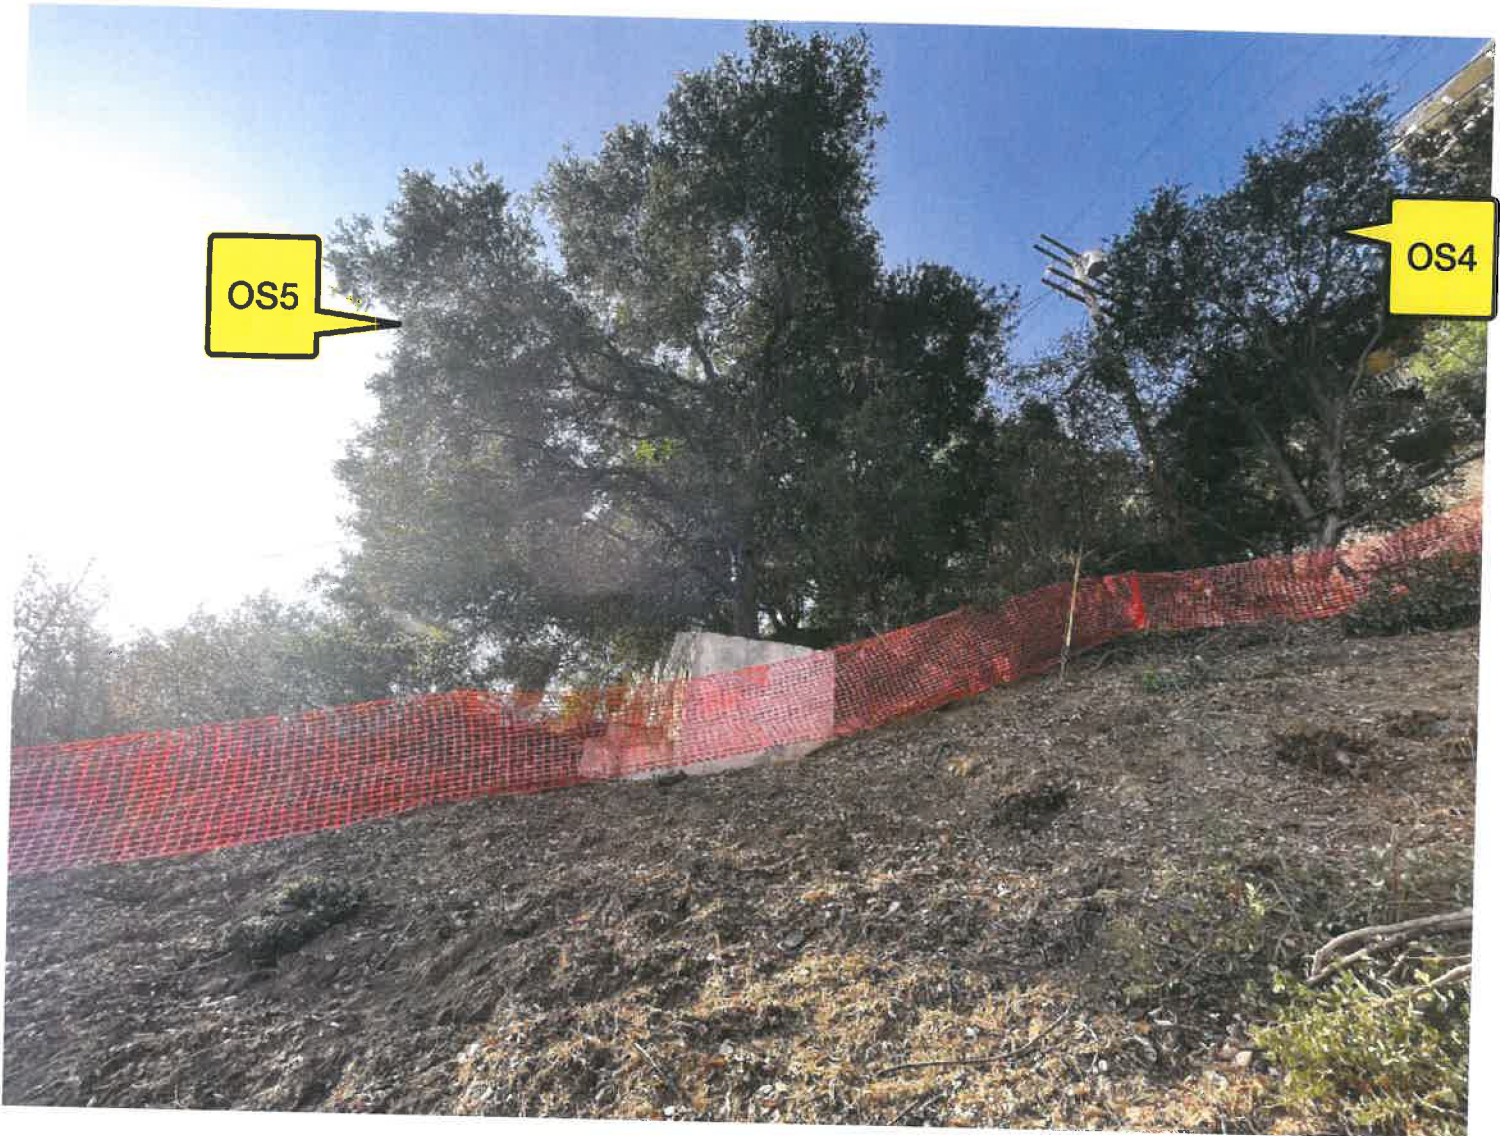
Coast live oak (*Quercus agrifolia*) tree #OS5 is located in an elevated concrete planter uphill from construction, and is outside of the construction zone and will not be impacted. This tree will receive no impact and will be retained and protected in place.

PHOTO 6 - Coast live oak (*Quercus agrifolia*) tree #OS5 is located in an elevated concrete planter uphill from construction, and is outside of the construction zone and will not be impacted. This tree will receive no impact and will be retained and protected in place.

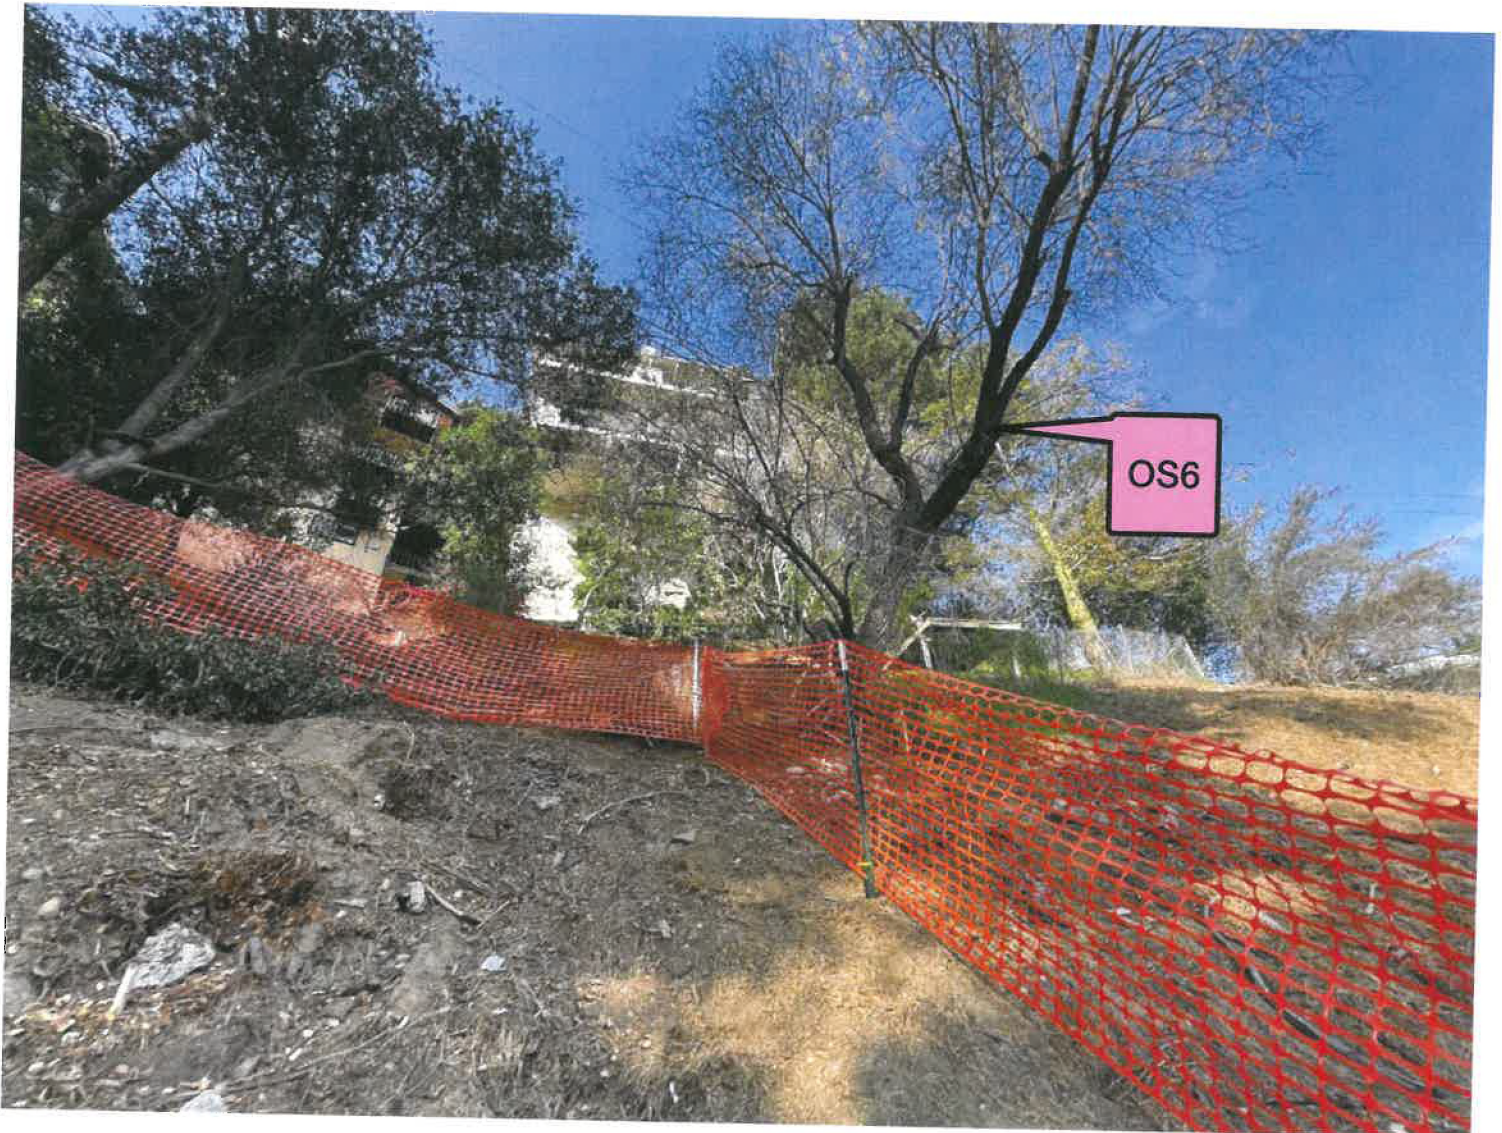
Mexican elderberry (*Sambucus mexicana*) tree #OS6 is off-site in the "sewer easement" area that extends about 6 feet across and is outside of the construction zone and will not be impacted. This tree is almost dead.

PHOTO 8 - Shows Off Site Mexican elderberry (*Sambucus mexicana*) tree #OS6. This tree will receive no impact and will be retained. This tree is off-site in the "sewer easement" area that extends about 6 feet across, this tree is poor condition and is almost dead, most likely due to drought conditions.

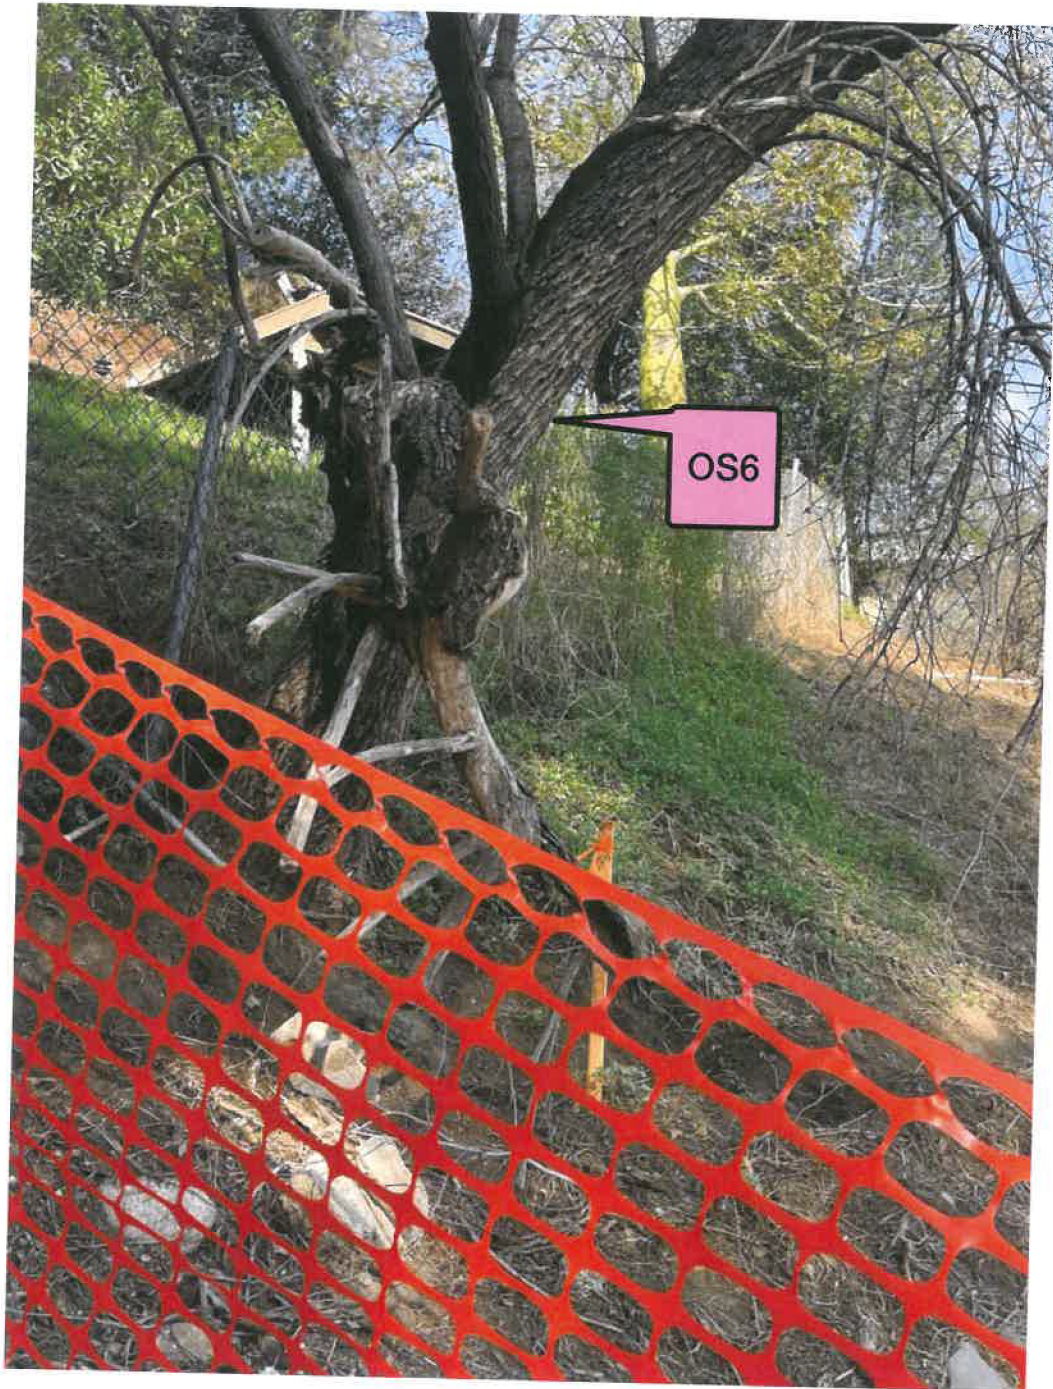
PHOTO 9 - Shows Off Site Mexican elderberry (*Sambucus mexicana*) tree #OS6. This tree will receive no impact and will be retained. This tree is off-site in the "sewer easement" area that extends about 6 feet across, this tree is almost dead.

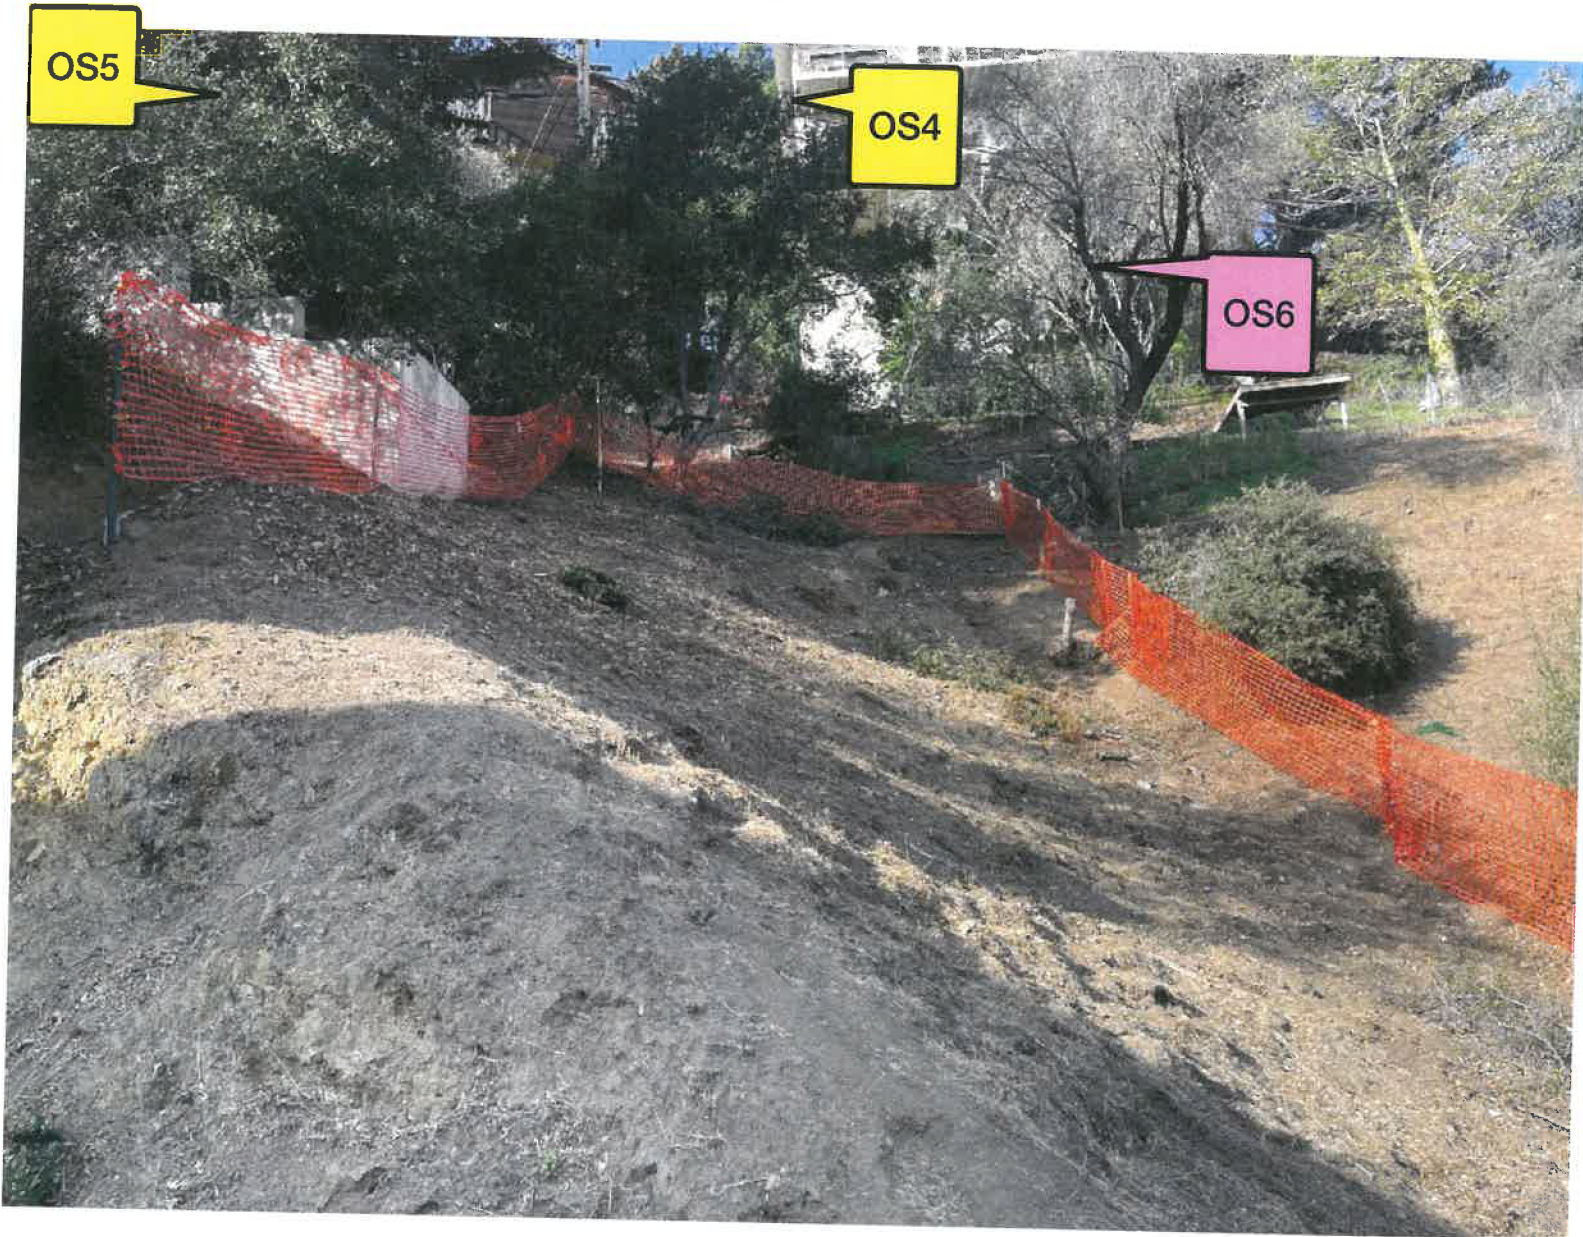
PHOTO 10 - Shows portion of slope where new project will be developed.

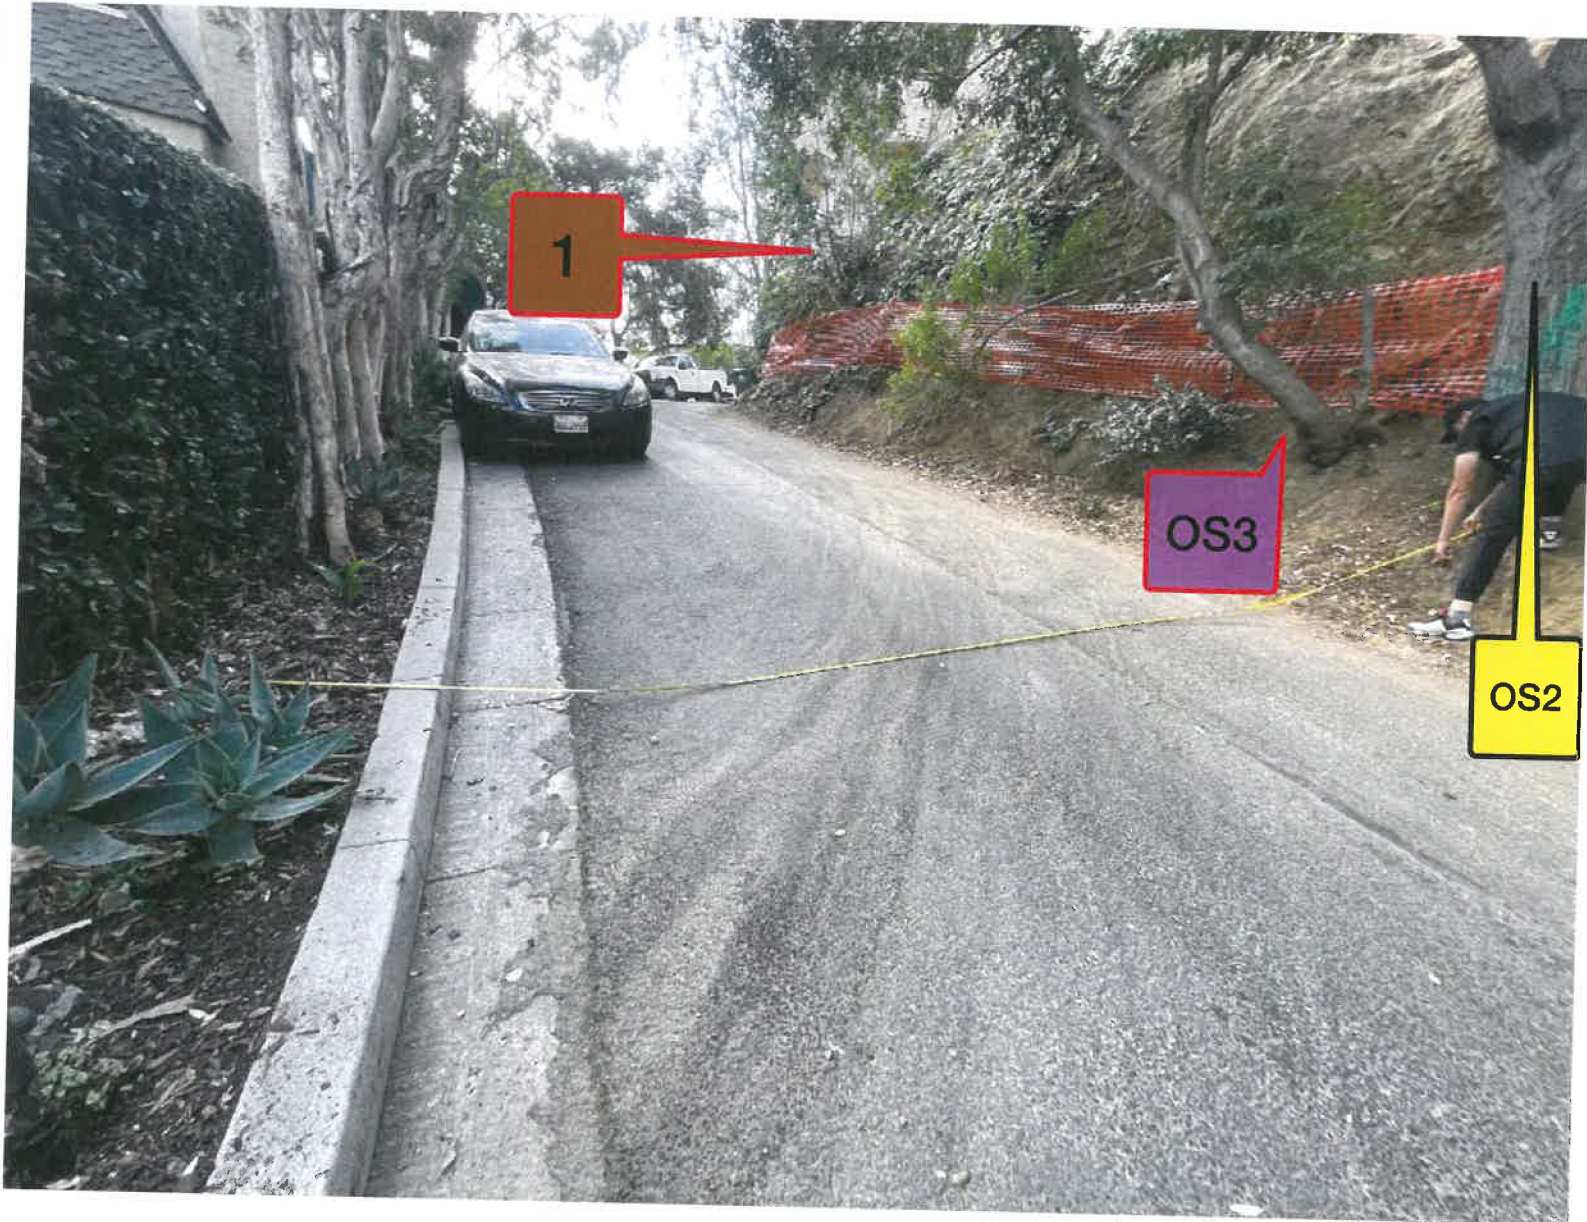
PHOTO 11 - Shows front slope and steep terrain. House will be built directly into hillside. The small Toyon shrub #1 is located directly on the steepest portion of the front slope. This photo is also showing the back of curb location of the required widening of the road. required widening of the road.
