Re: Council File No. 25-1518; 11973-11975 West San Vicente Boulevard / California Environmental Quality Act (CEQA) / Appeal

Re: Council File No.: 25-1518 - Appeal of Building and Safety Commission's Approval of Demolition Permit for Barry Building Located at 11973 San Vicente Boulevard

11973 San Vicente Boulevard

ASCE 41-13 Seismic Assessment

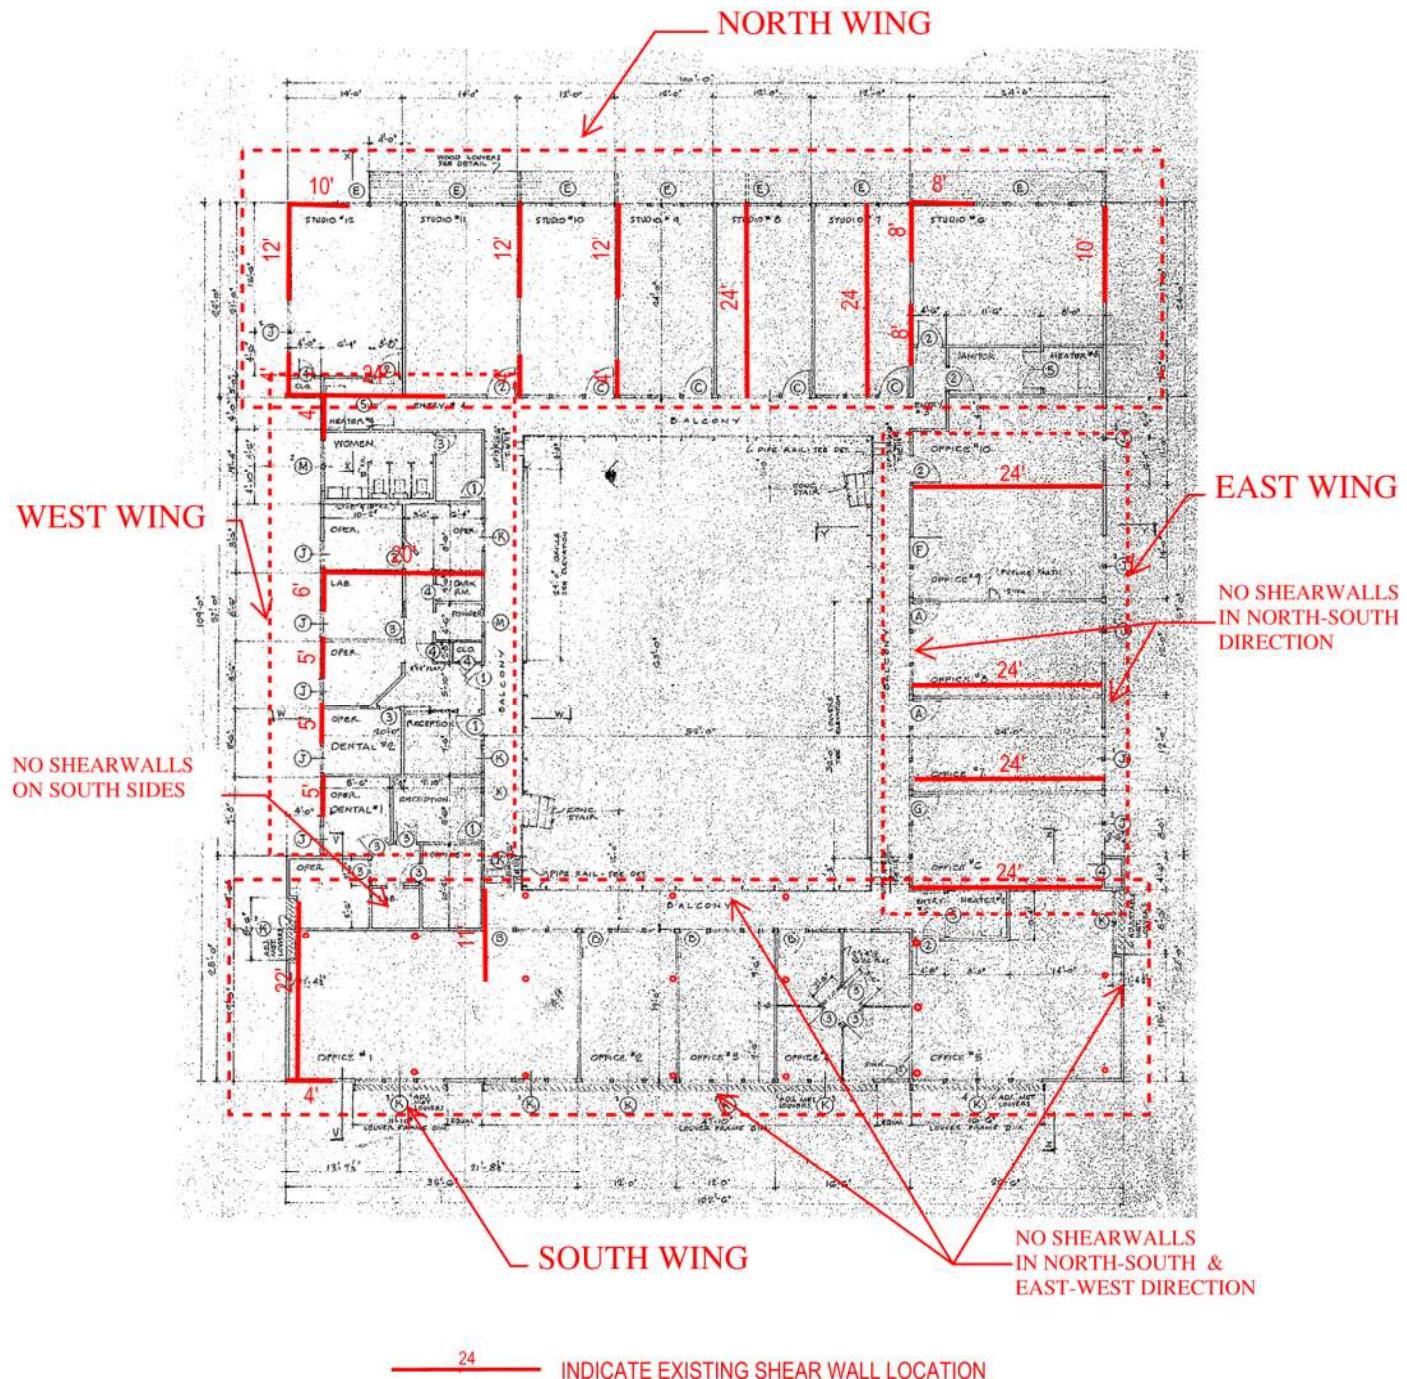
Figure 3.1: Existing Shear Wall Locations

16.1 Basic Checklist		
Item	Non-Compliant/Unknown	Description
Load Path	Non-Compliant	Discontinuous horizontal diaphragms occur at second floor and roof. Vertical elements of seismic-force-resisting system (such as wood shear walls or frames) were not found at all sides of the perimeter. Interior demising walls do not form a complete seismic-force-resisting system as they are discontinuous between floors.
16.1.2LS Life Safety Basic Configuration Checklist		
Item	Non-Compliant/Unknown	Description
Load Path	Non-Compliant	See 16.1 for Description
Weak Story	Non-Compliant	Vertical discontinuities of seismic-force-resisting system were not found at all sides of the perimeter. Interior demising walls do not form a complete lateral bracing system as they are discontinuous between floors.

Soft Story	Unknown	Stiffness of the seismic-force-resisting system cannot be confirmed, as the seismic-force-resisting system (wood shear walls) are not found at all sides of perimeter, and wood shear walls are found discontinuous between floors.
Vertical Irregularities	Non-Complaint	Vertical elements of seismic-force-resisting system (Wood shear walls) were found discontinuous between floors.
Torsion	Unknown	The story center of rigidity cannot be confirmed.
Overturning

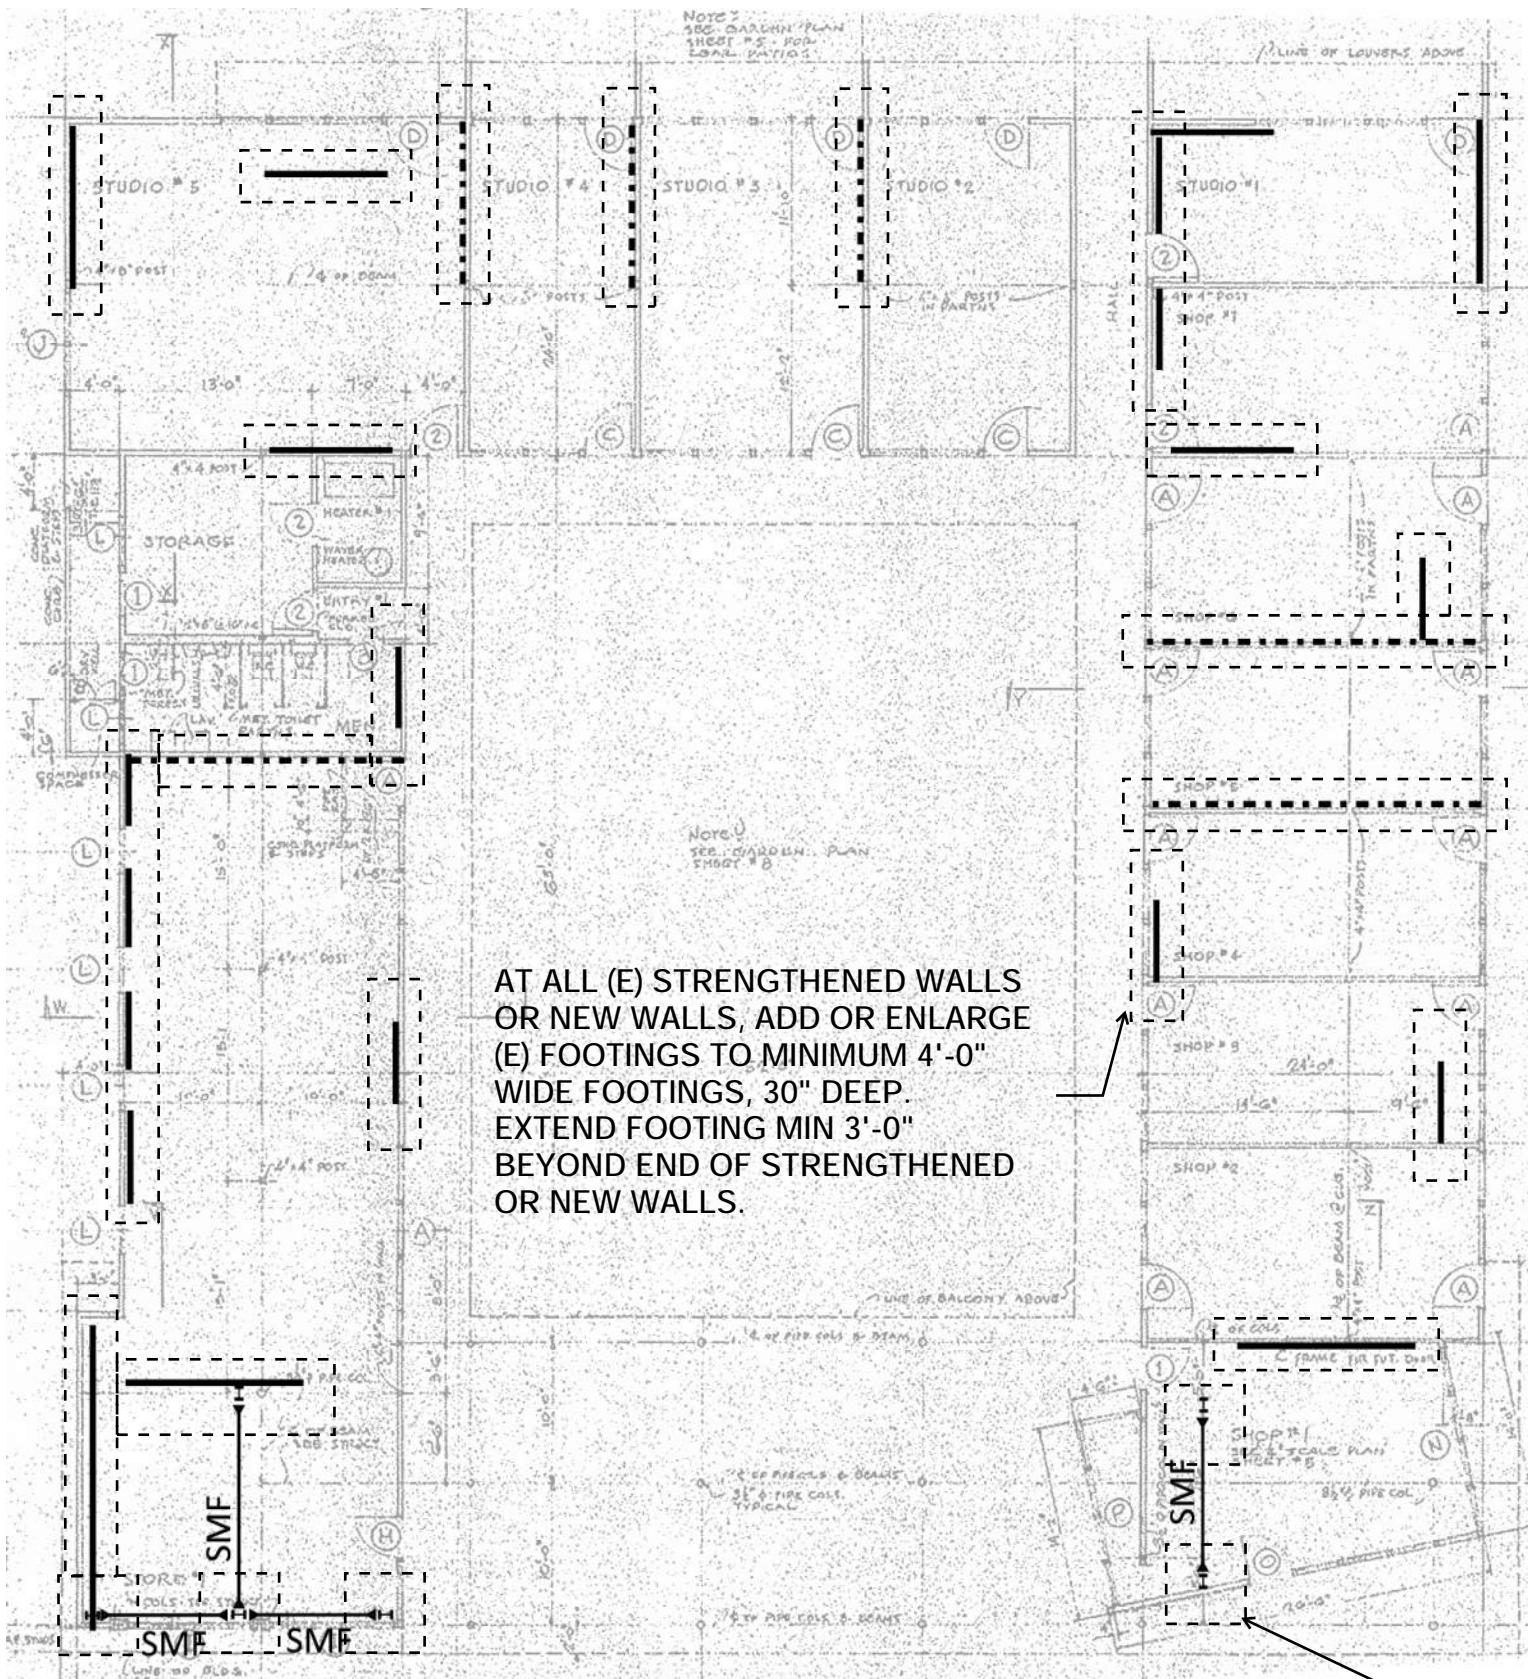
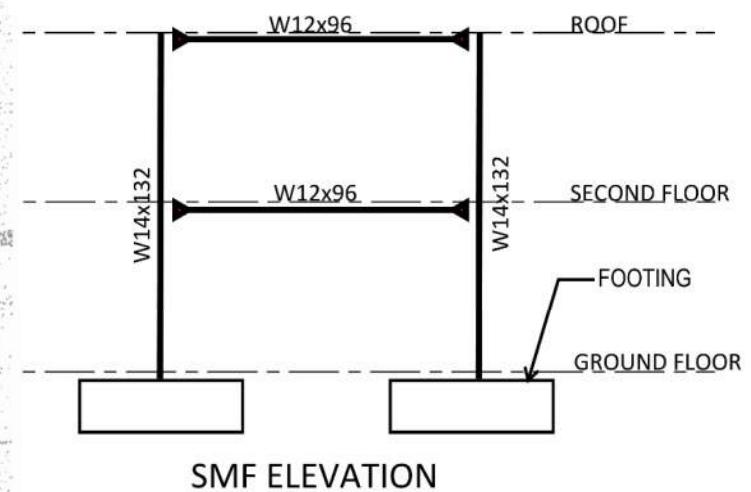
Figure 7.1: Conceptual Shear Wall and Steel Moment Frame Locations

The analysis indicates high demand over capacity ratios for all parts of the existing building. These high ratios indicate that the building is likely to suffer significant damage when subject to a moderate to strong earthquake in the Los Angeles basin. Some portions of the building have no significant seismic resisting elements that can resist the seismic forces from the roof and second floor and can result in a possible collapse when subject to a moderate to strong earthquake. These structural deficiencies represent life safety hazards to occupants in and around the building. The above mentioned seismic retrofits would correct the structural deficiencies identified in this report.

- 10'-0" LONG WOOD SHEAR WALL w/1/2" PLYWOOD & 10d@3":12, ADD (2) SIMPSON HD14 AND 4x8 POST EA END.

----- STRENGTHEN (E) WOOD SHEAR
WALL w/1/2" PLYWOOD &
10d@3":12, ADD (2) SIMPSON
HD14 AND 4x8 POST EA END.

TYPICAL AT ALL FLOOR AND ROOF:
ADD 3/4" FLOOR AND ROOF PLYWOOD
OVER (E) SHEATHING AND NAIL
w/10d@4:12.

— NEW FOOTINGS 6'-0" x 6'-0" x
— 30" DEEP FOOTINGS UNDER
ALL SMF COLUMNS, U.N.O.
