**RE: Request to Include Attachments in Council File 25-1518 (too large to upload via the City's Public Comment Portal) ... Please see email for details ... (Email 1 of 4) ...**

# THE BARRY BUILDING - 11973-11975 SAN VICENTE BLVD

May 26, 2021  
Job No. 12-L038B

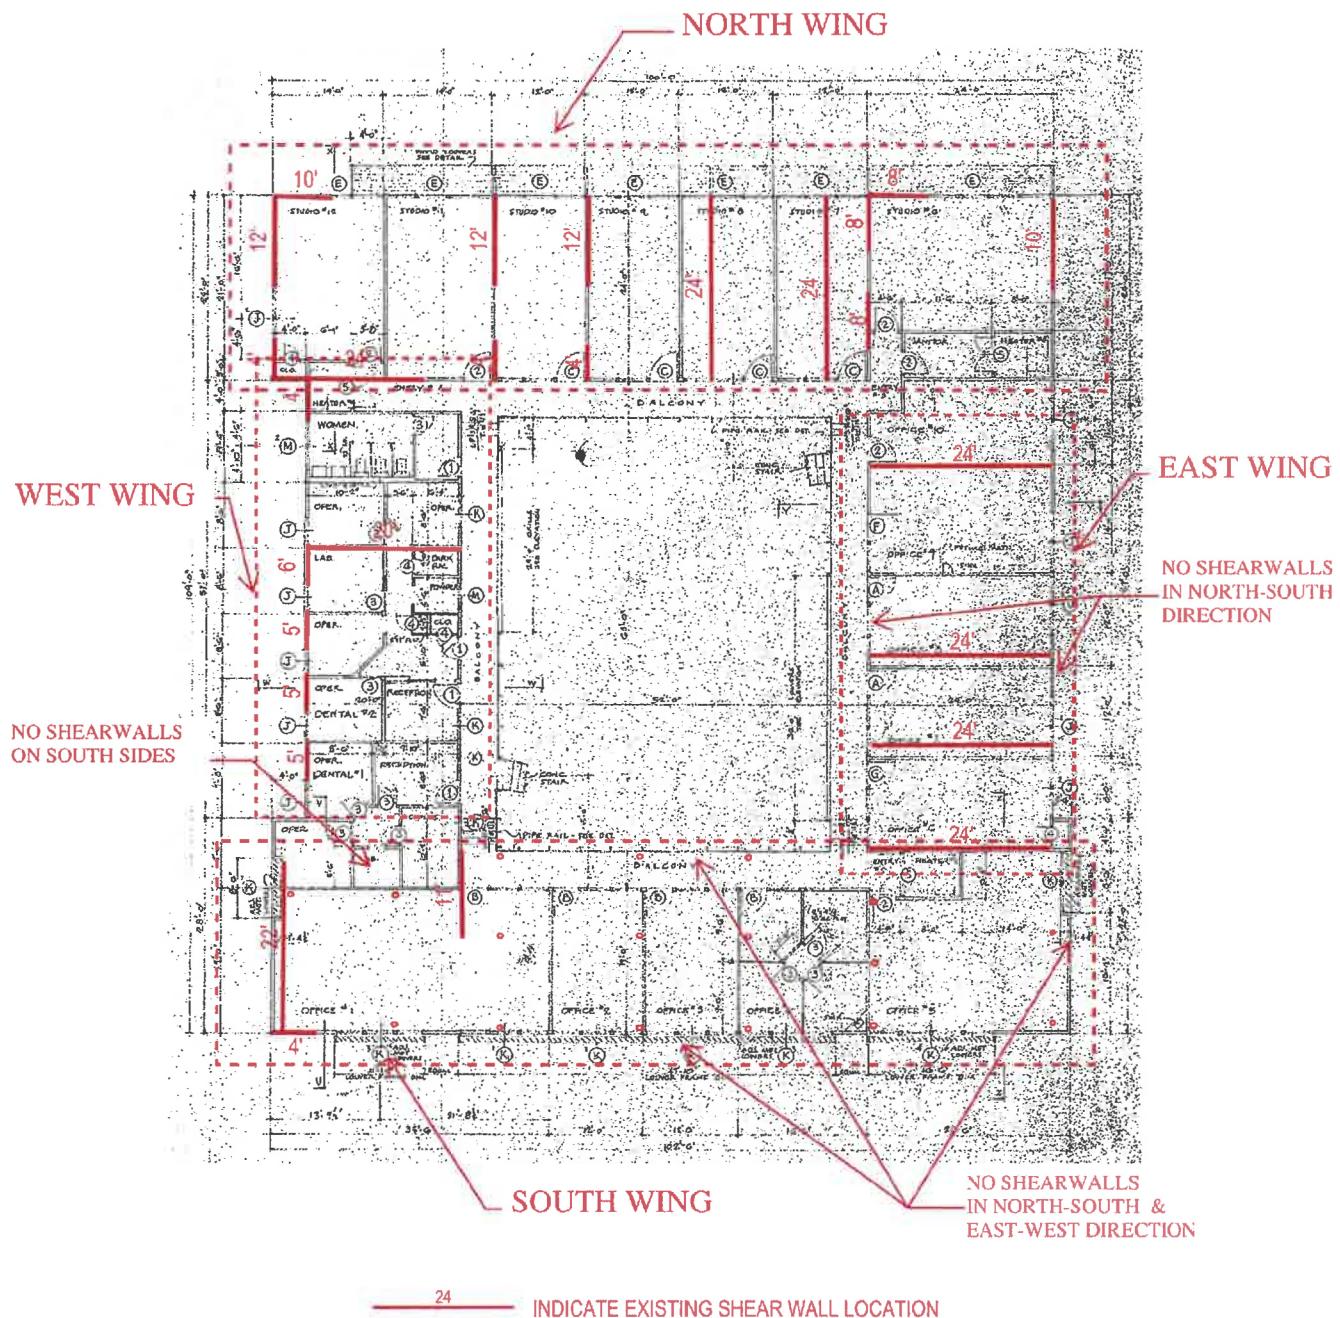
**Figure 3.1:** Existing Shear Wall Locations

<b>16.1 Basic Checklist</b>		
<b>Item</b>	<b>Non-Compliant/Unknown</b>	<b>Description</b>
Load Path	Non-Compliant	Discontinuous horizontal diaphragms occur at second floor and roof. Vertical elements of seismic-force-resisting system (such as wood shear walls or frames) were not found at all sides of the perimeter. Interior demising walls do not form a complete seismic-force-resisting system as they are discontinuous between floors.
<b>16.1.2LS Life Safety Basic Configuration Checklist</b>		
<b>Item</b>	<b>Non-Compliant/Unknown</b>	<b>Description</b>
Load Path	Non-Compliant	See 16.1 for Description
Weak Story	Non-Compliant	Vertical discontinuities of seismic-force-resisting system were not found at all sides of the perimeter. Interior demising walls do not form a complete lateral bracing system as they are discontinuous between floors.

Item	Non-Compliant/Unknown	Description
Redundancy	Non-Complaint	Vertical discontinuities of seismic-force-resisting system were not found at all sides of the perimeter.
Shear Stress Check	Non-Complaint	The shear stress check provides an assessment of the overall level of demand on the structure. Existing shear walls are found to be overstressed.
Stucco (Exterior Plaster) Shear Wall	Unknown	Plywood sheathing on existing exterior wall shear walls cannot be confirmed. Existing shear walls could be a stucco shear wall
Gypsum Wallboard or Plaster Shear Walls	Non-Complaint	Existing interior demising walls are found to be Gypsum board.
Narrow Wood Shear Walls	Non-Compliant	Existing shear walls were found with an aspect ratio less than 2-to-1.

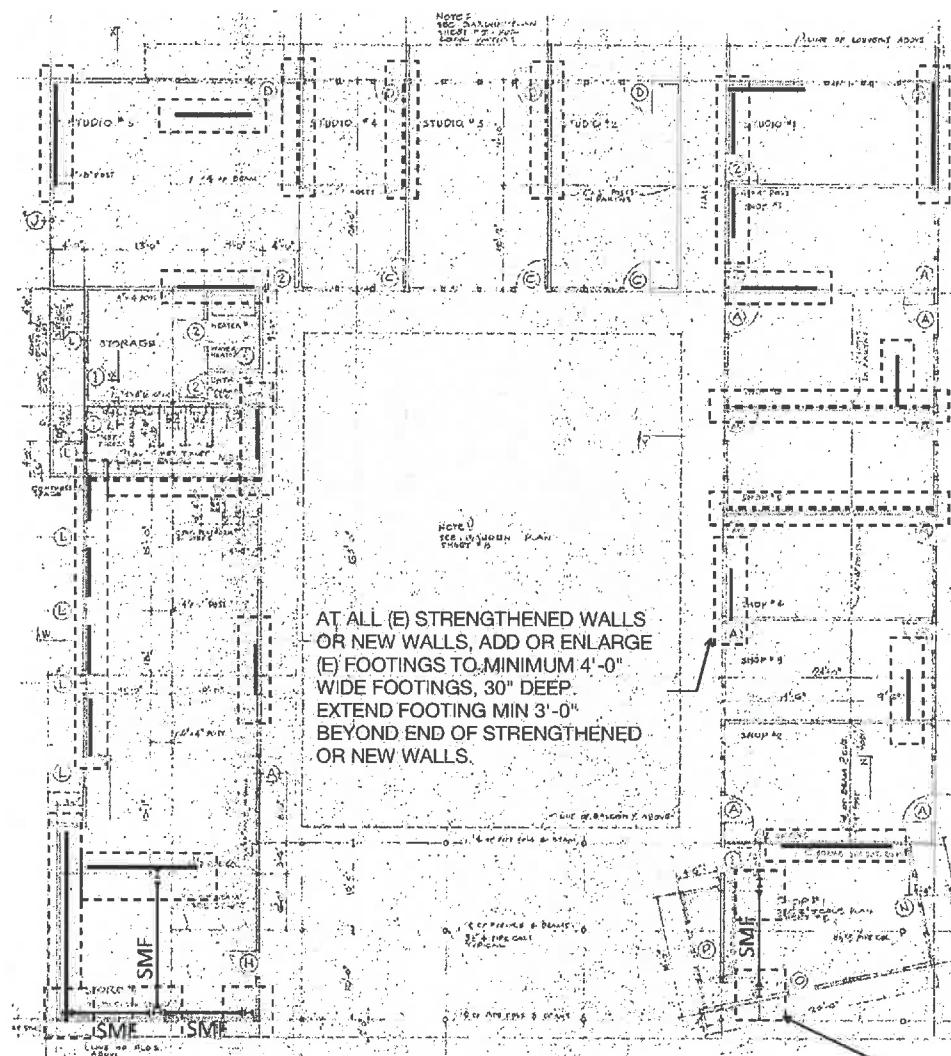
Figure 7.1: Conceptual Shear Wall and Steel Moment Frame Locations

The analysis indicates high demand over capacity ratios for all parts of the existing building. These high ratios indicate that the building is likely to suffer significant damage when subject to a moderate to strong earthquake in the Los Angeles basin. Some portions of the building have no significant seismic resisting elements that can resist the seismic forces from the roof and second floor and can result in a possible collapse when subject to a moderate to strong earthquake. These structural deficiencies represent life safety hazards to occupants in and around the building. The above mentioned seismic retrofits would correct the structural deficiencies identified in this report.

*Consideration for Reducing Impact of Retrofit on Historical Fabric:* The above seismic retrofit can be done to minimize the impact on the building historic fabric. The addition of new plywood shear walls can be performed on the inside force of the exterior walls to avoid removing or damage the exterior skin. The new walls can be located to avoid closing any existing historic windows. The new steel moment resisting frames that are located at the front wing can be placed interior to the building footprint. The second floor and roof diaphragm will require enhanced nailing to allow the adjustment of the frame relocations.

10'-0" LONG WOOD SHEAR WALL w/1/2" PLYWOOD & 10d@3":12, ADD (2) SIMPSON HD14 AND 4x8 POST EA END.

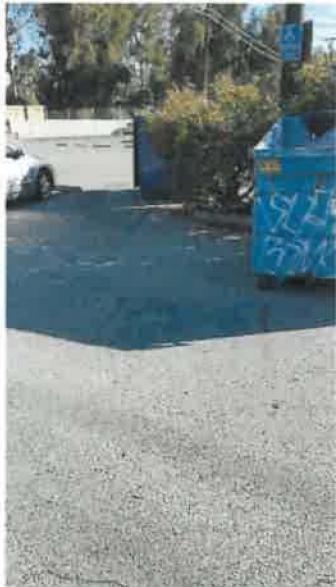
**The parking lot has 1 ADA stall. The marking is faded beyond recognition. It cannot be measured to verify compliance with CBC Sections 11B-502.1, 502.2 and 502.3.**

The sign posted in front of the stall is missing the lettering required in CBC Section 11B-502.6.2.

The accessible parking space has a faded marking and a pole mounted sign.

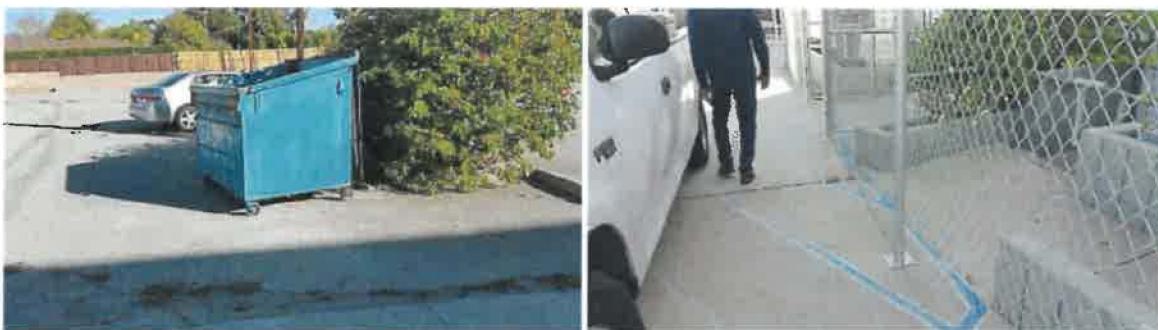
**The paving adjacent to the ADA stall shows the asphalt cracks and settlement, which may not be in compliance with CBC Section 11B-502.4.**

The cracked asphalt adjacent to the accessible parking space and the marking leading to the building's rear entrance and the CMU Addition.

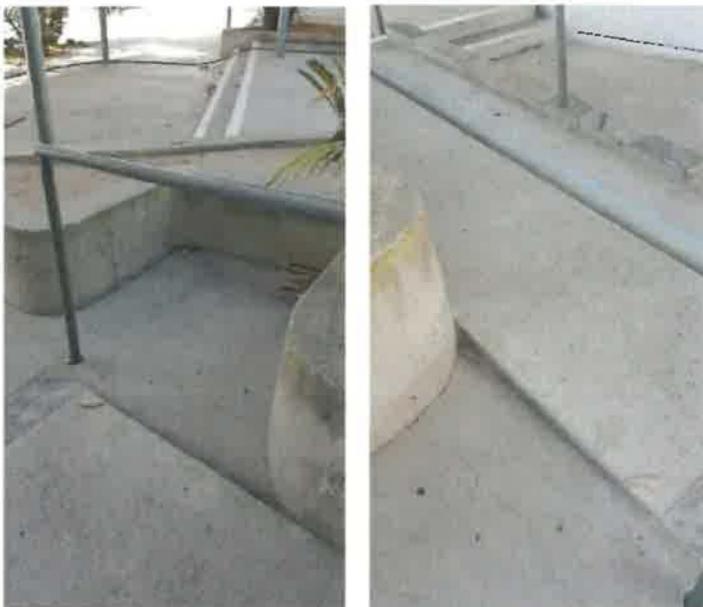
**A portion of the courtyard ramp is missing the edge protection to be in full compliance with CBC Section 11B-405.9**

Courtyard ramp is missing the edge protection on one side.

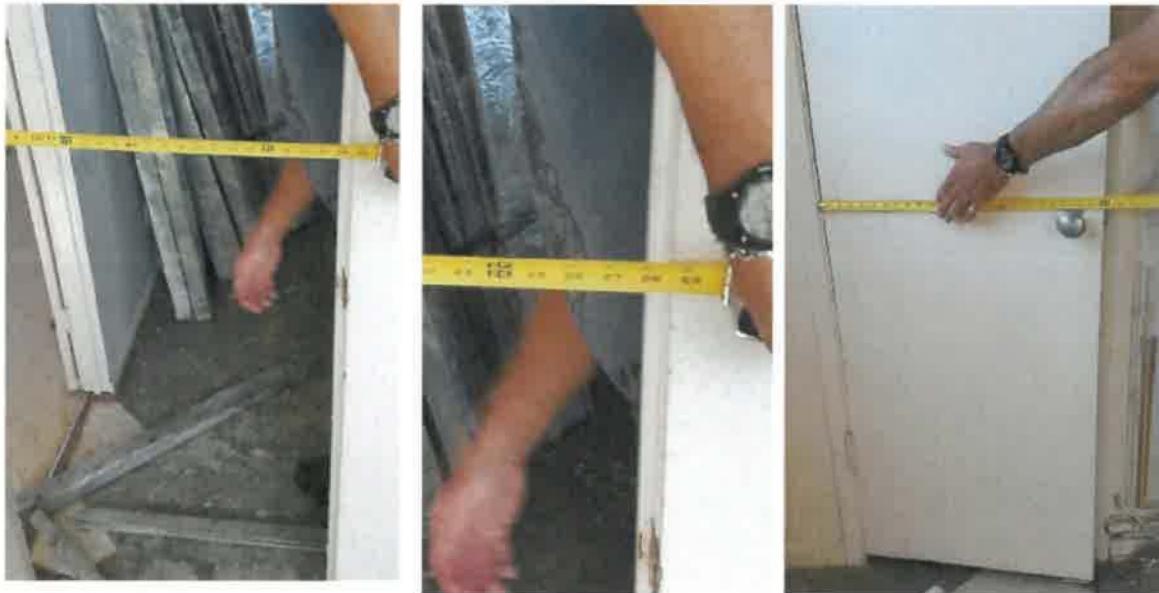
**The door width is not in compliance with CBC Section 11B-404.2.3.**

The tenant interior doors are only 28" and 24" wide.

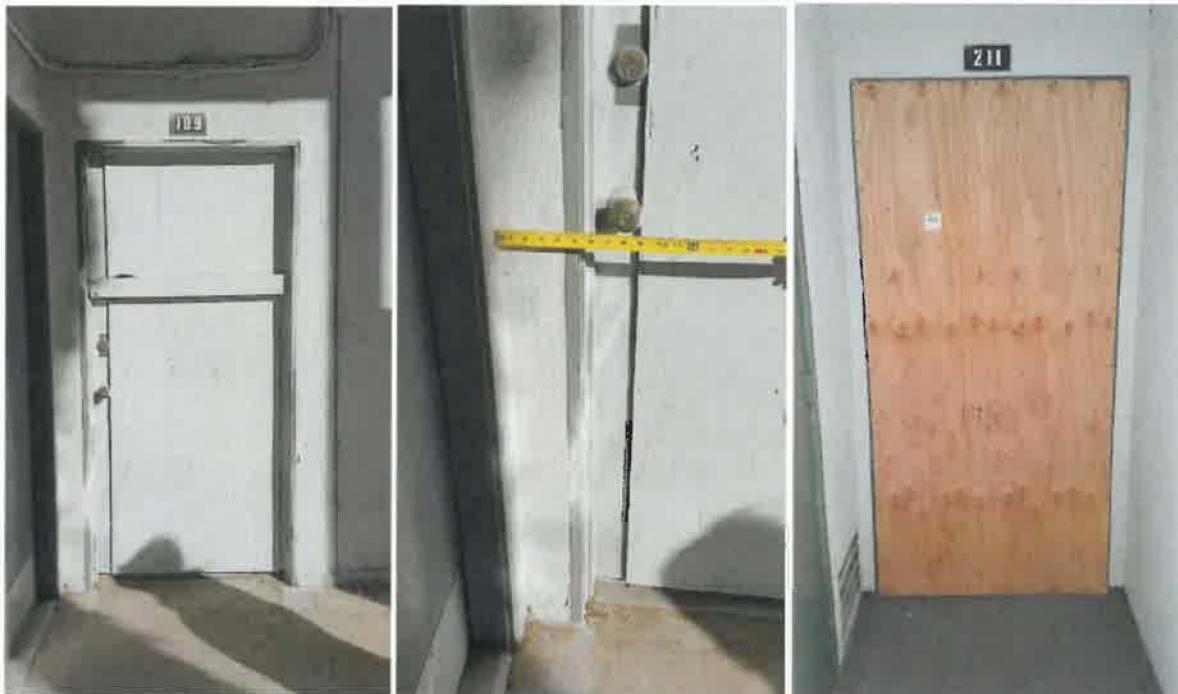
A first floor tenant's entry door only has 42" deep maneuvering clearance due to a projected wall.

A first floor tenant's door does not have the code required 12" push side clearance.

At least two second floor tenant's doors do not have the code required 12" push side clearance.

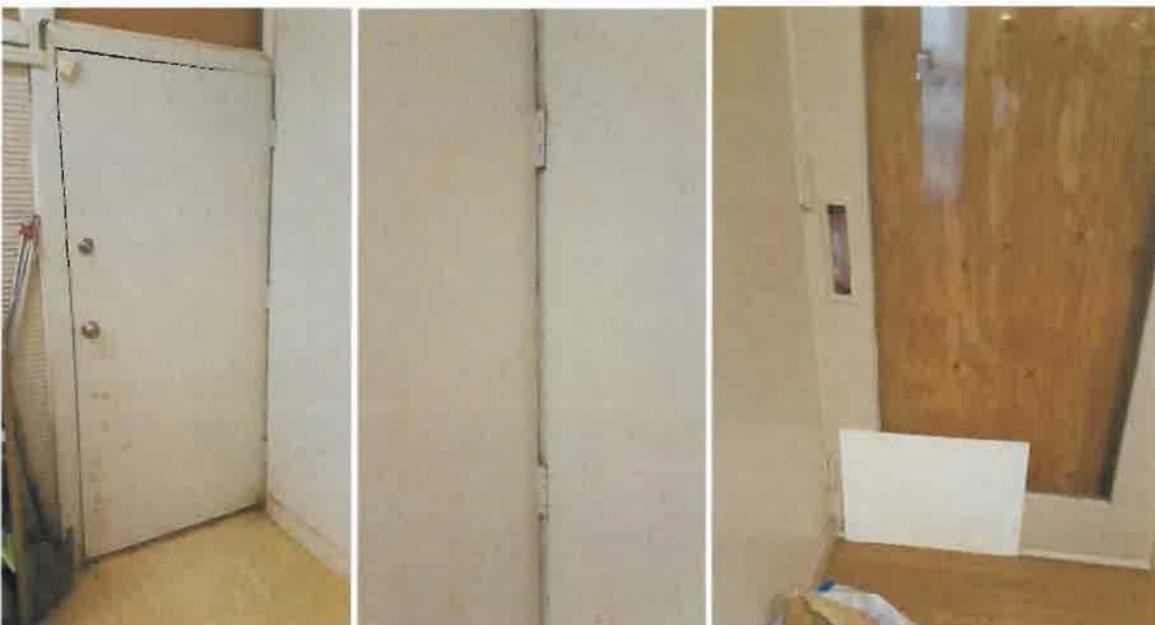
**The door opening degree is not in compliance with CBC Section 11B-404.2.3.**

Some of the first floor tenant doors cannot open 90 degrees due to the door jamb installed into the wall.

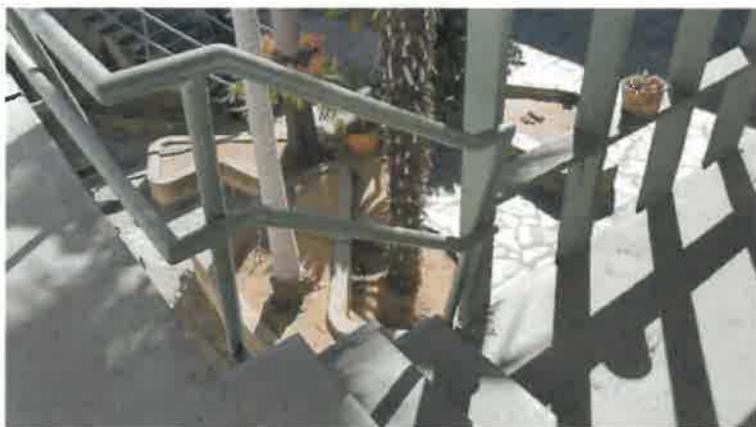
**The four second floor stairs do not have handrail extensions at the bottom landing; therefore, they are not in compliance with CBC Section 11B-505.10.3.**

A second floor stair is missing a handrail extension at the bottom landing.

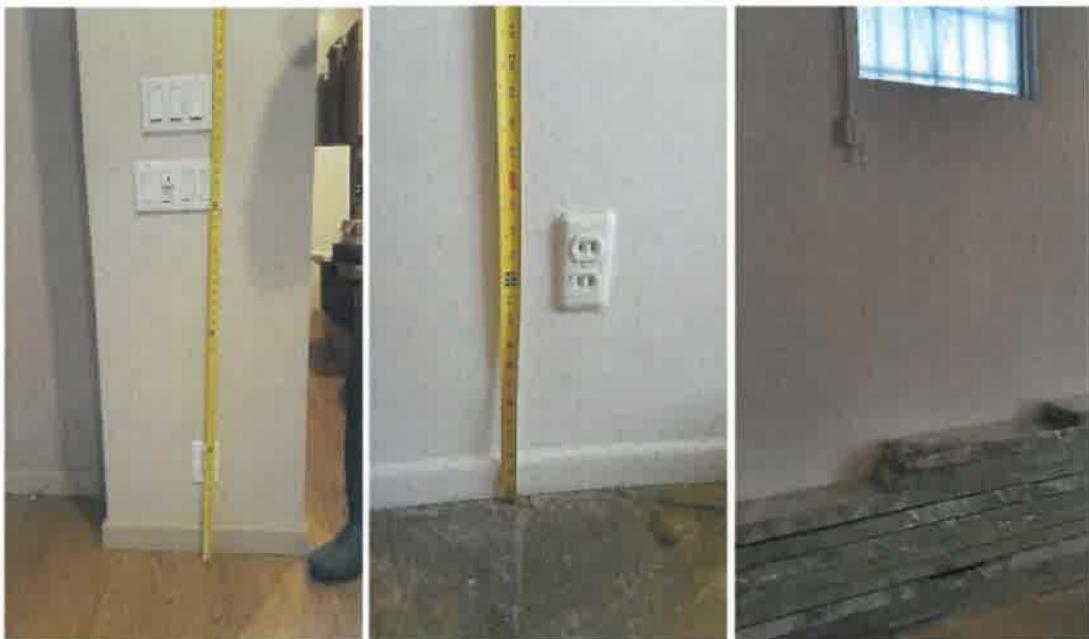
The electrical receptacle outlets' mounting height should be 15" minimum. **The majority of the original outlets do not comply with CBC Section 11B-308.1.**

The original outlets are mounted at typical 12" above the floor. One outlet is mounted higher than 48" above the floor.
