DEPARTMENT OF
CITY PLANNING
OFFICE OF HISTORIC RESOURCES
200 N. SPRING STREET, ROOM 620
LOS ANGELES, CA 90012-4801
(213) 978-1200

CITY OF LOS ANGELES 3
CALIFORNIA

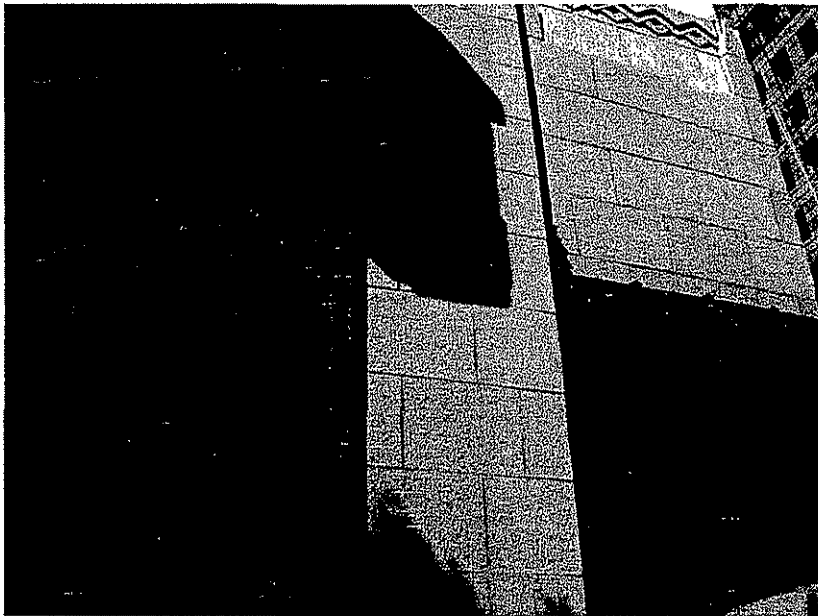
Photo #8: Restored cast-iron storefront and terra cotta repair, west elevation.

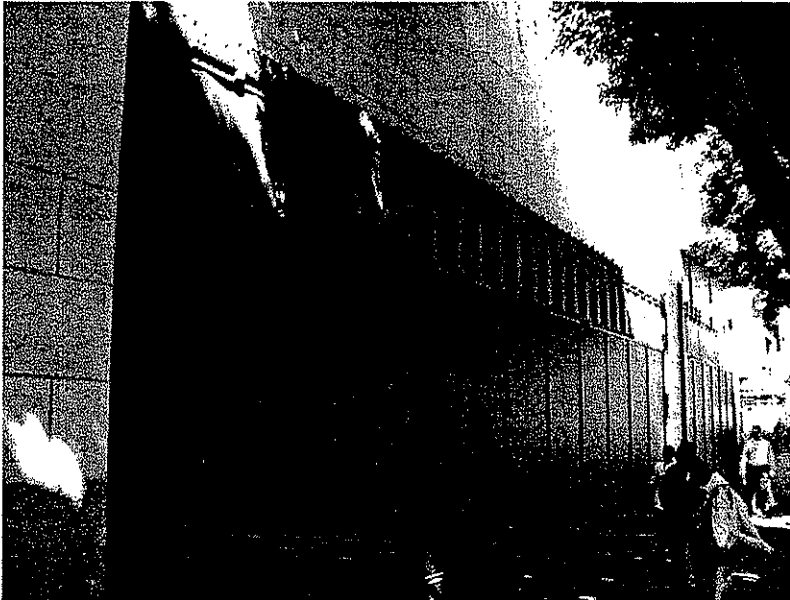
Photo #9: Storefronts along Fifth Street. The historic cast iron detail was retained and leases to any commercial tenant will stipulate that cast iron be retained, and size of openings cannot be changed. Storefront windows were left in place. The interior space is still vacant at this time.

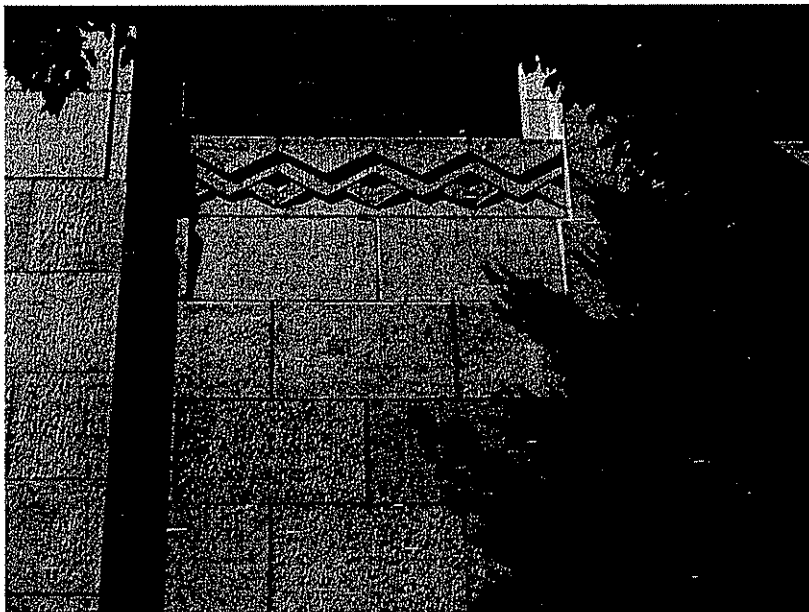
Photo #12: Terra cotta on west elevation. Any cracked or damaged pieces were replaced, and surface was reglazed to provide uniform appearance.

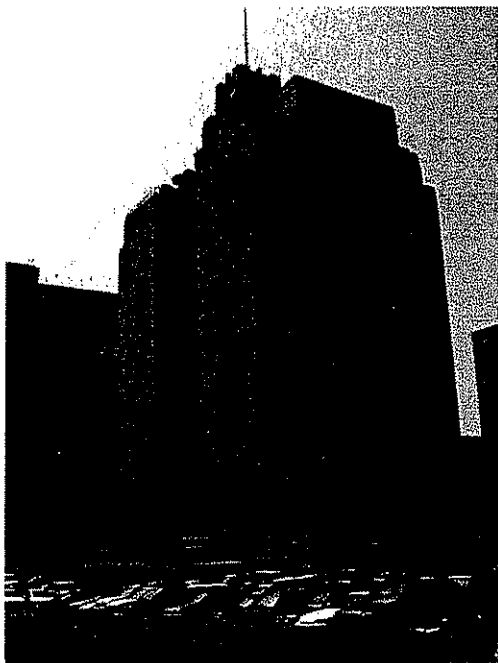
Photo #13: North wall. No work occurred on this elevation due to imminent construction of adjacent building. Proposed new windows on north wall were deleted due to modification to plans for adjacent building that made new openings in the Title Guarantee undesirable.

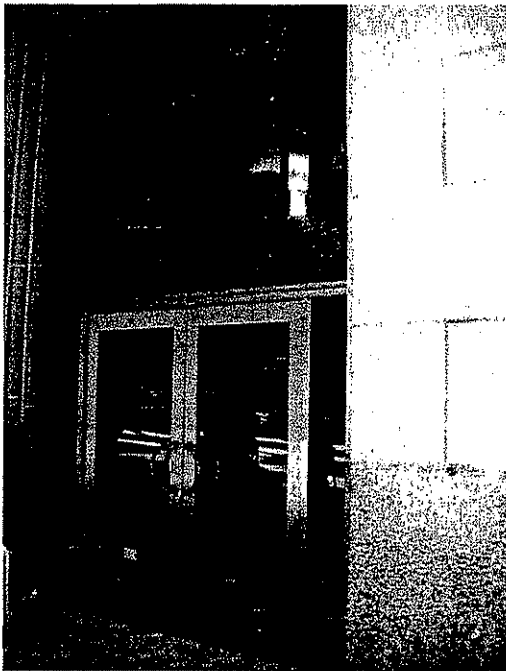
Photo #18: Entrance doors, cleaned and repaired.

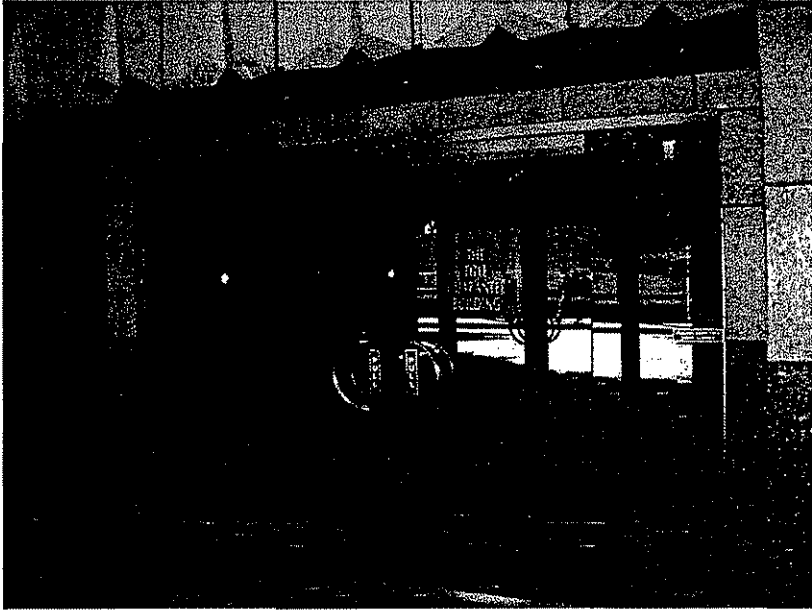
Photo #19: New internal doors located between vestibule and main elevator lobby.

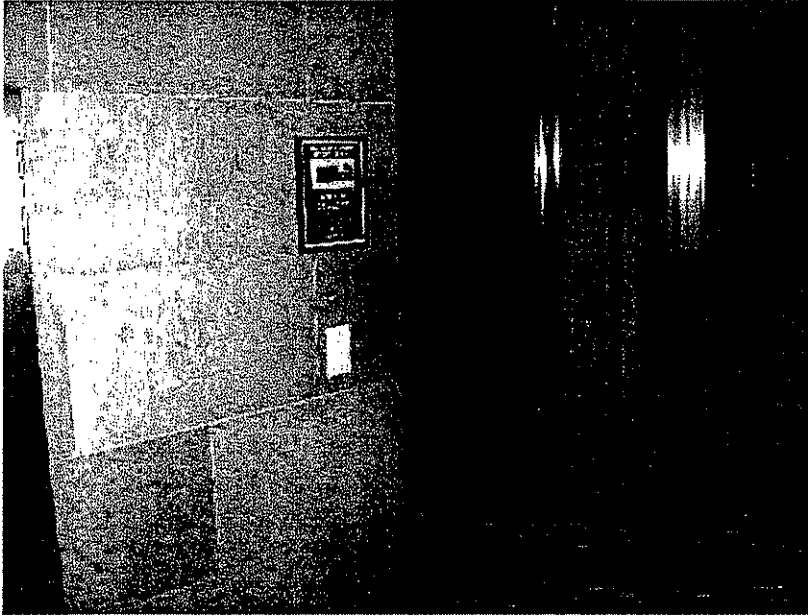
Photo #23: Door replaced in elevator lobby, first floor.

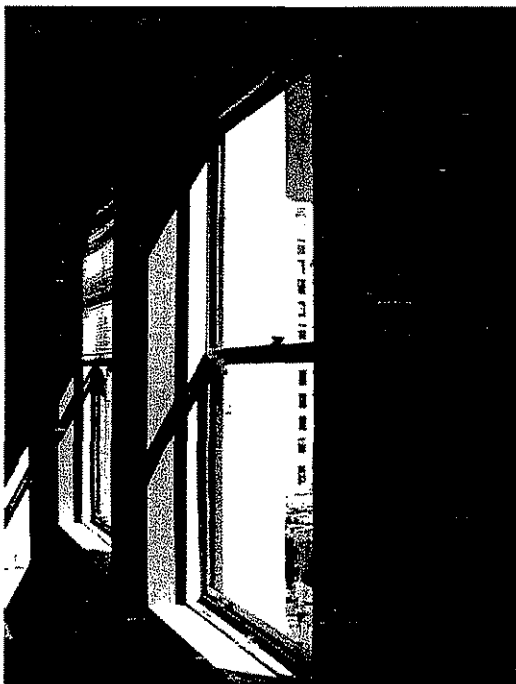
Photo #38: Original steel 1/1 windows on all facades were restored. Most are in operable condition.

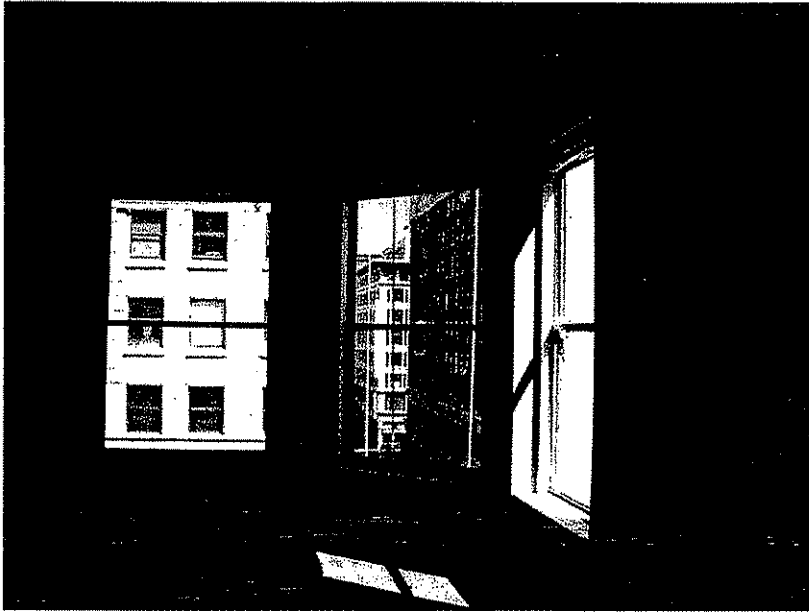
Photo #39: Original steel, 1/1 windows on all facades were retained and restored. Most are in operable condition.

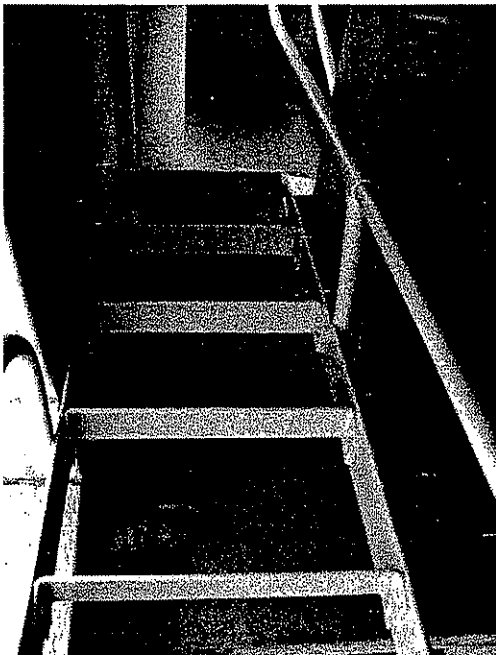
Photo #50: Original fire escape stair, internal to west elevation. Repaired and painted. Will continue in use as fire escape. The fire escape was accepted by the City of Los Angeles based on the alterations to make it accessible with a door, rather than the window, as originally designed in 1931.

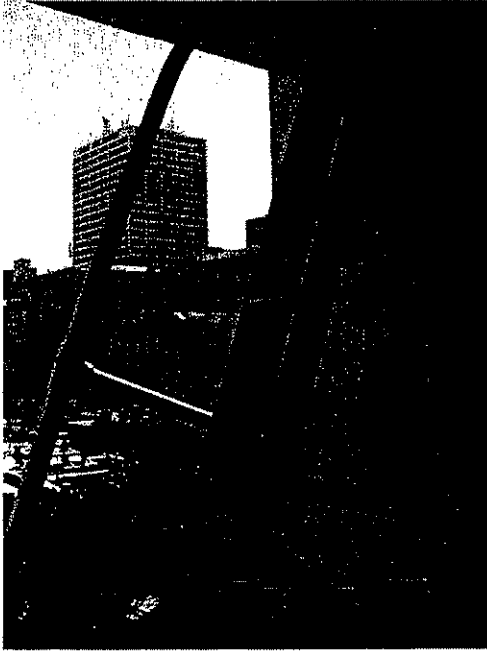
Photo #51: Original fire escape stair, internal to west elevation. Repaired and painted. Will continue in use as fire escape.
