Sunset - UCLA Trunk Line Break

Council E&E Committee

August 6, 2014

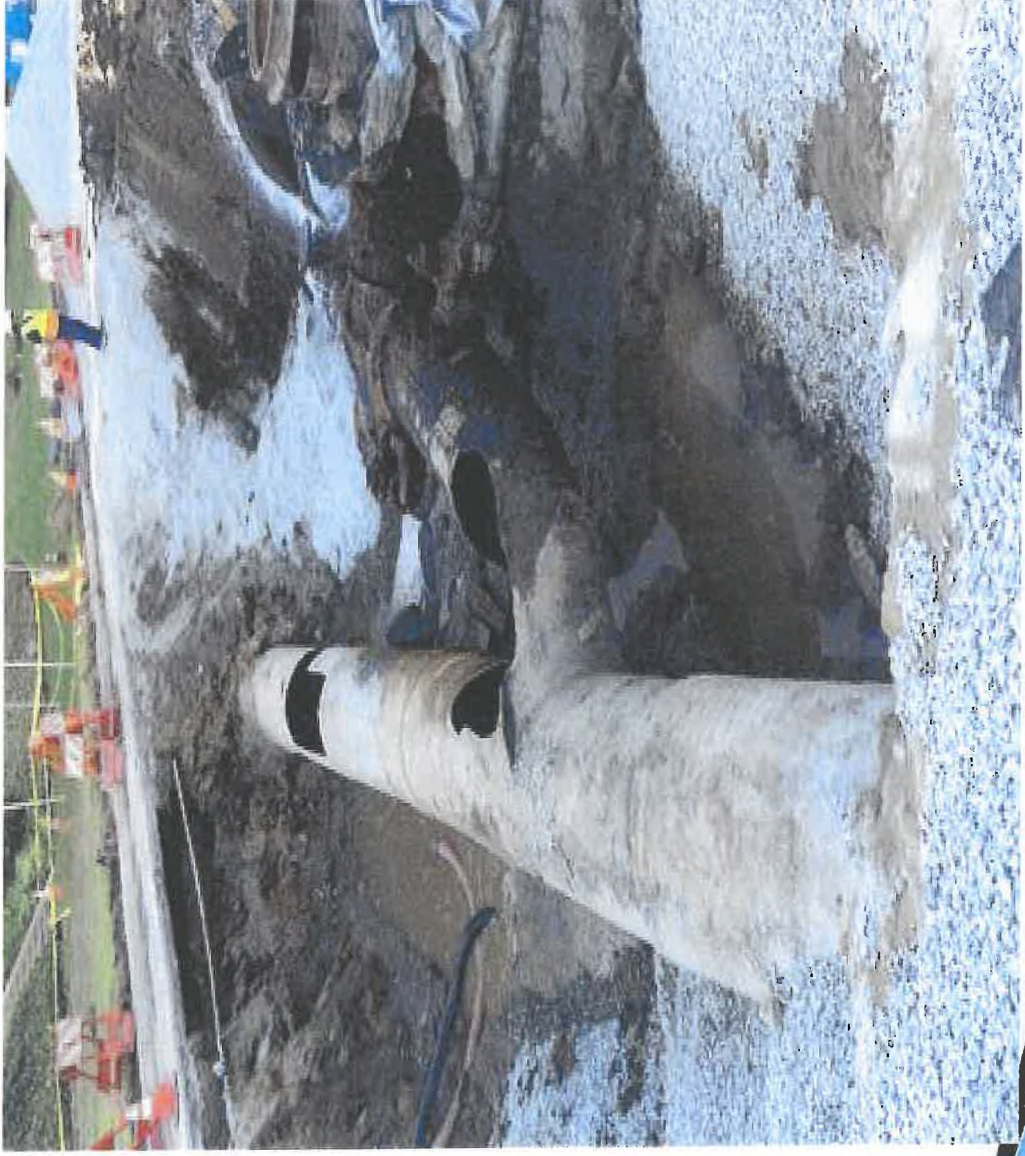
Breach at connection between lines

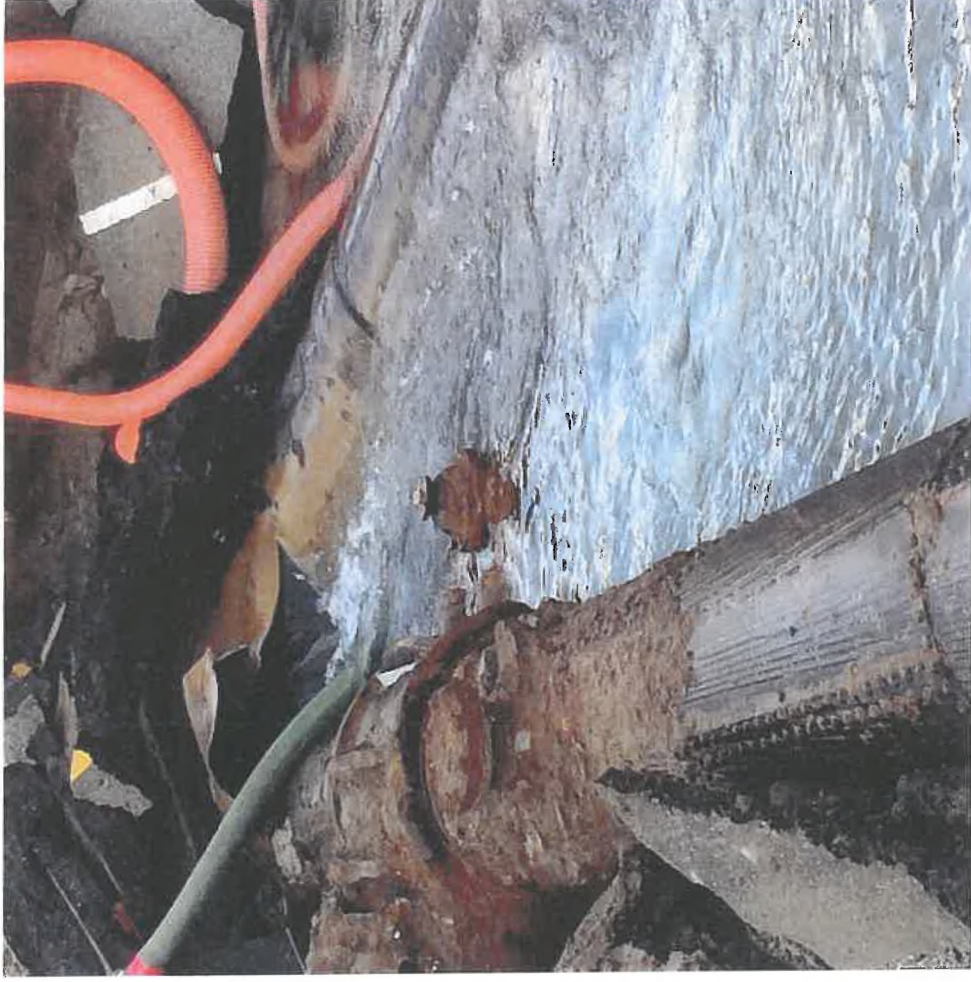
Controlling Water Flow

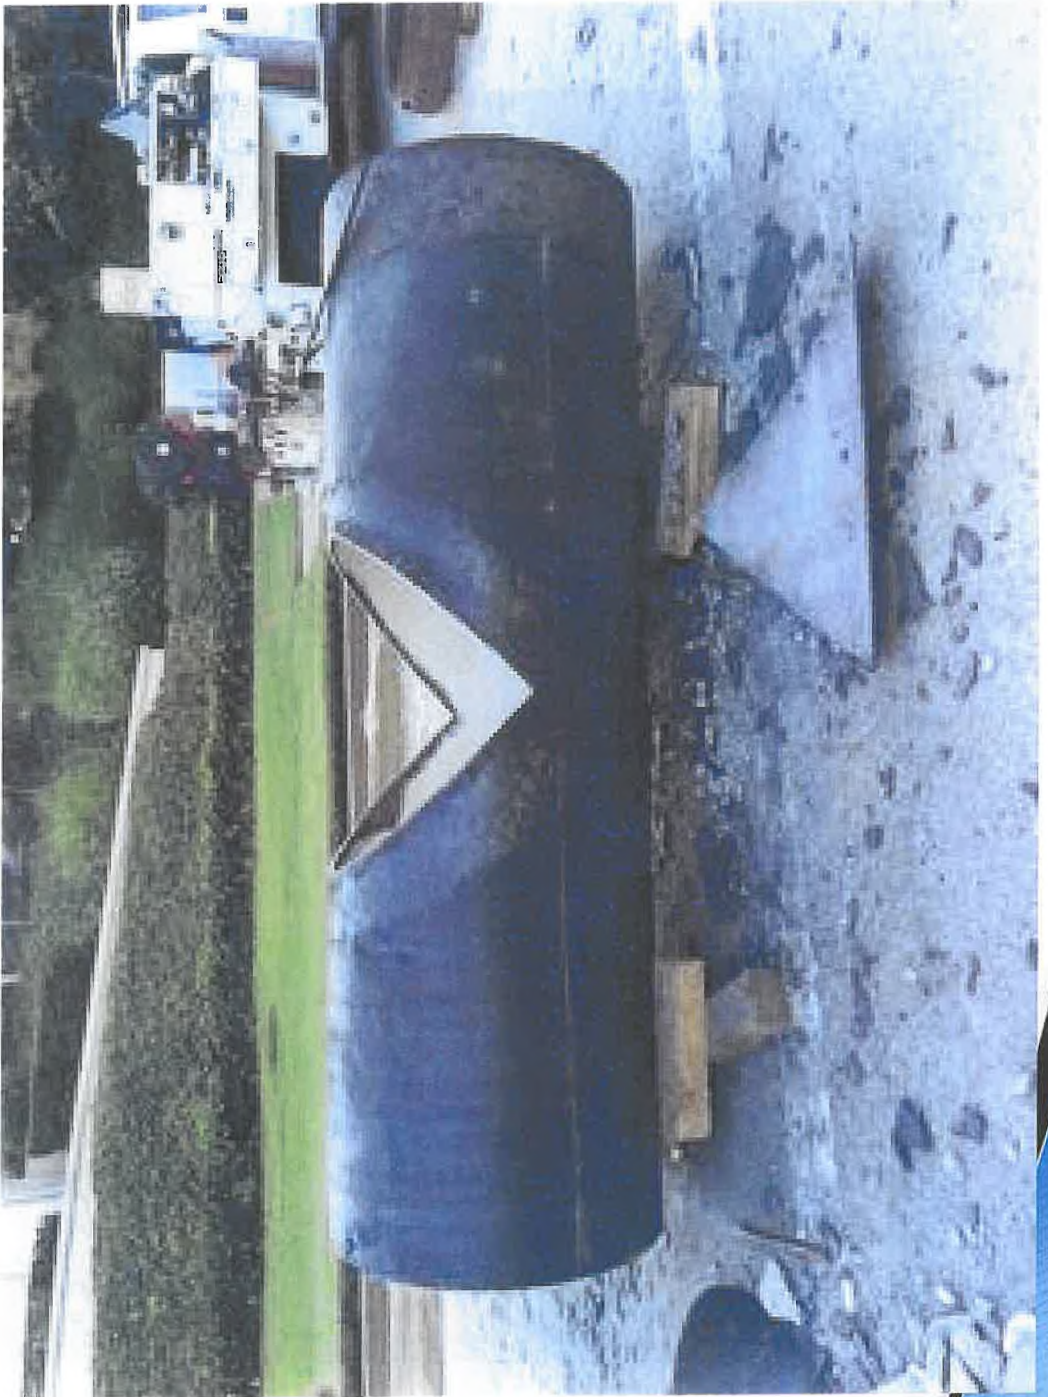
Straight Section of pipe

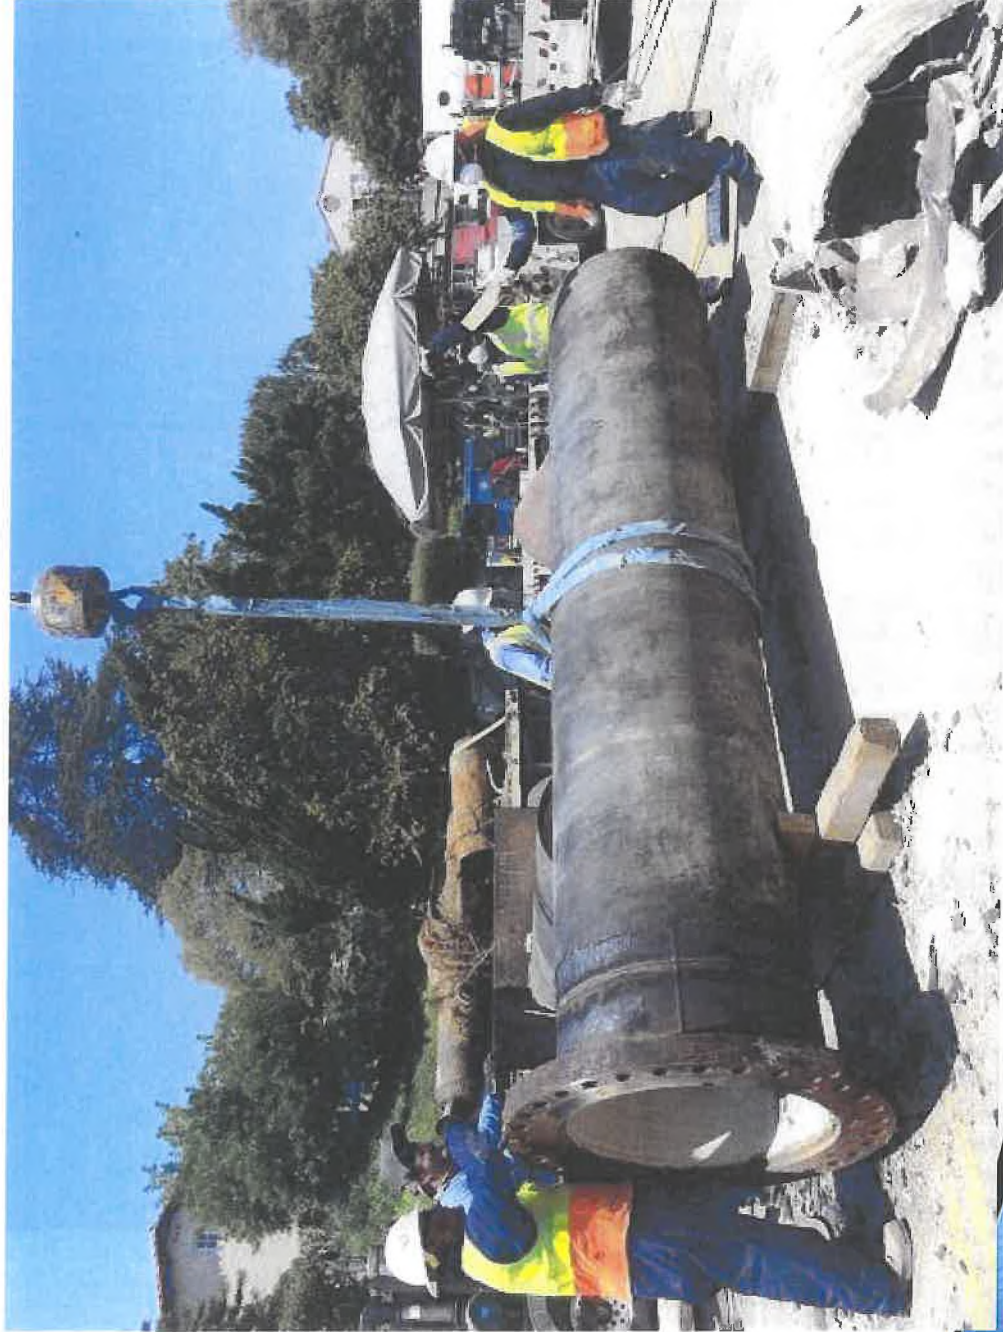
**Welding high pressure water pipe
is a highly skilled trade**

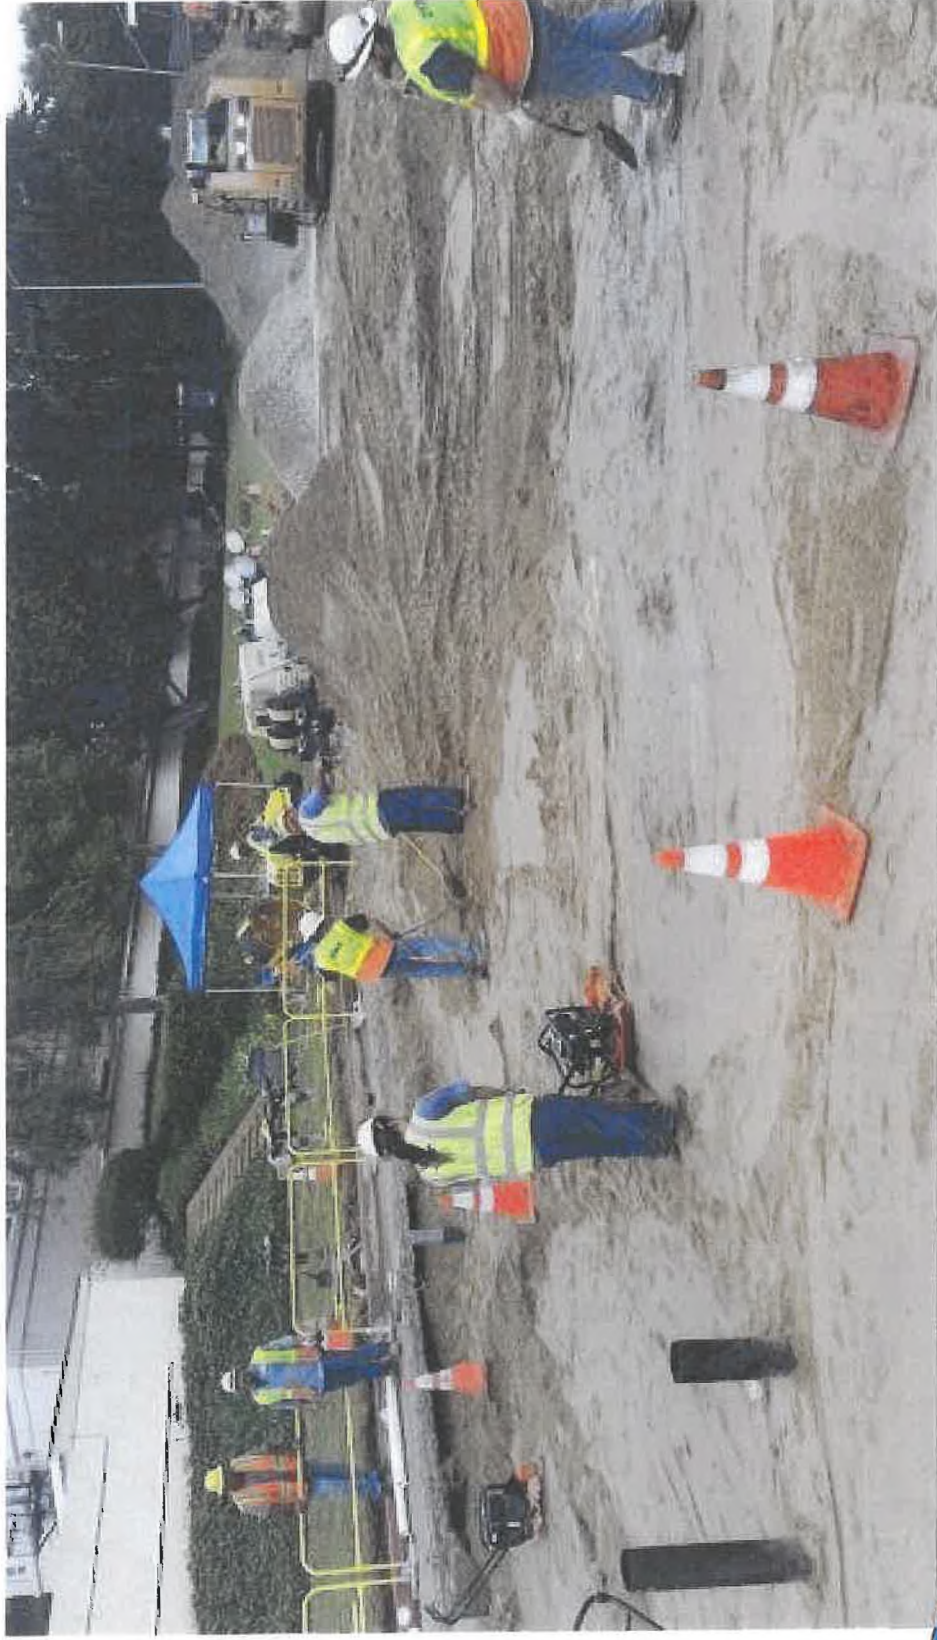
Paving - Sunday afternoon.

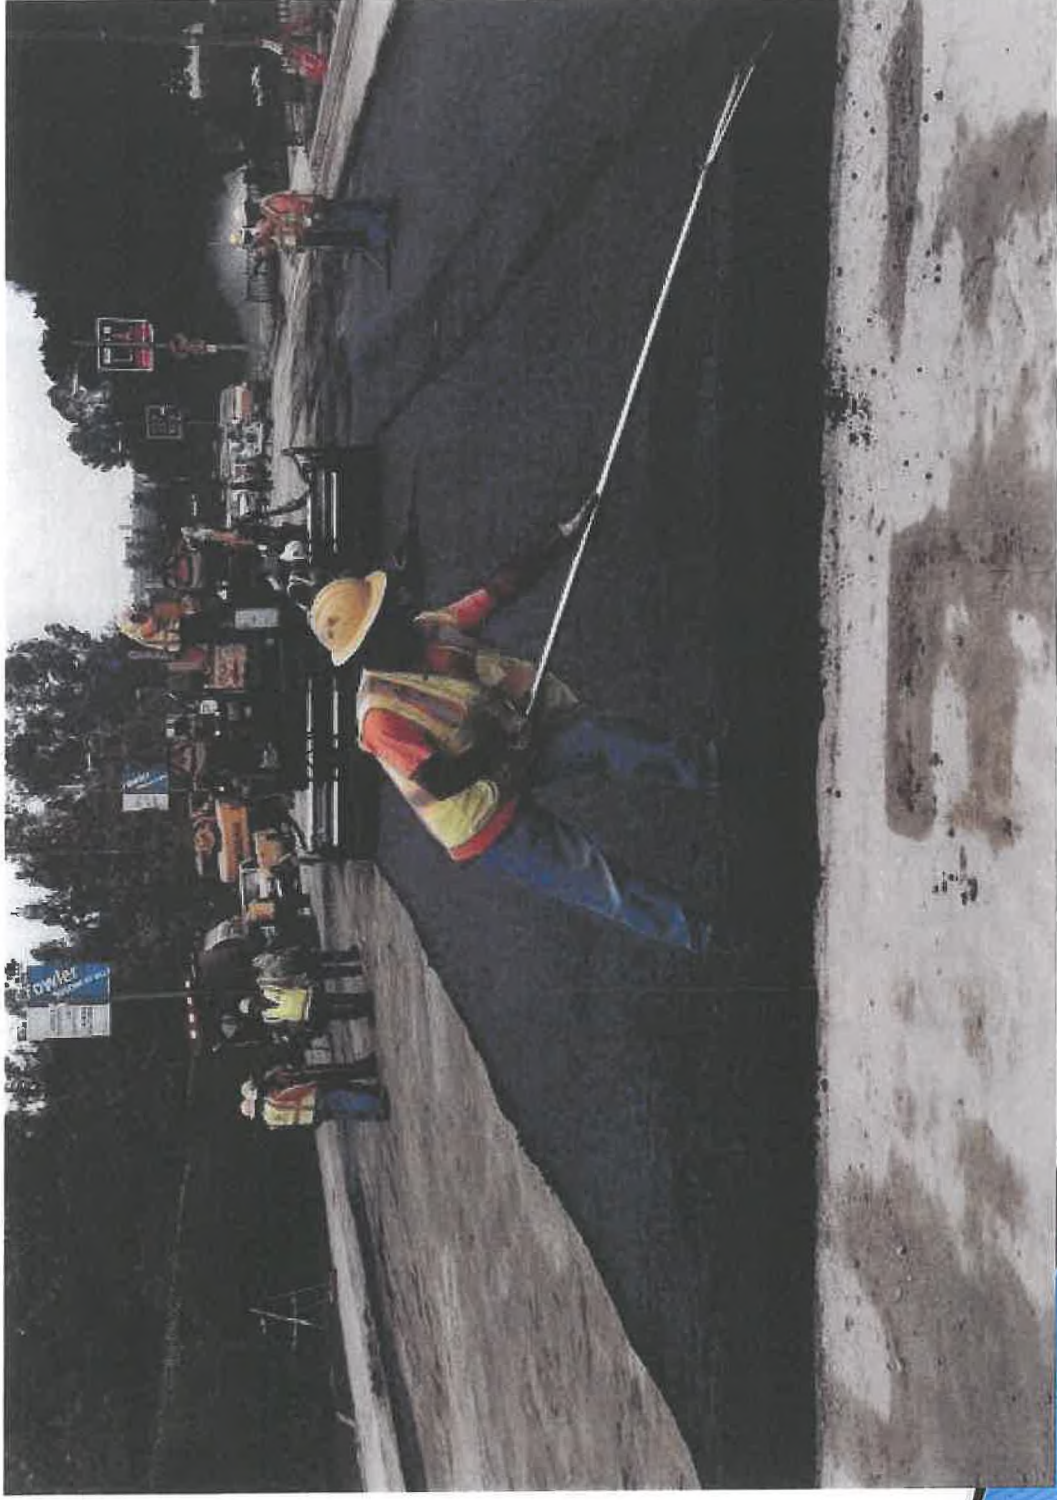
Striping- Complete 12:05am

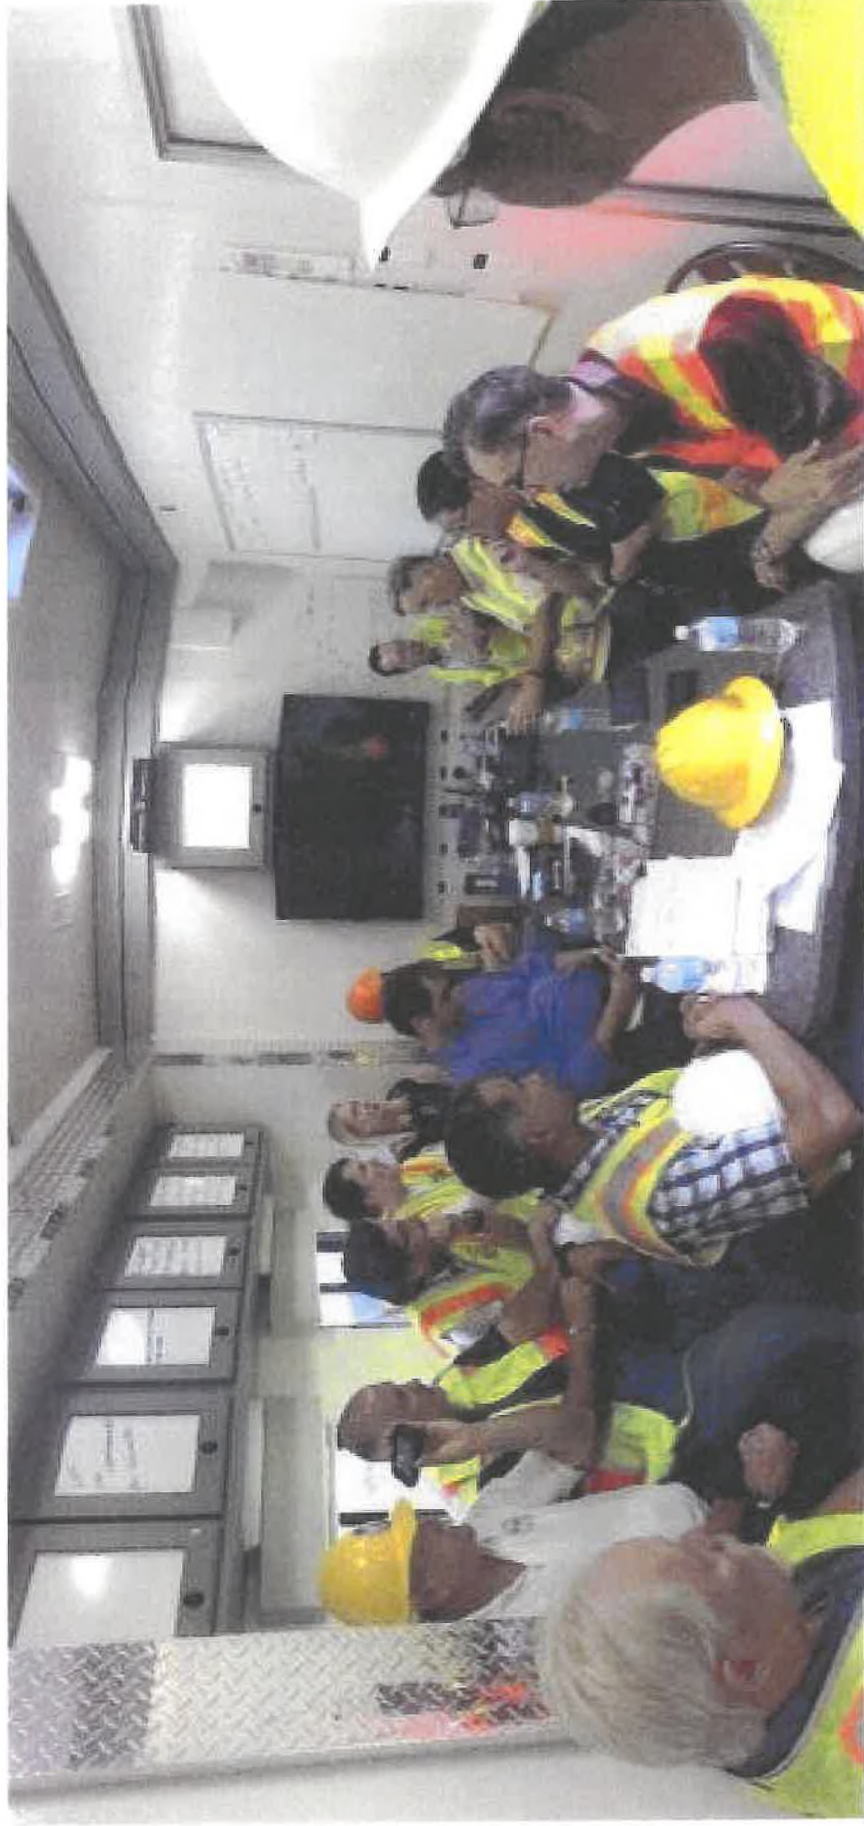
“Pin Hole” Corrosion and Pitting

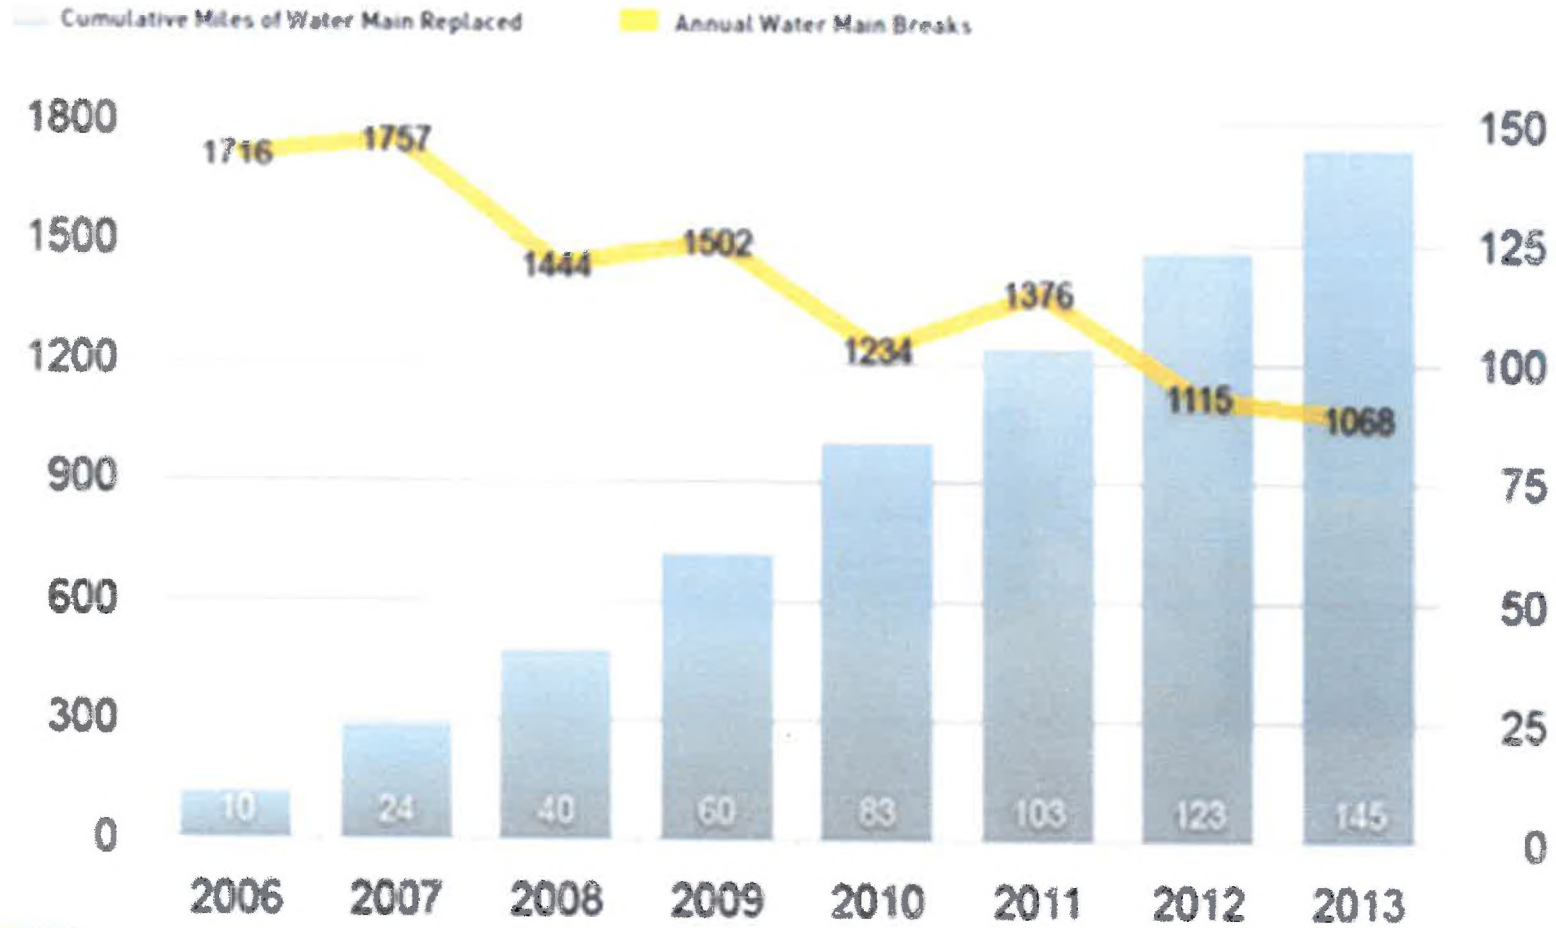
Main Replacement Levels and Leaks

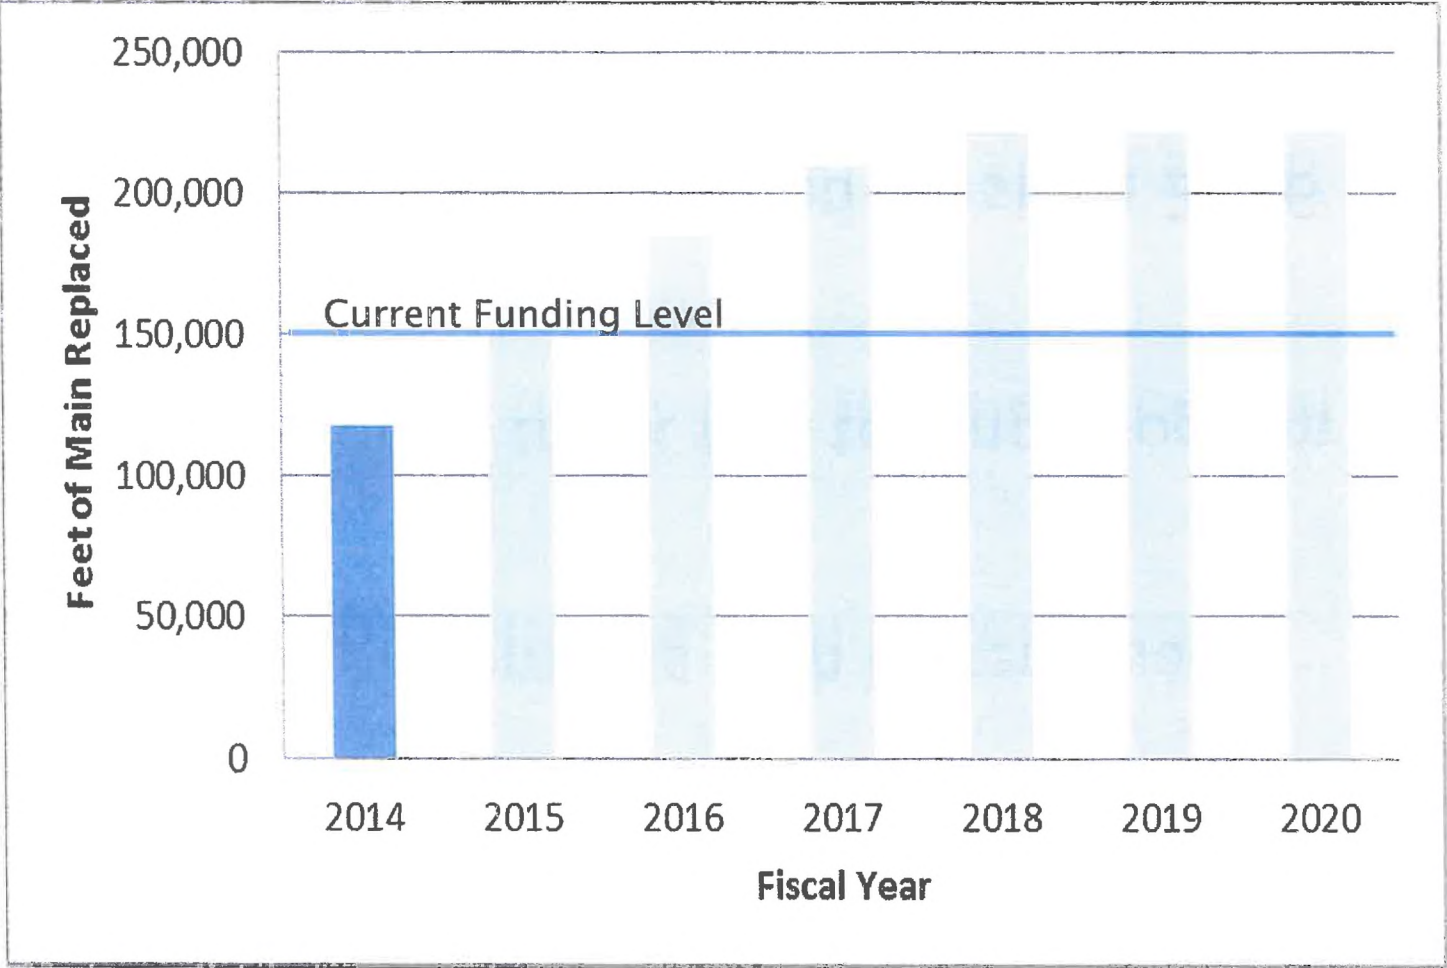
Mainline Replacement Program
