Re: **Council File: 20-0246 & April 17, 2020, Order Tolling Deadlines**  
12244-12248 West Pico Boulevard / Chili Bowl / Historic-Cultural  
Monument

November 2, 2020  
Project No. 2339-006  
Historic Preservation Services for  
12244 Pico Boulevard, Los Angeles, CA

**MEMORANDUM FOR THE RECORD**

SUBJECT: Historic Preservation Services for 12244 Pico Boulevard, Los Angeles, California

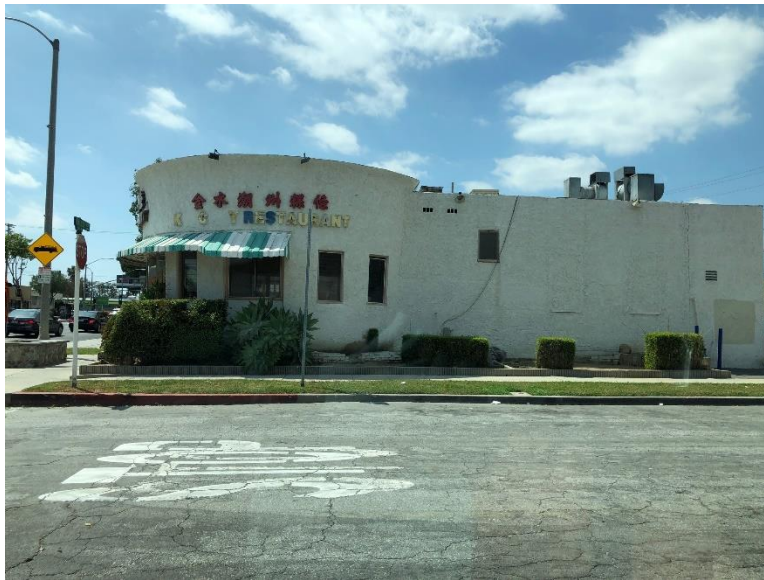
Of the five extant Chili Bowl Restaurants that Whizin commissioned, four are located in Alhambra, Glendale, Huntington Park, and the subject property. Although the Alhambra Chili Bowl Restaurant has been re-clad in rough textured stucco and some windows on the rectangular bay have been infilled, the Alhambra example generally retains integrity and reflects the design of the original prototype (Figure 1, *Chili Bowl Restaurant, Alhambra*; Figure 2, *Chili Bowl Restaurant, Alhambra*).

**Figure 2. Chili Bowl Restaurant, Alhambra**  
 SOURCE: Sapphos Environmental, Inc., 2019

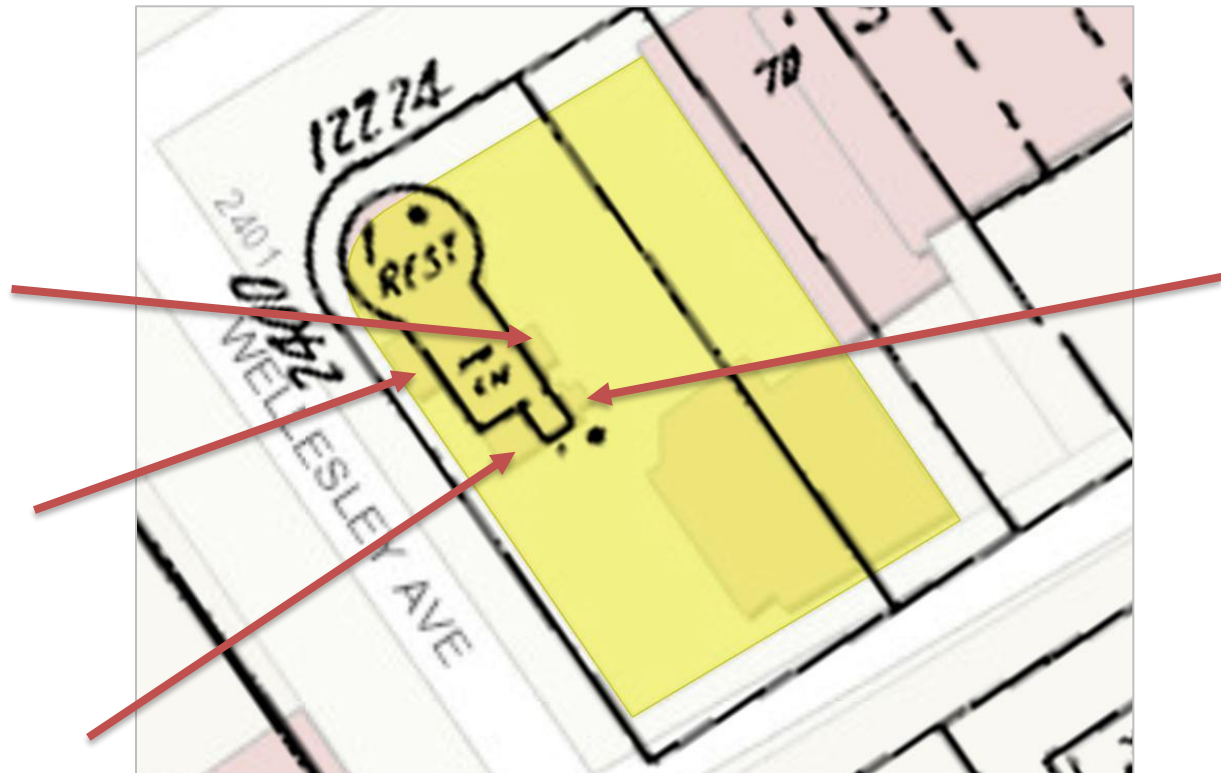
Based upon a review of the historic Sanborn Fire Insurance Maps and the current Los Angeles County Assessor map, the Chili Bowl has been substantially altered over the course of time. As shown in Figure 6, the footprint of the Chili Bowl no longer reflects the historical footprint of the building. The historic Sanborn Fire Insurance Map was overlain on the current footprint as documented by the Assessor. Several side and rear additions, both permitted and unpermitted, are clearly visible and are highlighted with red arrows. The additions are incompatible in terms of materials and design (Figure 7, *Southern and Western Additions*).

**Figure 6. 12244 Pico Boulevard**

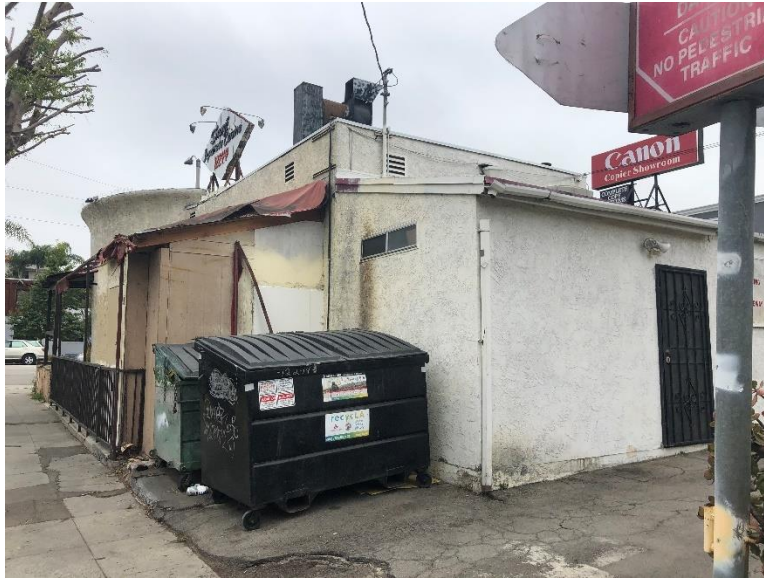
**Figure 7. Southern and Western Additions**  
 SOURCE: Sapphos Environmental, Inc., 2020

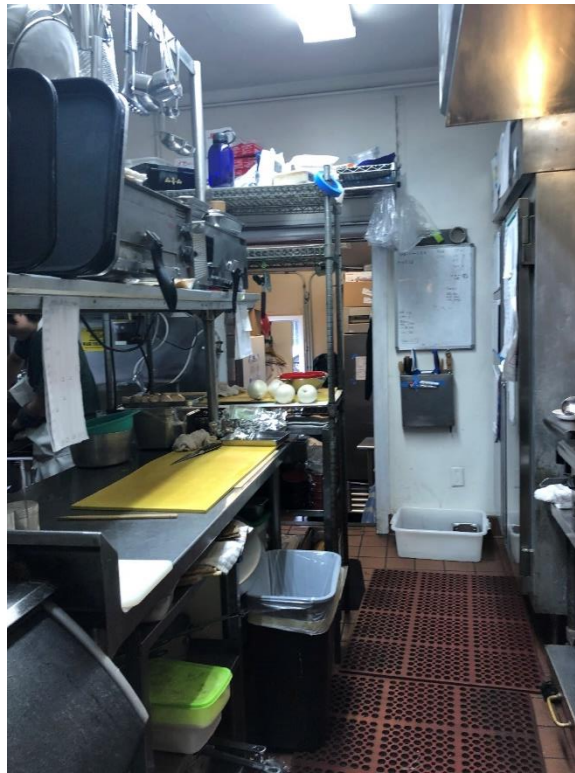
The kitchen features modern equipment that does not date to the period of significance (Figure 12, *Kitchen Detail*).

**Figure 12. Kitchen Detail**
