## Communication from Public

**Name:** Gaspar Obando  
**Date Submitted:** 10/11/2022 10:29 PM  
**Council File No:** 22-0499  
**Comments for Public Posting:** Honorable Councilmembers: I am the civil engineer and owner of this property. Please accept the attached letter to provide on the record of our email notifications to UFD, LADBS, and BOE of our intention to retain the toyon and withdraw the tree removal application before the 09-15-22 UFD Recommendation Report. We provided multiple notifications, submitted to LADBS updated plans for review, and provided UFD with an updated arborist tree report showing an updated site plan/grading plan protecting the toyon and off-site oak tree. Despite all that, the UFD report report mistakenly mentions as basis of moving forward with the appeal the following statement: “the Project for which the CEQA determination was made still requires removal of a protected tree.”

PROJECT OVERVIEW	
Site Address	2669 N. Bronholly Dr., Los Angeles, CA 90068
Location and/or Specific Plan	Bronson Canyon
Project Description	New Single Family Residence
Number of Protected Trees on Site	0
Number of Recommended Removals	0

**NEW CONSTRUCTION SINGLE FAMILY DWE

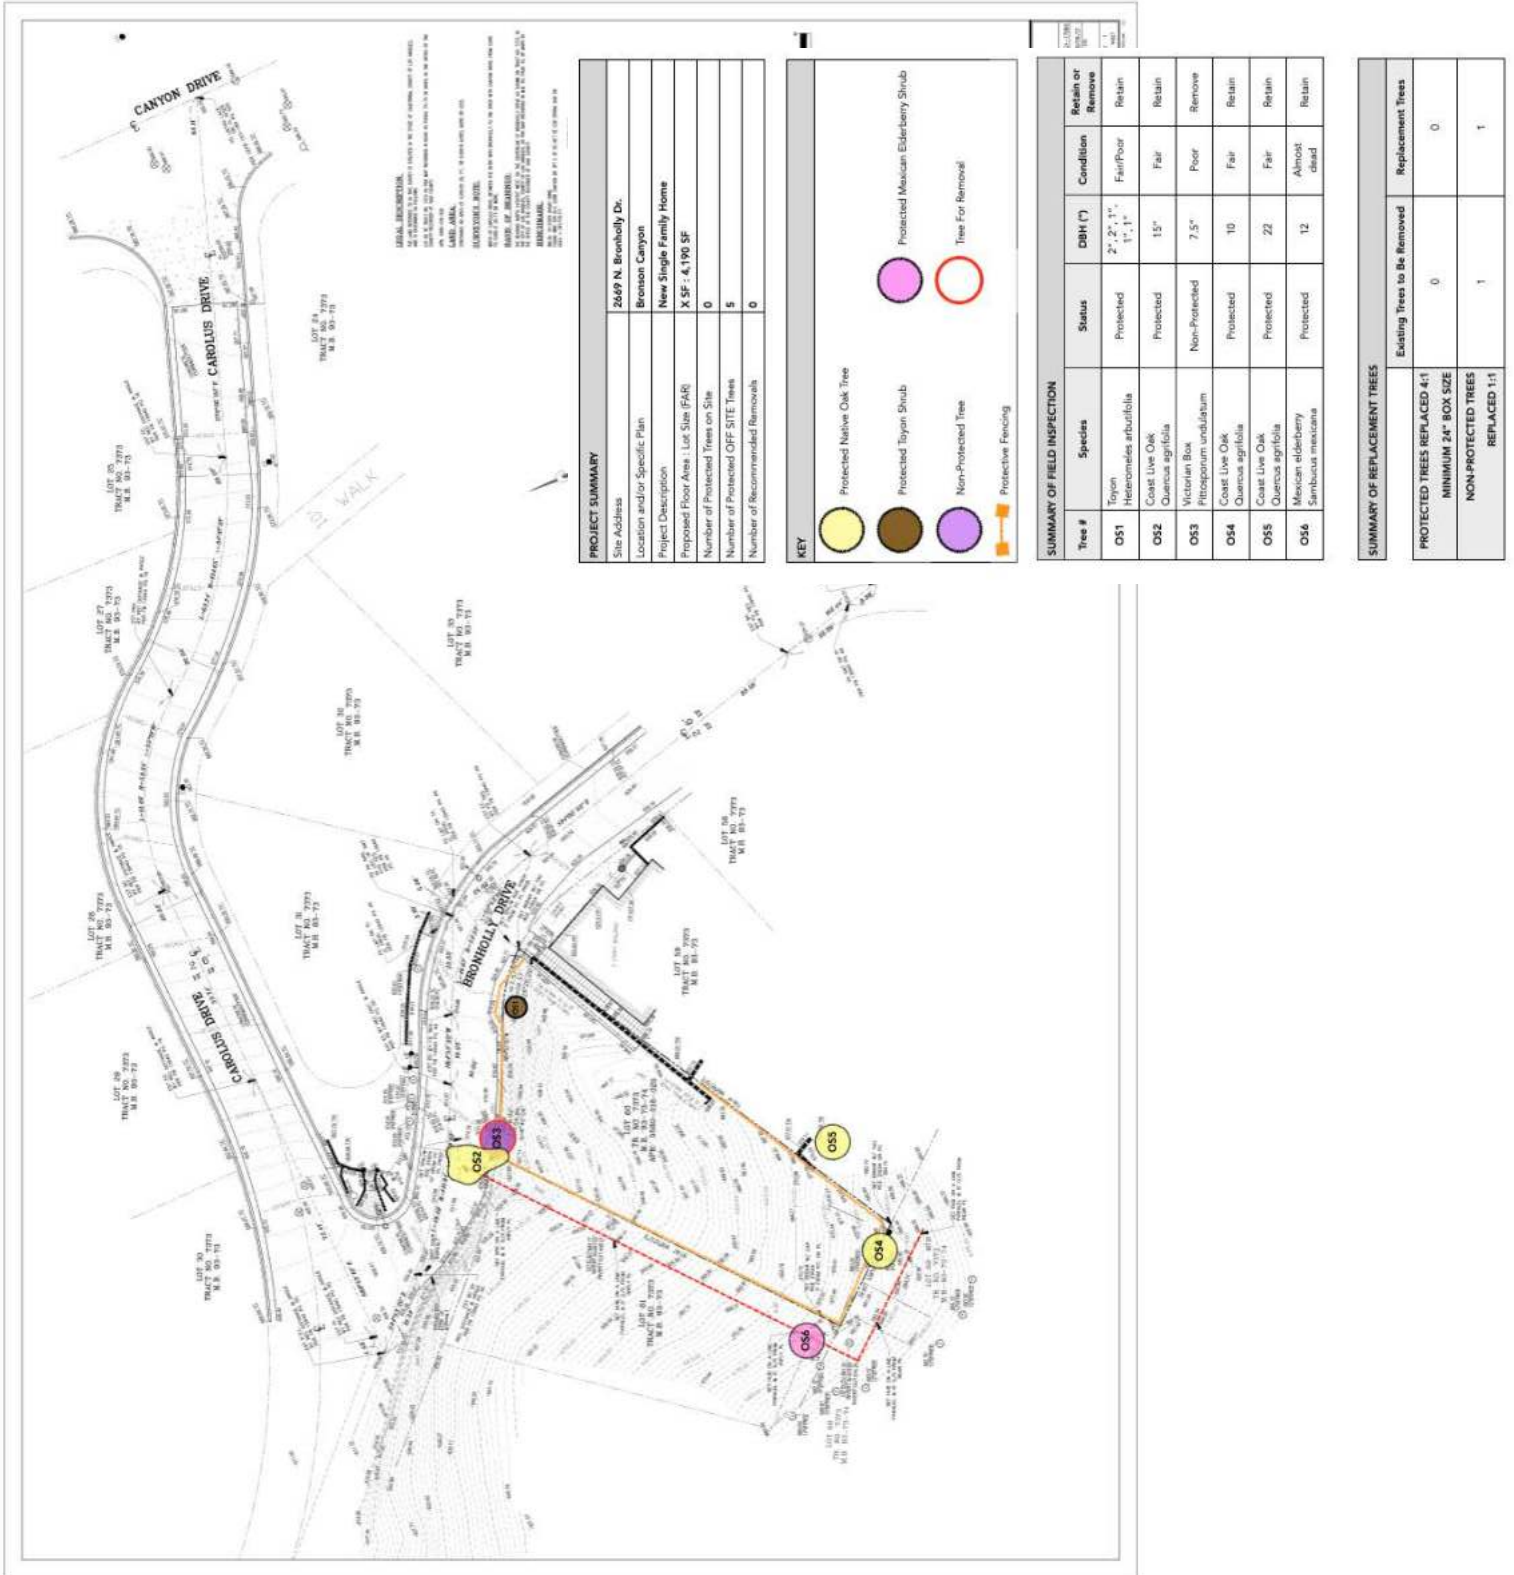
# APPENDIX A.1 - TREE LOCATION - SURVEY MAP

Detailed information with respect to size, condition, species and recommendations are included in the Summary of Field Inspections in Appendix C. The trees are numbered on the Tree Location Map in Appendix A.

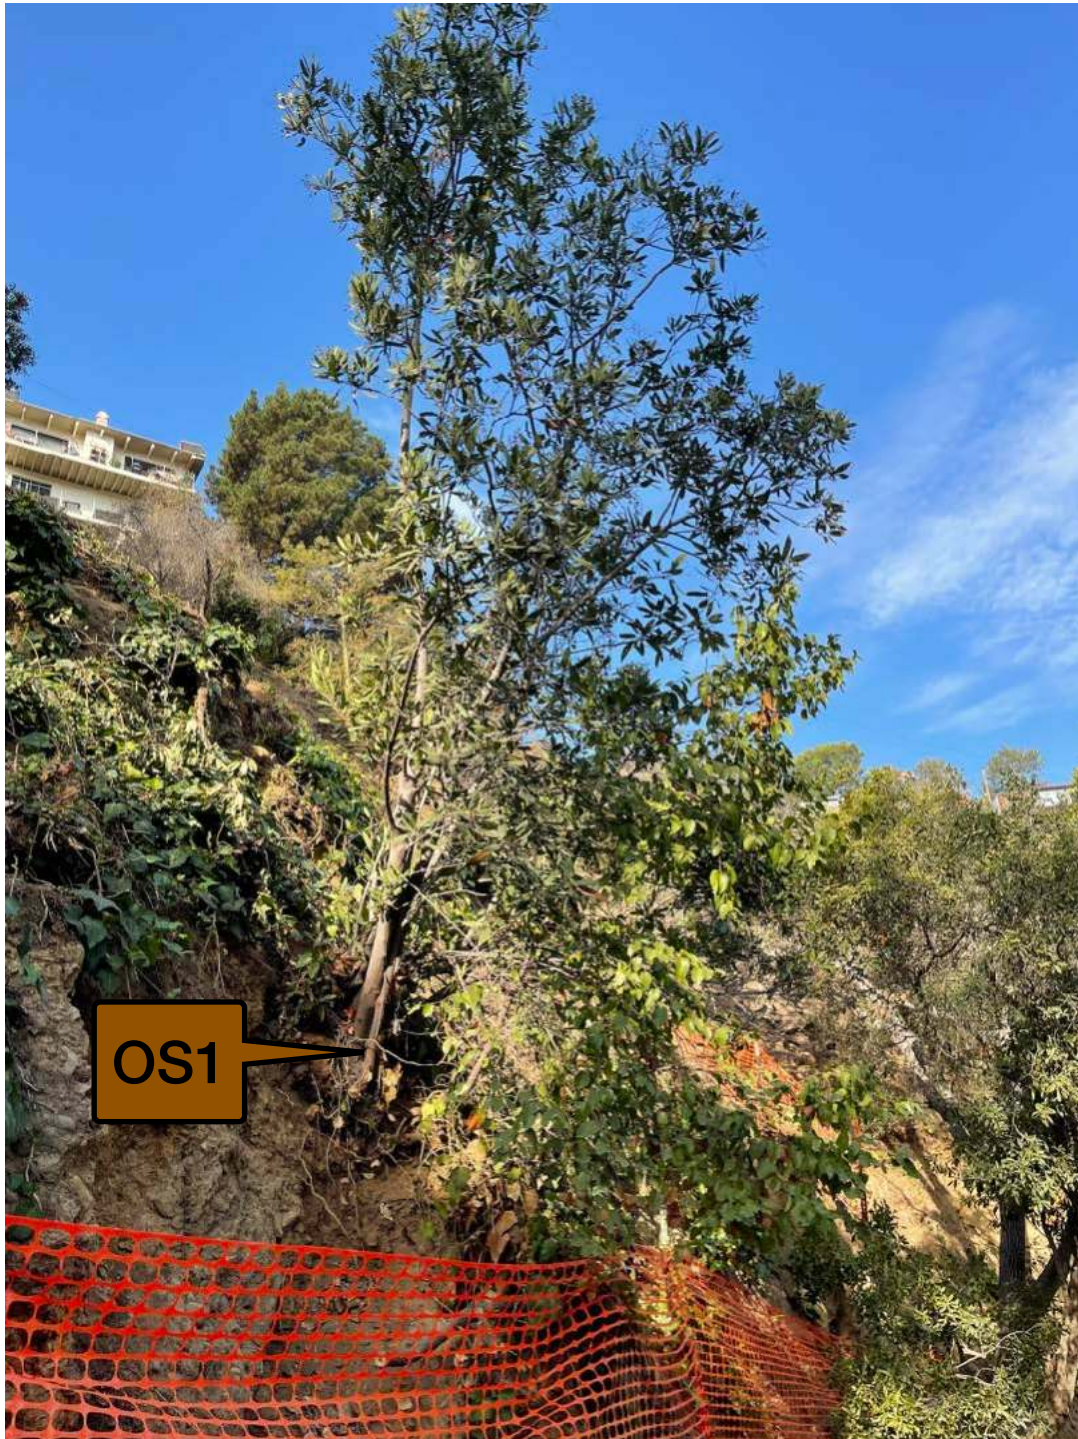
**PHOTO 1** - Toyon (*Heteromeles arbutifolia*) tree #OS1 located at base of slope, will be minimally impacted by grading and will be retained. Grading will occur 1.4' horizontal and 1.9' above the base of the slope. This tree is located on a very steep slope, it is almost dead and very small in size. Grading will around tree will be done by hand to minimize impact.

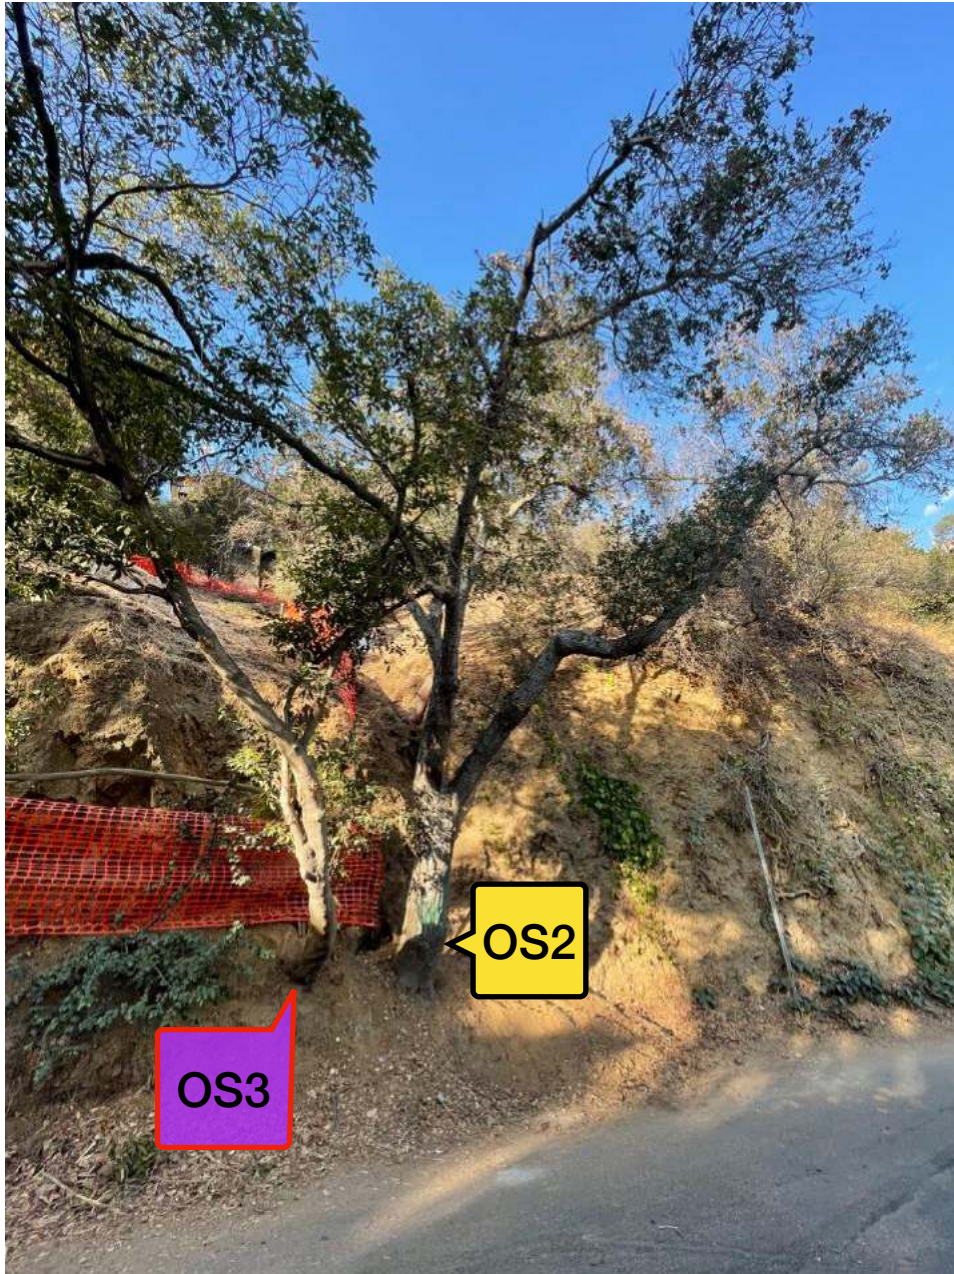
**PHOTO 2** - Coast live oak (*Quercus agrifolia*) tree #OS2 is in the public right-of-way will receive minimal impact. Grading will occur approximately 5 feet above the Oak trunk. A 12” wall is proposed to keep out sediment. The road is proposed to be widened with a regular curb to be installed near the base of the tree. If roots are encountered a shallow curb will be installed instead and will be supported by a tube driven into the ground. This tree will be retained and protected in place.

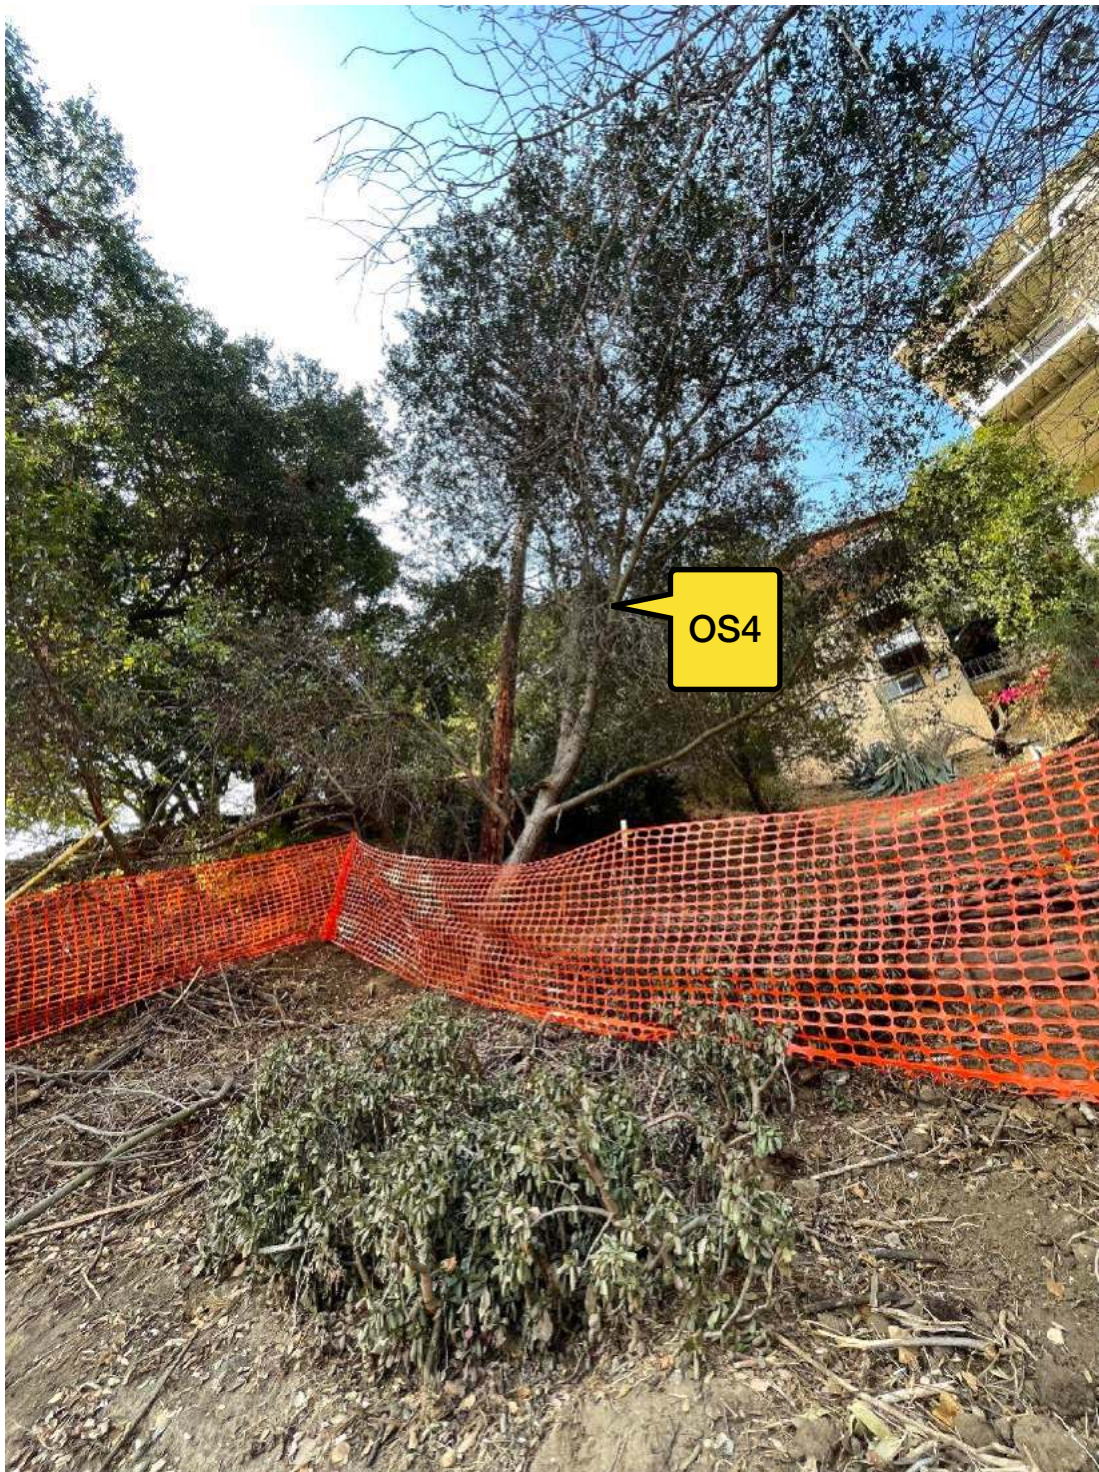
**PHOTO 5** - Coast live oak (*Quercus agrifolia*) tree #OS4 will not be impacted. The proposed ADU is sited approximately 7' downhill from the oak trunk. This tree will receive no impact and will be retained and protected in place.

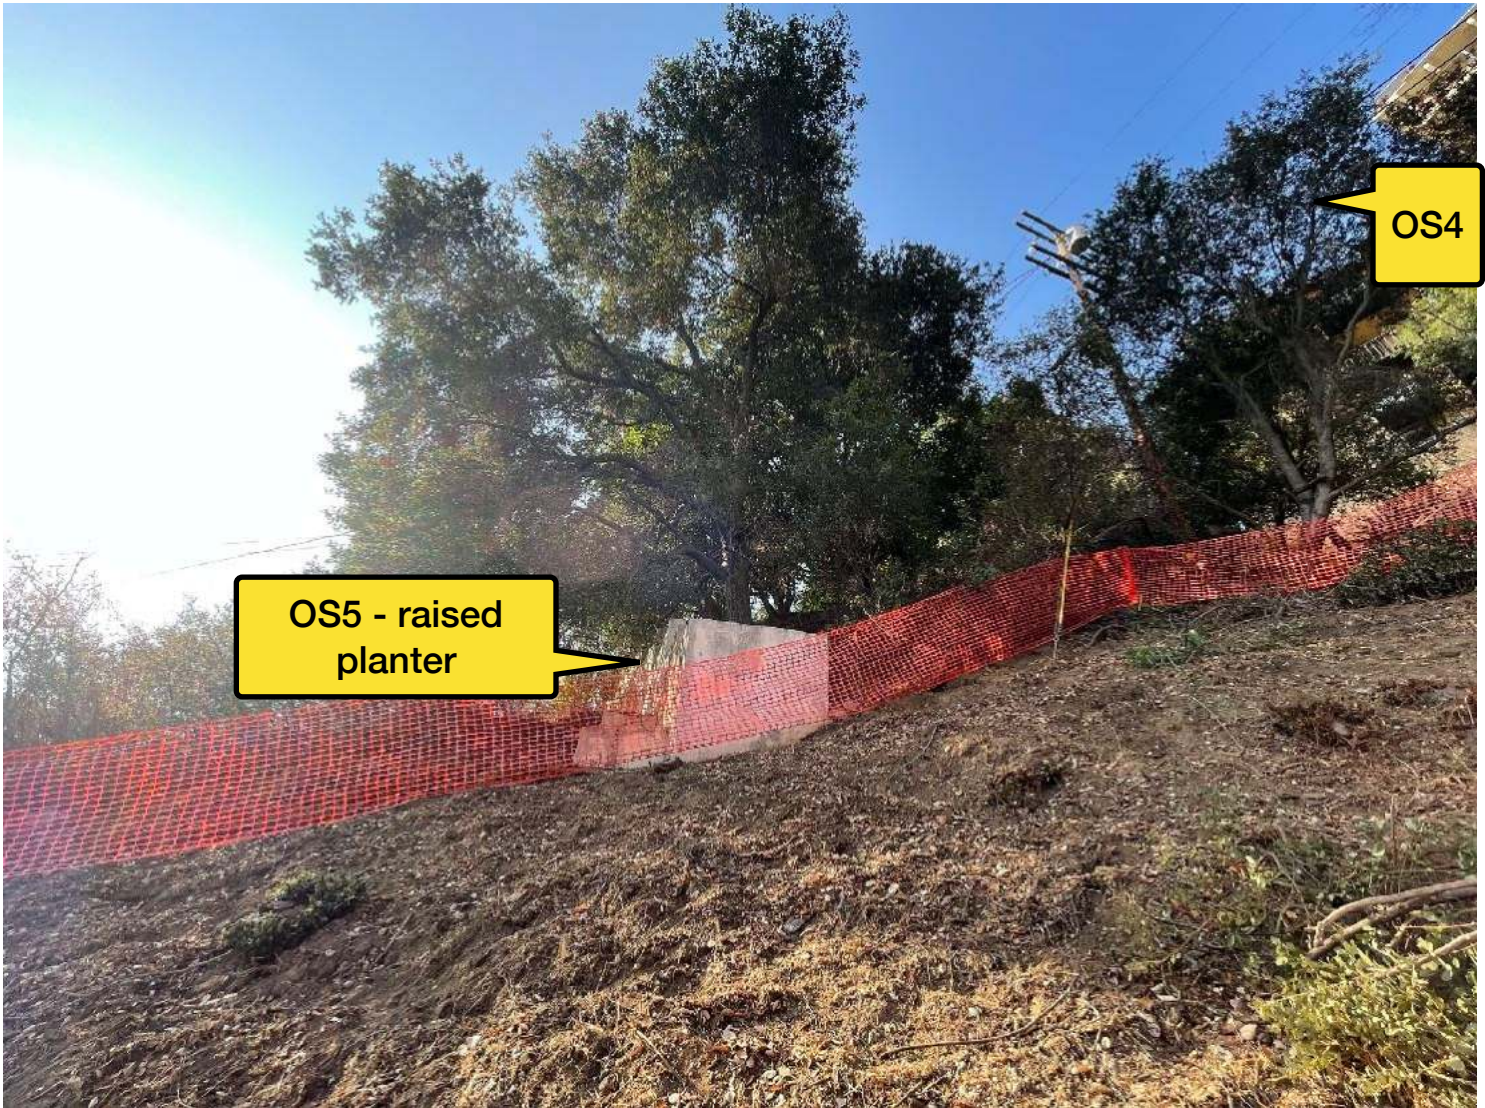
**PHOTO 6** - Coast live oak (*Quercus agrifolia*) tree #OS5 is located in an elevated concrete planter uphill from construction, and is outside of the construction zone and will not be impacted. This tree will receive no impact and will be retained and protected in place.

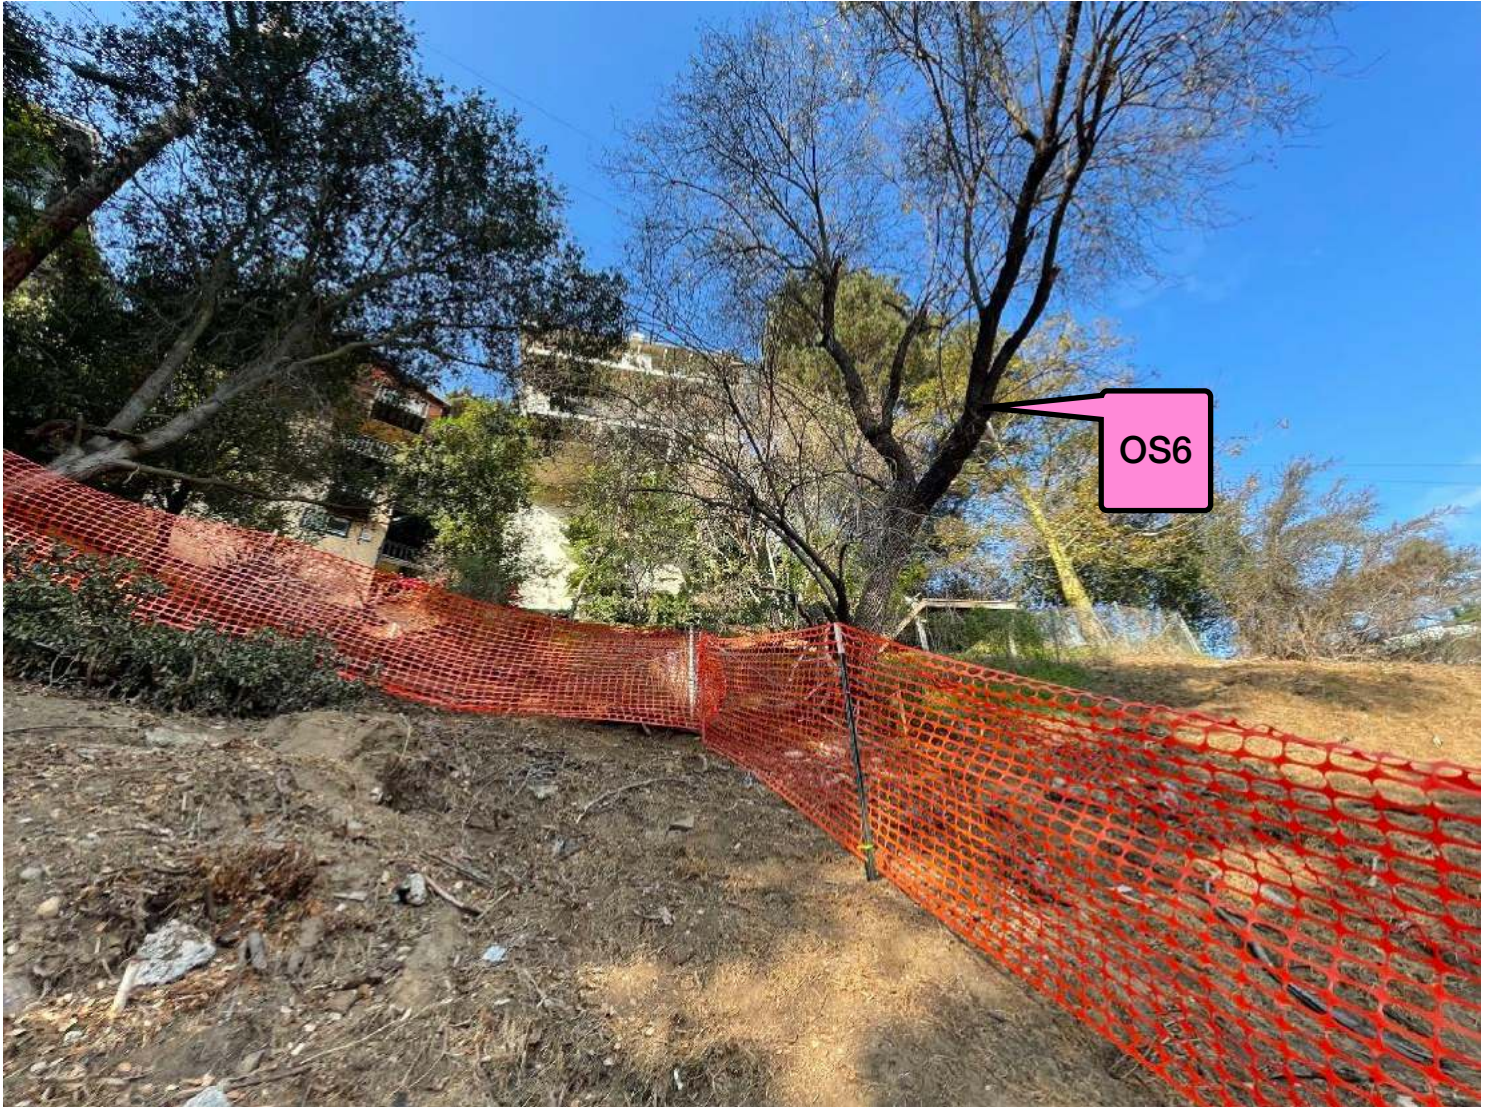
**PHOTO 7** - Shows Off Site Mexican elderberry (*Sambucus mexicana*) tree #OS6. This tree will receive no impact and will be retained. This tree is off-site in the "sewer easement" area that extends about 6 feet across, this tree is poor condition and is almost dead, most likely due to drought conditions.

Mexican elderberry (*Sambucus mexicana*) tree #OS6 is off-site in the "sewer easement" area that extends about 6 feet across and is outside of the construction zone and will not be impacted. This tree is almost dead.

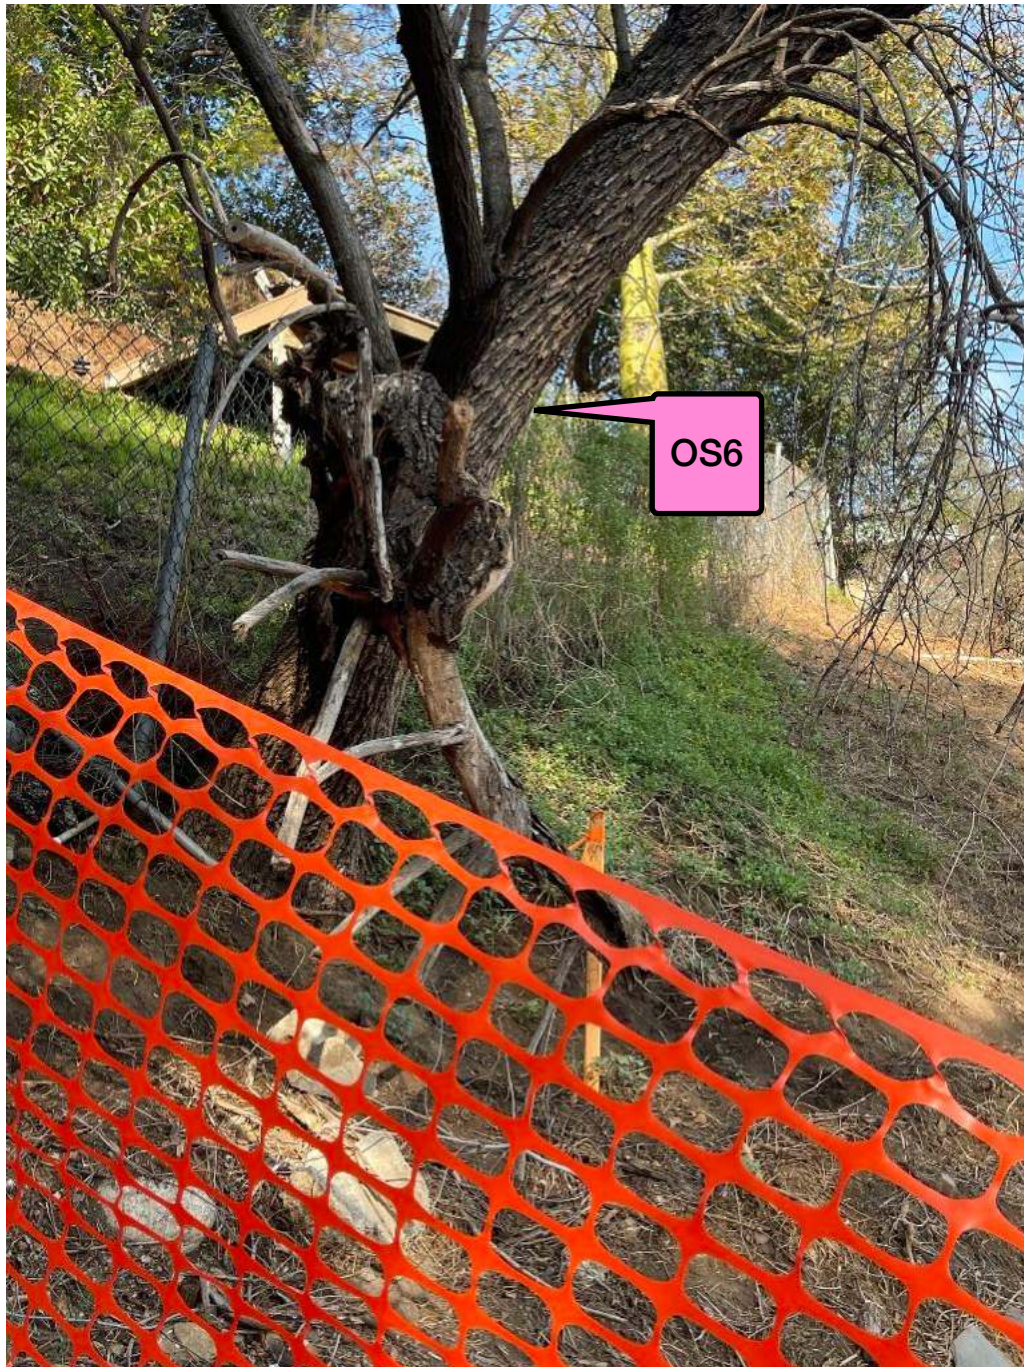
**PHOTO 8** - Shows Off Site Mexican elderberry (*Sambucus mexicana*) tree #OS6. This tree will receive no impact and will be retained. This tree is off-site in the "sewer easement" area that extends about 6 feet across, this tree is almost dead.

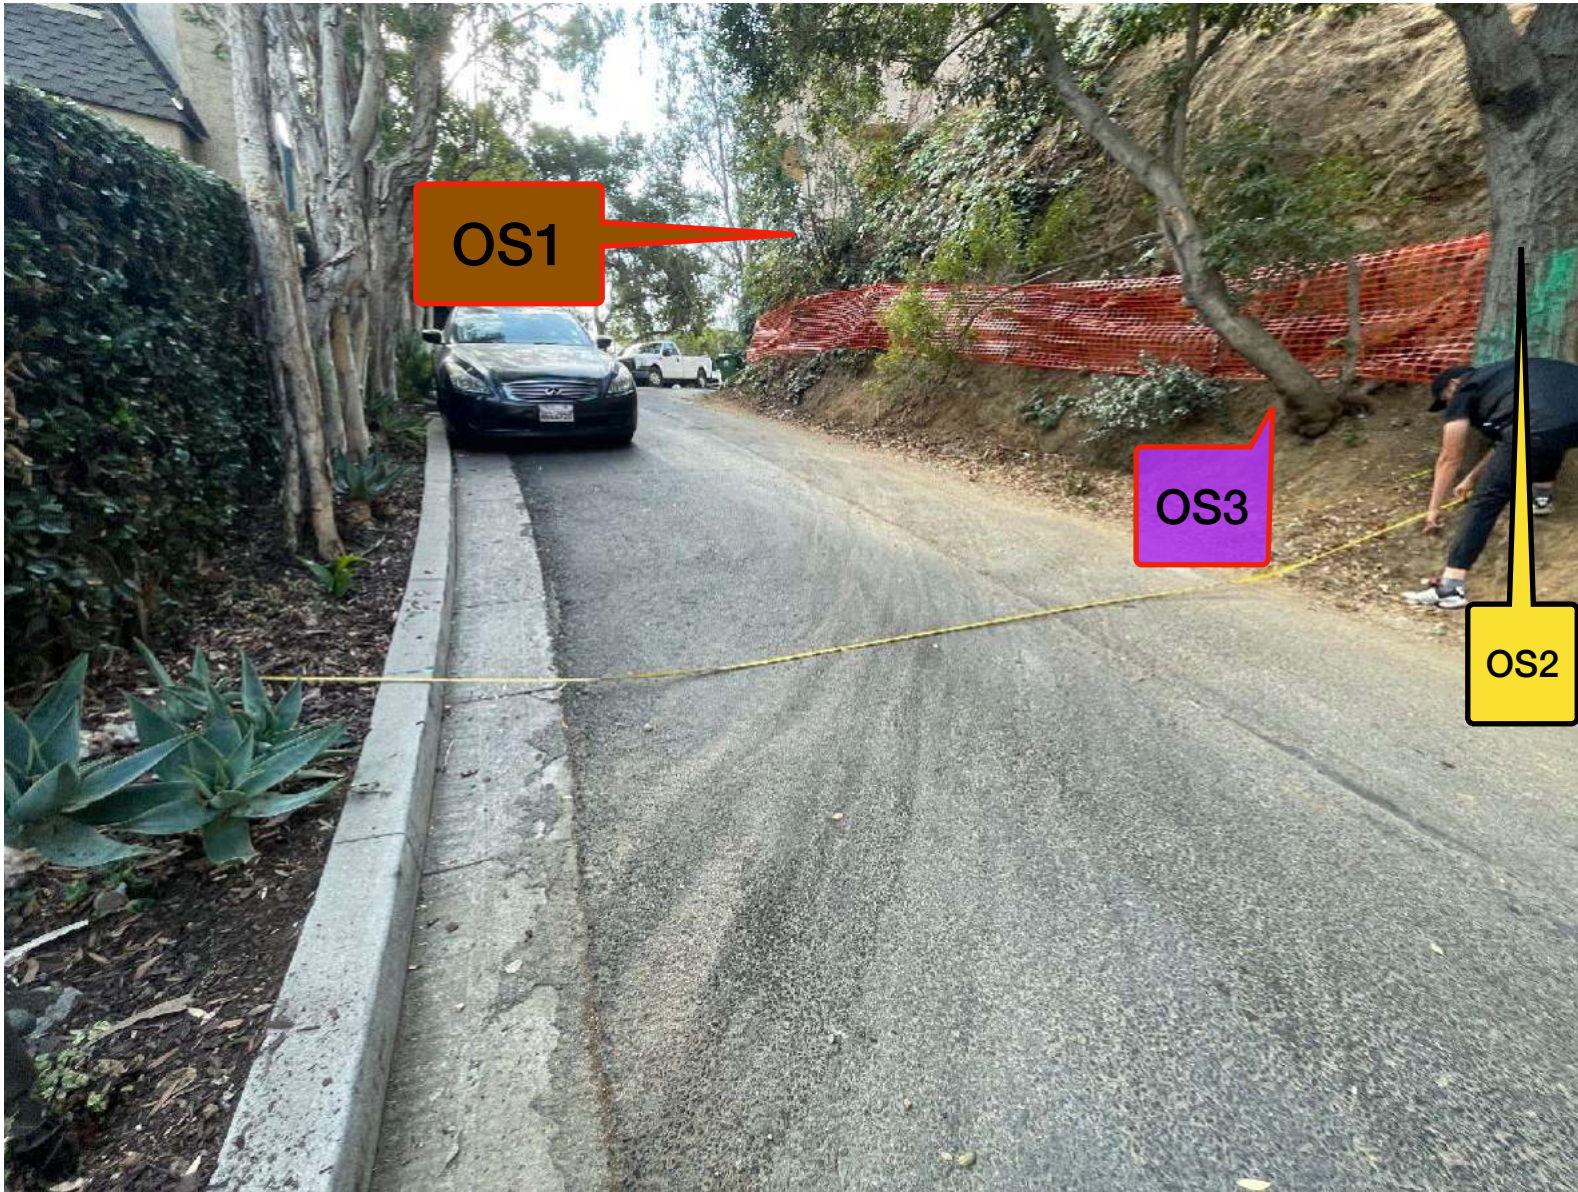
**PHOTO 10** - Shows front slope and steep terrain. House will be built directly into hillside.

The small Toyon shrub #OS1 is located directly on the steepest portion of the front slope. This photo is also showing the back of curb location of the required widening of the road.

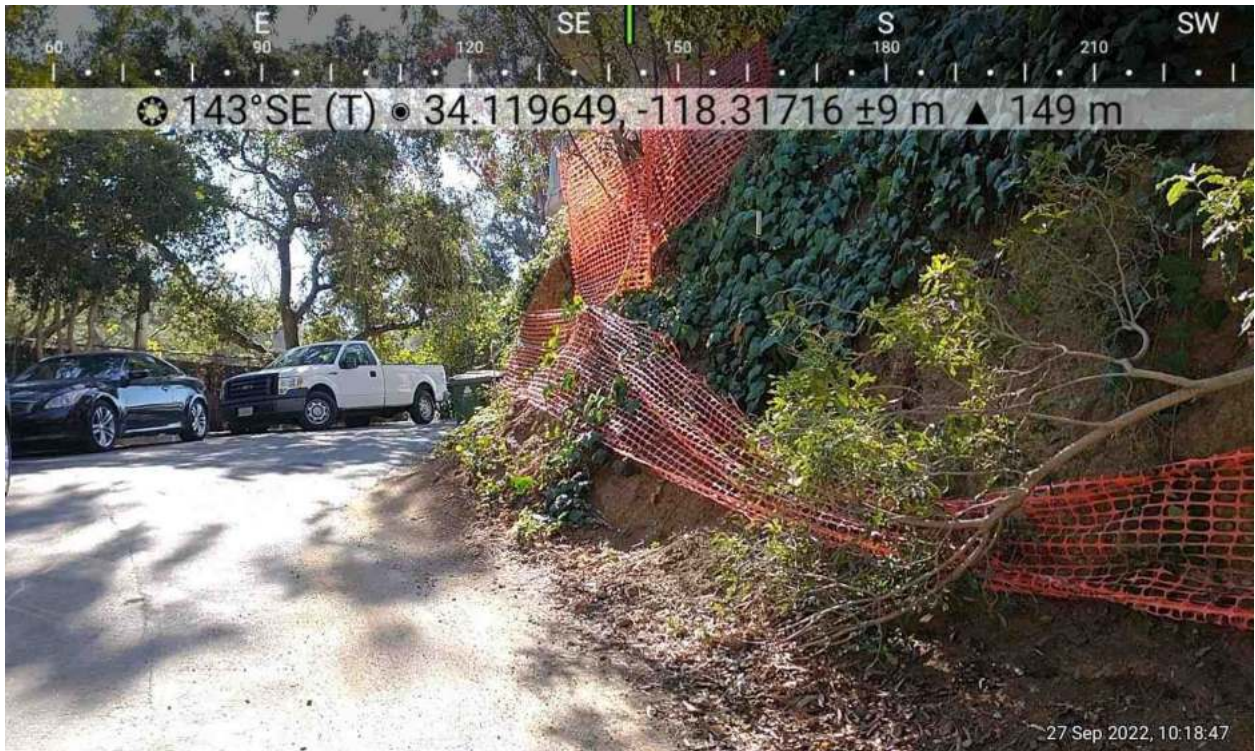
*Photo 1. View of eastern portion of project site on right with Bronholly Avenue on left.*
