Re: Council File No.: 25-1518 - Appeal of Building and Safety Commission's Approval of Demolition Permit for Barry Building Located at 11973 San Vicente Boulevard

LEAD HAZARD EVALUATION REPORT

Project ID: 34247-Asbestos
Address: 11973 San Vicente Boulevard, Los Angeles 90071

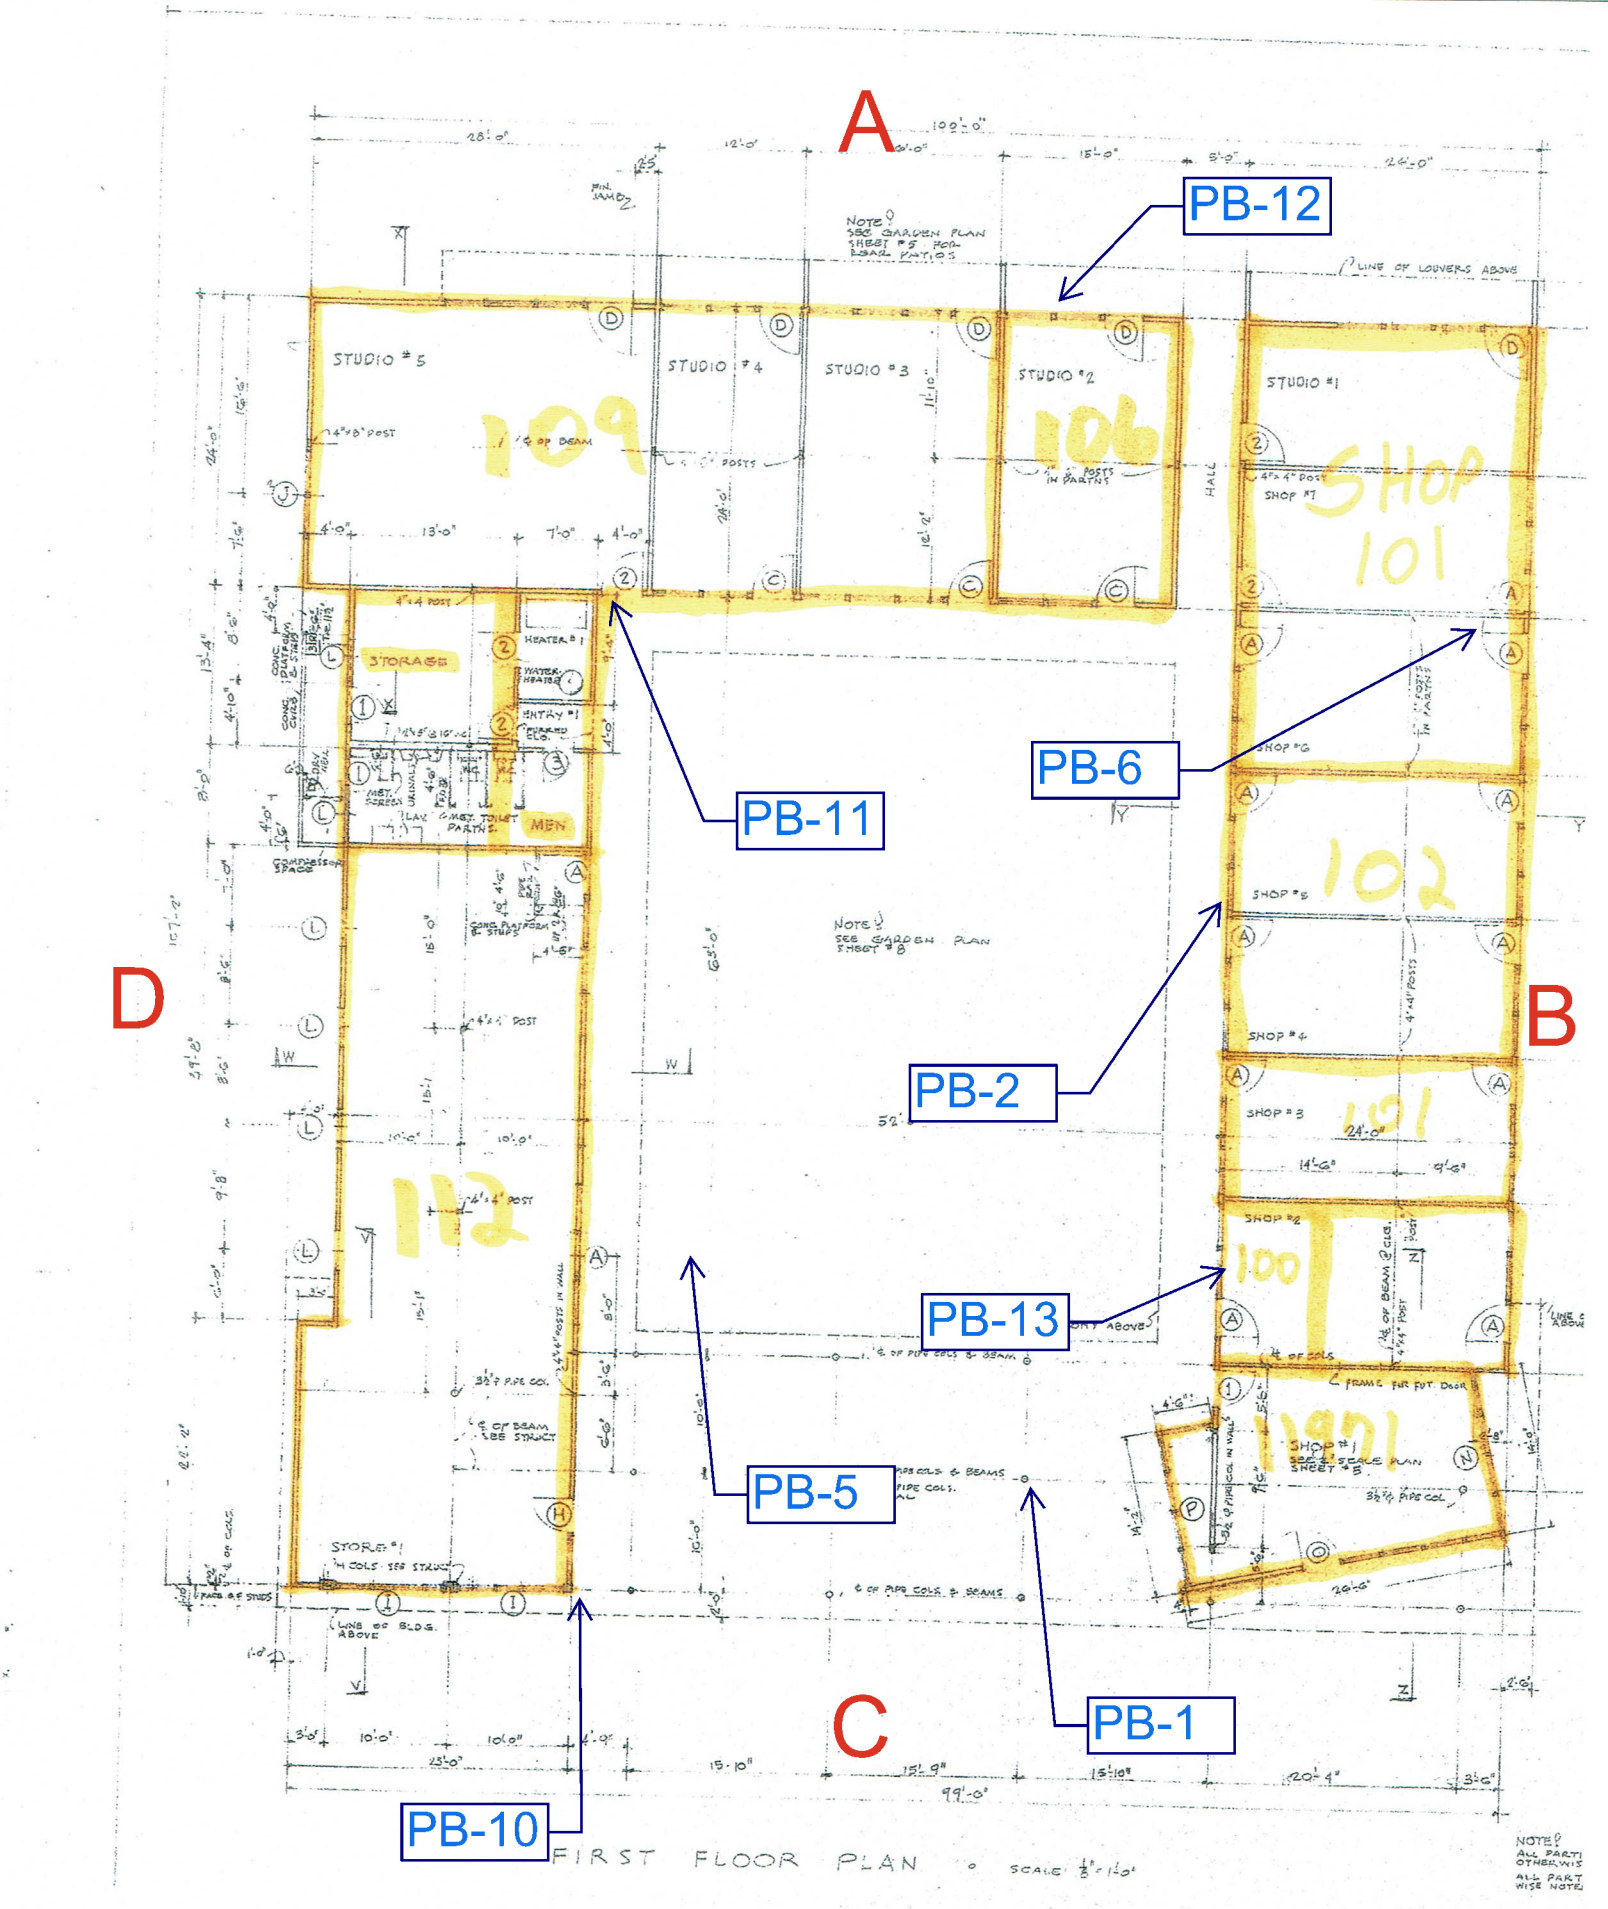
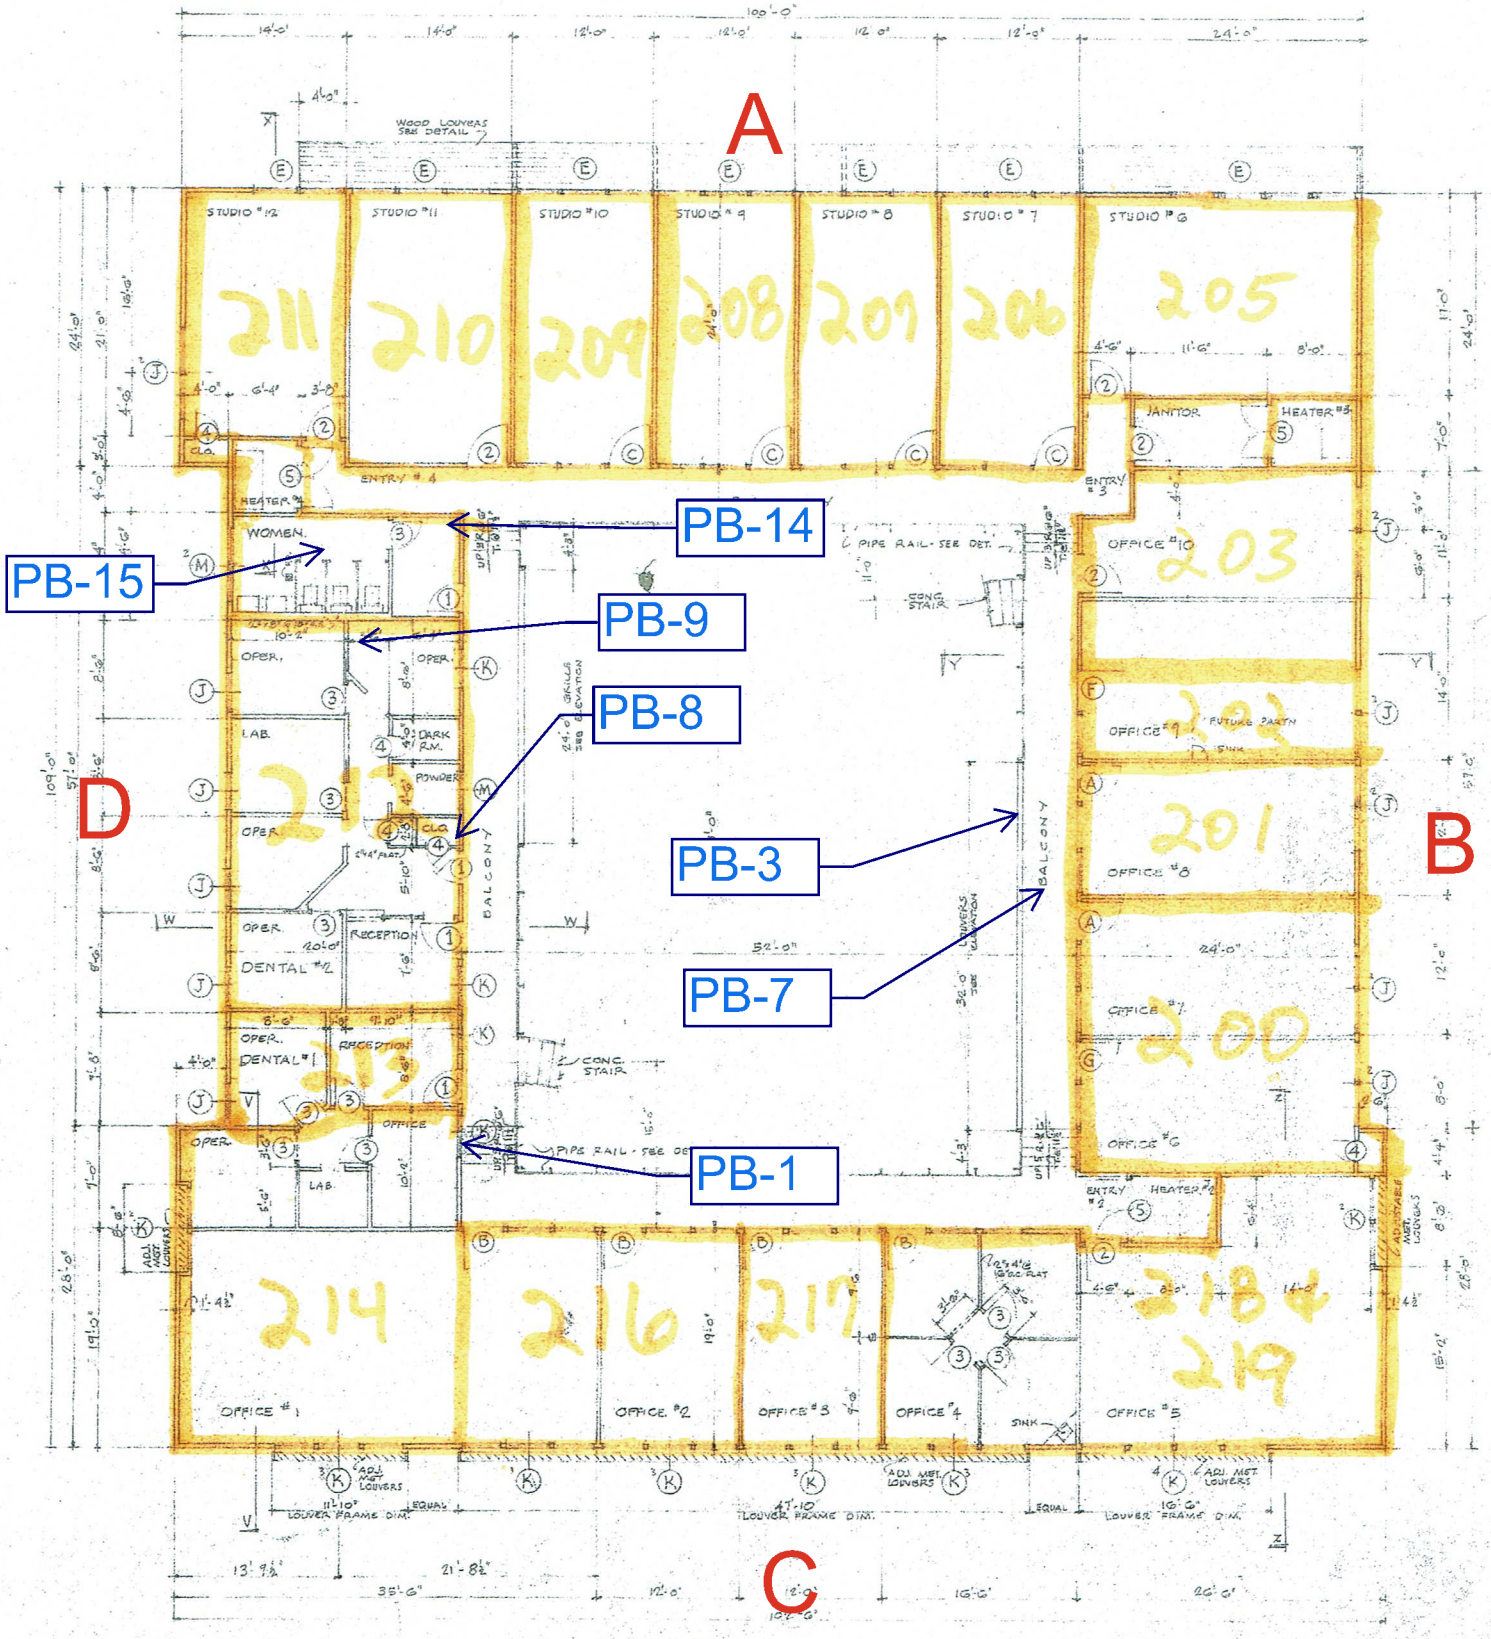
SECOND FLOOR PLAN · SCALE: 1/8"=1'-0"

☐ No lead-based paint detected ☑ Intact lead-based paint detected ☑ Deteriorated lead-based paint detected
