EXHIBIT B

Re: 11973 San Vicente Boulevard Project / ENV-2019-6645-EIR / State Clearinghouse No. 2020110210

1. *11971 San Vicente Boulevard – Retrofit Schemes* by Englekirk Structural Engineers (June 2021) (Soft Story Retrofit Letter Report) (Attachment A to this letter);
2. *11971 San Vicente Boulevard – Retrofit Schemes* by Englekirk Structural Engineers (June 2022) (Attachment B to this letter);
3. *11973 San Vicente Boulevard, ASCE 41-13 Seismic Assessment* by Englekirk Structural Engineers (June 2022) (Attachment C to this letter);
4. *Project Impacts Assessment, 11973 San Vicente Boulevard* by Historic Resources Group (October 2022) (Attachment D to this letter);
5. *Barry Building ADA Update Requirements* by Gruen Associates (June 2021) (Attachment E to this letter);
6. *Barry Building Renovations* by Hill International (November 2022) (Attachment F to this letter); and
7. *Barry Building Land Residual Analysis* by CBRE, Inc. (March 2023) (Pro forma) (Attachment G to this letter).

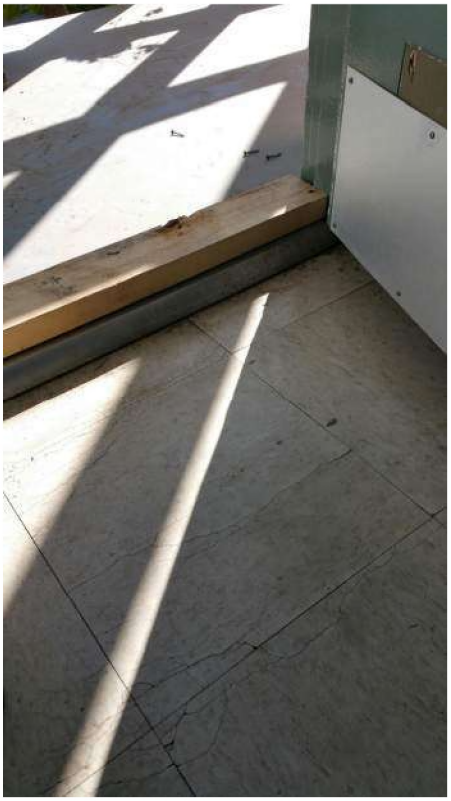
The door threshold is not in compliance with CBC Sections 11B-404.2.5 & 11B-303.3.

The women's restroom door threshold has a bevel that exceeds the 1:2 slope.

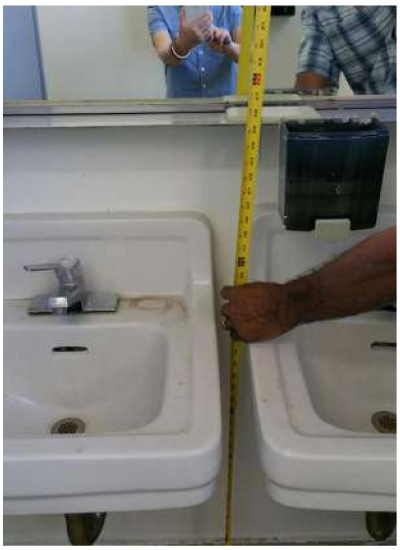
The women's restroom lavatories are spaced close to each other and to the adjacent wall. **The mirror height is more than 40" above the floor; therefore, it is not in compliance with CBC Section 11B-603.3.**

The mirror height is 45" above the floor.

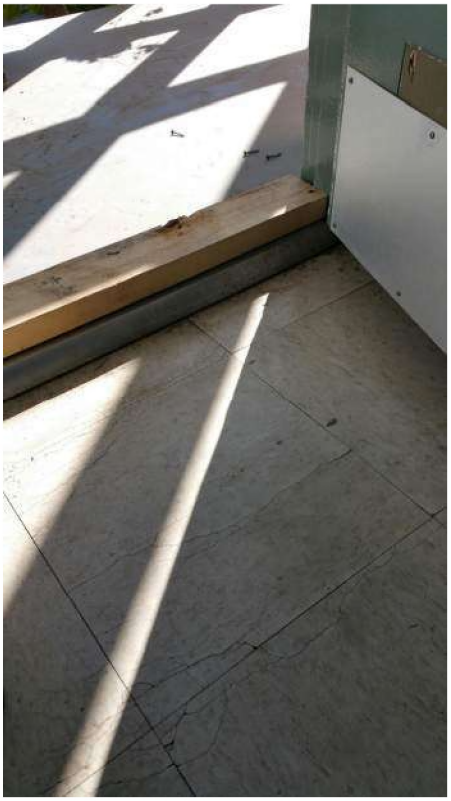
The door threshold is not in compliance with CBC Sections 11B-404.2.5 & 11B-303.3.

The women's restroom door threshold has a bevel that exceeds the 1:2 slope.

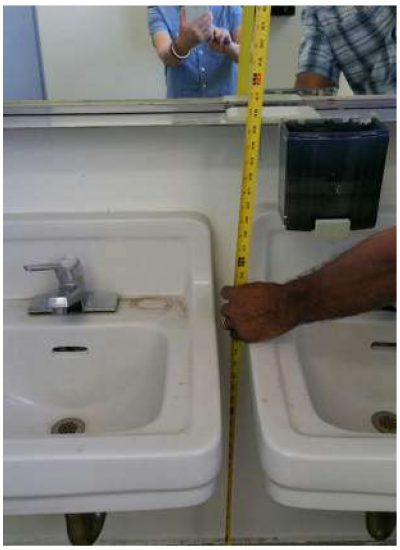
The women's restroom lavatories are spaced close to each other and to the adjacent wall. **The mirror height is more than 40" above the floor; therefore, it is not in compliance with CBC Section 11B-603.3.**

The mirror height is 45" above the floor.
