# Southwest Museum Rehabilitation Study

Phase I Planning

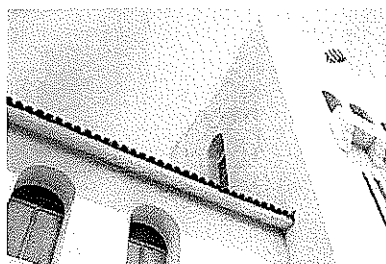
HR005 - South elevation of main building; replacement windows at East End

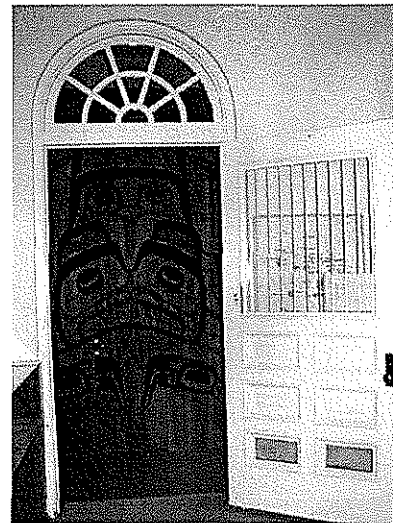
HR010 - Historic doorway from Plains Hall to Northwest Hall

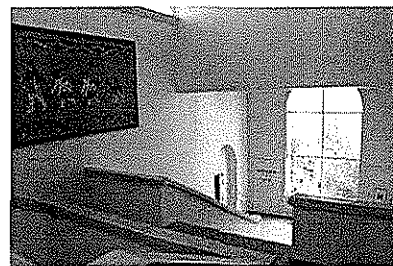
Connecting both upper exhibit halls to the main entrance of the Museum, the two-story Entrance Hall is a primary public space of the Museum consisting of a lower and upper lobby. Whereas minor alterations have occurred within this space, the original walls, ceiling, window and door openings, and light coves remain. Three lighting fixtures within this space are also original, their design and location having been chosen by Charles Lummis. The floor of the lower lobby has been carpeted, and the floor of the upper lobby has been covered in wood flooring, and yet the original flooring of both spaces may still be present underneath these alterations. A staircase leads from the lower lobby to the upper lobby, and while its finish has been altered and its steps carpeted it retains the significant character-defining features of its original construction and design. (See photos HR011, HR012, and HR013).

HR011 - Main stair (current condition)

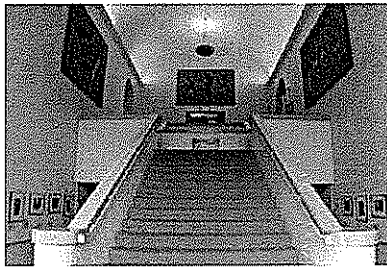
HR012 - Main stair

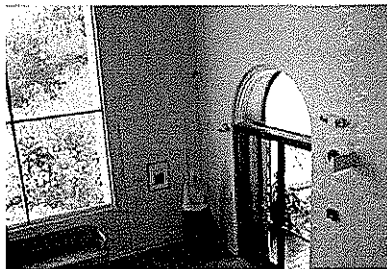
HR013 - Monumental window & door to terrace at lower lobby

The two-story window that dominates the south end of the entry hall was designed to introduce light into both levels. From the exterior, it is the focal point of the extended volume of the Entrance Hall that pushes out beyond the Main Museum and forms the visual center of the south façade. It is, therefore, a major character defining feature both within the entry hall and for the building as a whole. The window opening is original and significant, whereas the window materials have been replaced and are not significant.

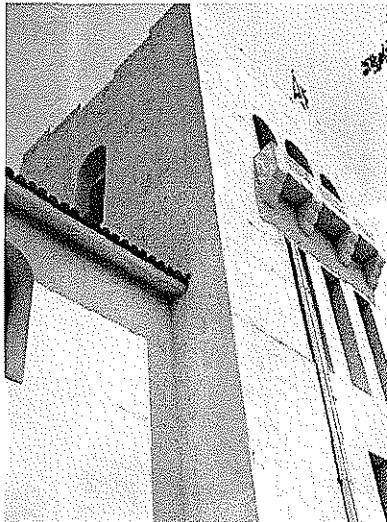
The Caracol Tower is an important element of both the exterior and interior of the Main Building, positioned directly east and south of the Main Building's central axis. The Tower's height, placement and bold design both compliment and set it apart from the horizontal mass of the rest of the Main Building. The crenellated parapet creates the appearance of a medieval battlemented tower. The Caracol Tower reflects the monumental Andalusian architecture of the Alhambra seen by Lummis in Spain while also alluding to the mission architecture of early California. The exterior finish of the Caracol Tower was altered during sandblasting and re-plastering procedures in 1955, 1968, and the 1980s. However, original finish that does remain is significant. (See photos HR018 and HR019).

HR018 - Caracol Tower: south façade

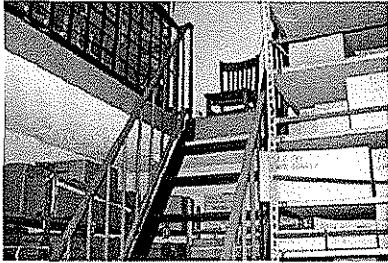
HR024 - Caracol 7; Mezzanine stair

Caracol 6 and Caracol 7 share similar features despite their different intended functions. Most notable are their mezzanines, which are similar to the mezzanine of Northwest Hall, but run around all four outer walls. In both mezzanines, a wood ledge has been added above the rails and is not significant. (See photos HR023 and HR024).

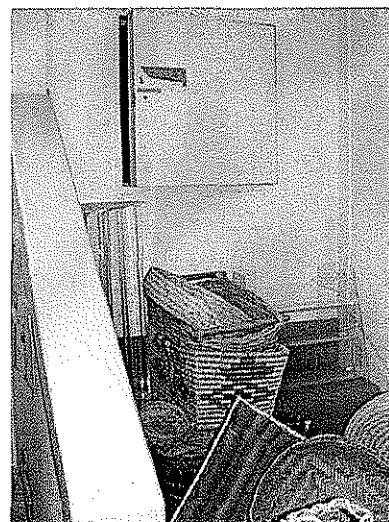
HR032 - Office area; closed off stairway up into Torrance Tower

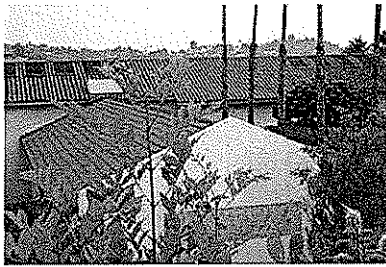
HR036 - Poole Wing: north elevation with cast concrete ornament

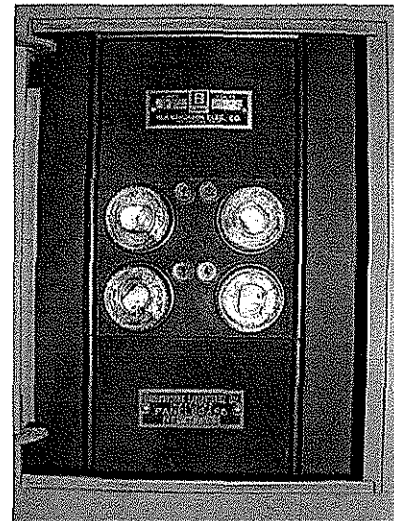
The 800 amp single-phase service feeds an overhead pull section, meter, and distribution sections located on the south wall of the Boiler Room on the 3rd level of the Caracol Tower. This board feeds subpanels for the Poole Wing addition, and for the exhibit areas. It is a very old switch and fuse board, which has no more space available, and contains a glass-fused integral branch circuit panel. It does not meet current codes, as it can no longer interrupt the available fault current. Also, some of the switchboard feeds are jumpered off the bus (thus offering no overcurrent protection), and one of its disconnect switches has a set of mismatched fuses. All of these are safety concerns. (See photo E002)

E002 - Boiler room fuse panel

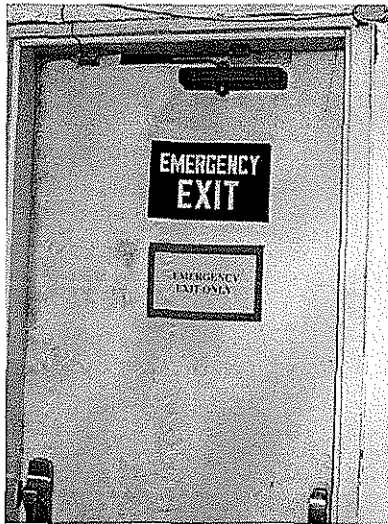
E019 - Administration area exit lacking proper illumination and signage.

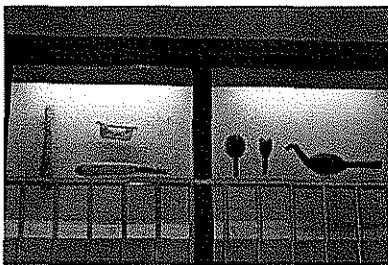
E020 - Inconsistent display case lighting typical throughout

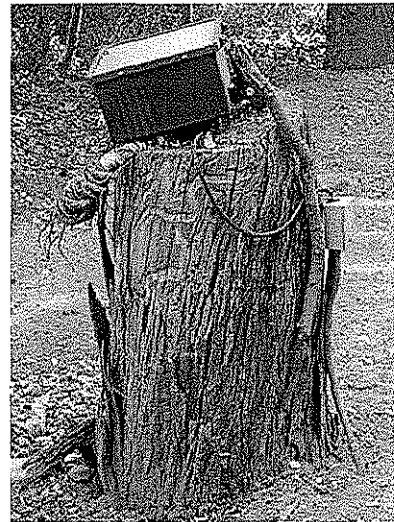
**E030** - De-activated exterior flood light at Caracol Tower

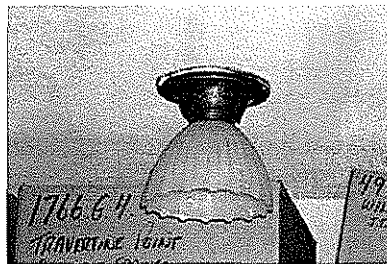
**E028** - Historic ceiling fixture typical in Caracol 6 & 7

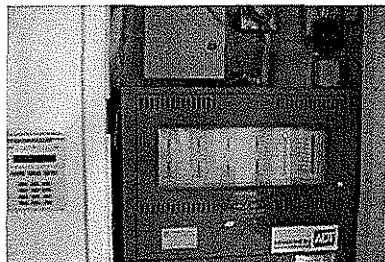
The project is provided with an outdated fire alarm system. Smoke detectors in several locations are improperly installed (See Photo LS004). SENSISCAN 1000 ADEMCO 694 EN Digital Communication by Fire-Lite Alarms Inc. (See Photo LS005) for a fire alarm system is provided at the main entrance on the second floor. The existing spacing and locations of smoke/heat detectors and manual pull stations are inadequate based on the current fire alarm design requirements. Furthermore, visual and audible alarm notification appliances were not observed during the site survey conducted.

LS005 - Fire detection/communication equipment

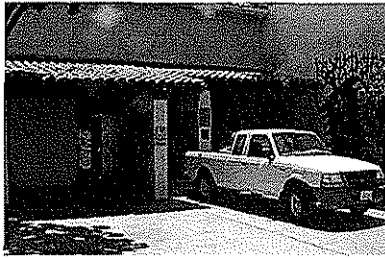
LS006 - Single, accessible stall;  
non-compliant
