PROTECTED TREE REPORT

V & G Development, INC.

2669 N. Bronholly Dr.

October 13, 2021

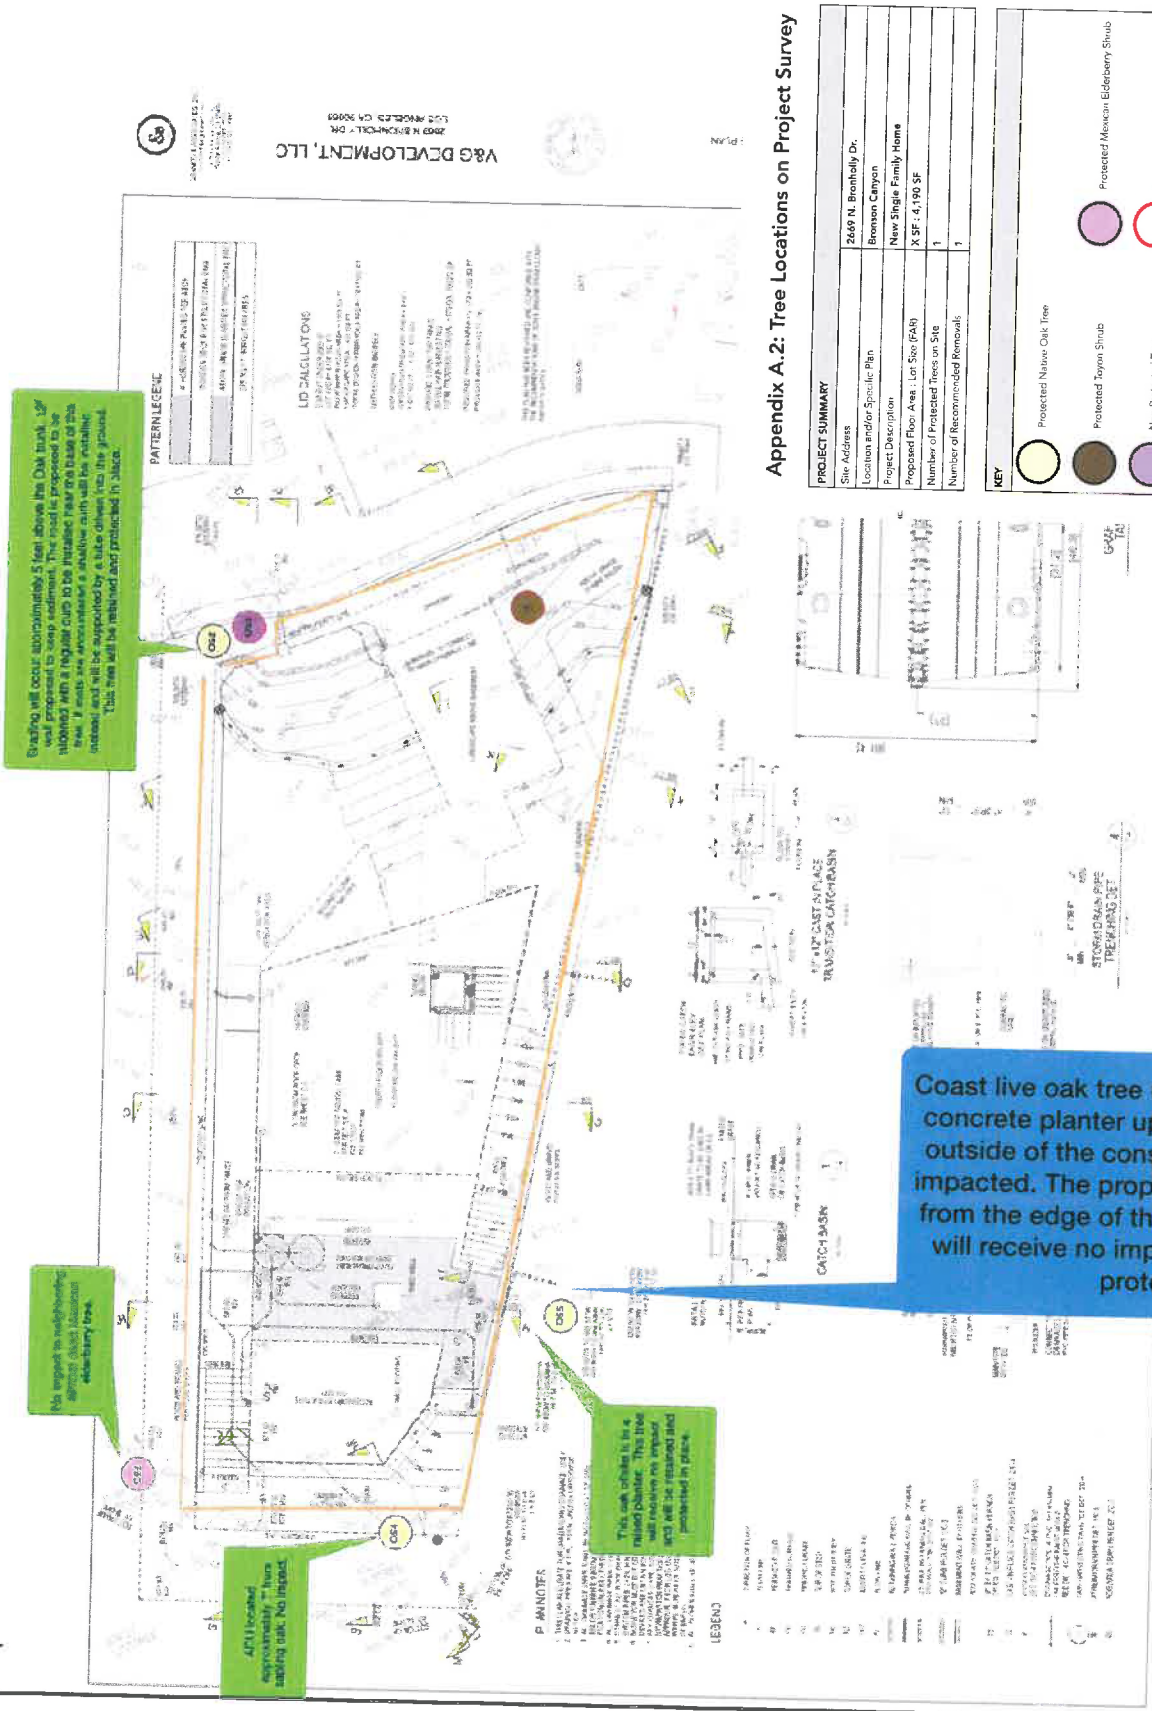
APPENDIX A.2 - TREE LOCATION MAP, SITE PLAN

Grading will occur approximately 5 feet above the Oak trunk. If you are prepared to lose sediment. The road is to be shown with a 1/4" grid to be installed near the base of the tree. If you are not prepared to lose sediment, a suitable method will be installed and will be supported by a base above the ground. This tree will be retained and protected in place.

This project is not impacting any existing trees.
