**US EPA Region 9 Enforcement and Compliance Assurance Division  
 Clean Air Act Section 112(r)  
 Inspection Report**

| <b>Inspection Date(s):</b> | May 31, 2024 | <b>Inspection Announced:</b> Yes |
| <b>Company Name:</b> JCI Jones Chemicals, Inc. | | |
| <b>Facility or Site Name:</b> JCI Jones Chemicals, Inc. – Torrance | | |

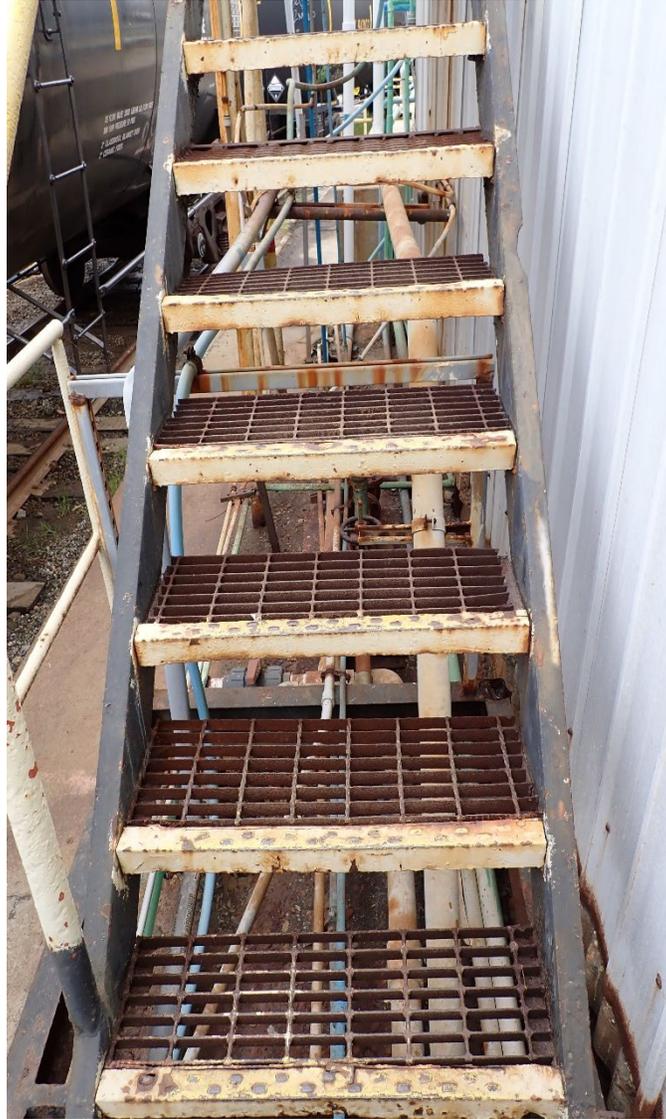
**Photograph 15 - File: P5310015.JPG**

Chlorine Railcar Loading/Unloading Platform: Overview of the stairs for the railcar platform.

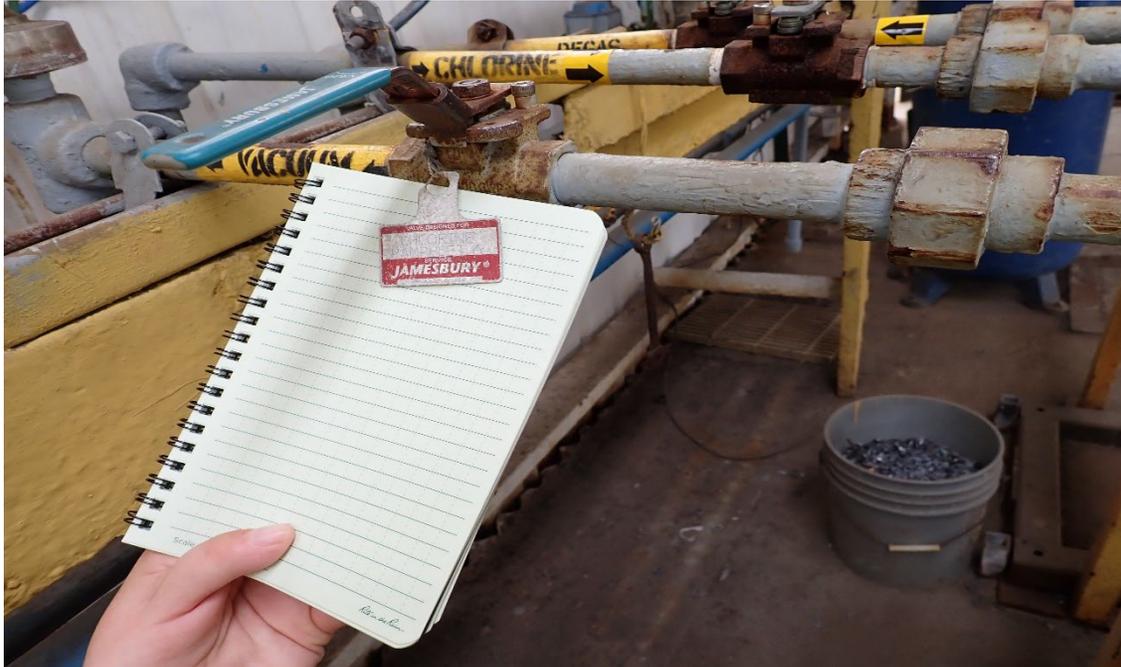
**Photograph 16 - File: P5310016.JPG**

Chlorine Filling Station 1: Manufacturer valve tag for vacuum return valve.

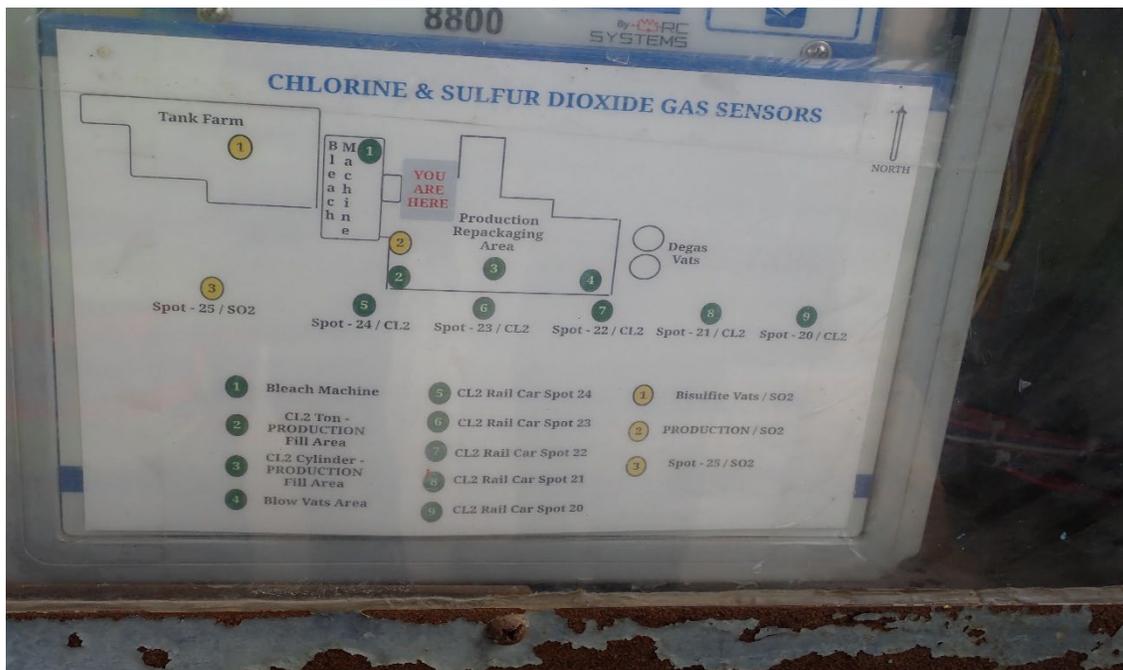
**Photograph 22 - File: P5310024.JPG**

Production Area: Schematic of the chlorine and sulfur dioxide gas sensors located in the plant.
