Re: Council File No. 25-1518; 11973-11975 West San Vicente Boulevard / California Environmental Quality Act (CEQA) / Appeal

Re: Council File No.: 25-1518 - Appeal of Building and Safety Commission's Approval of Demolition Permit for Barry Building Located at 11973 San Vicente Boulevard

11973 San Vicente Boulevard

ASCE 41-13 Seismic Assessment

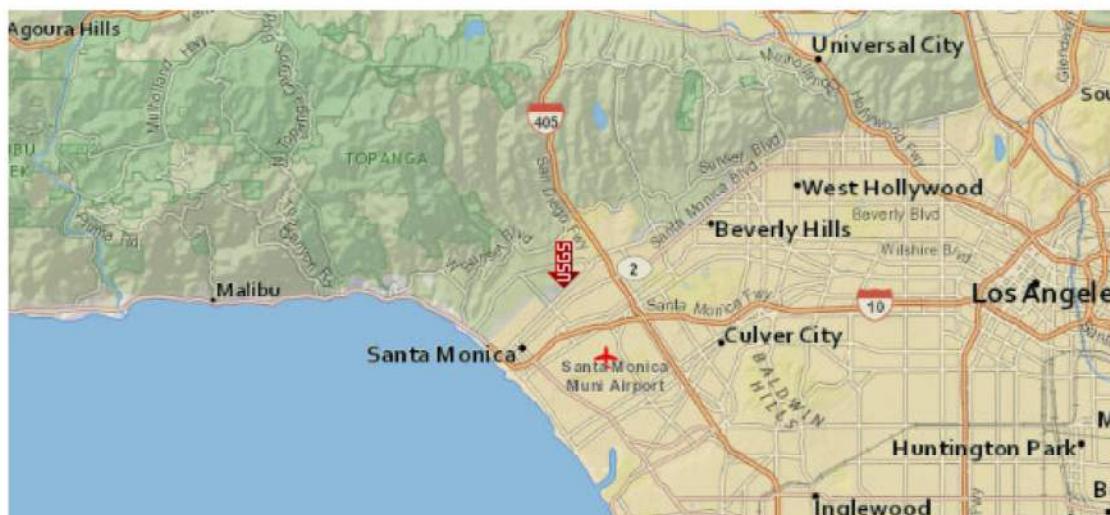
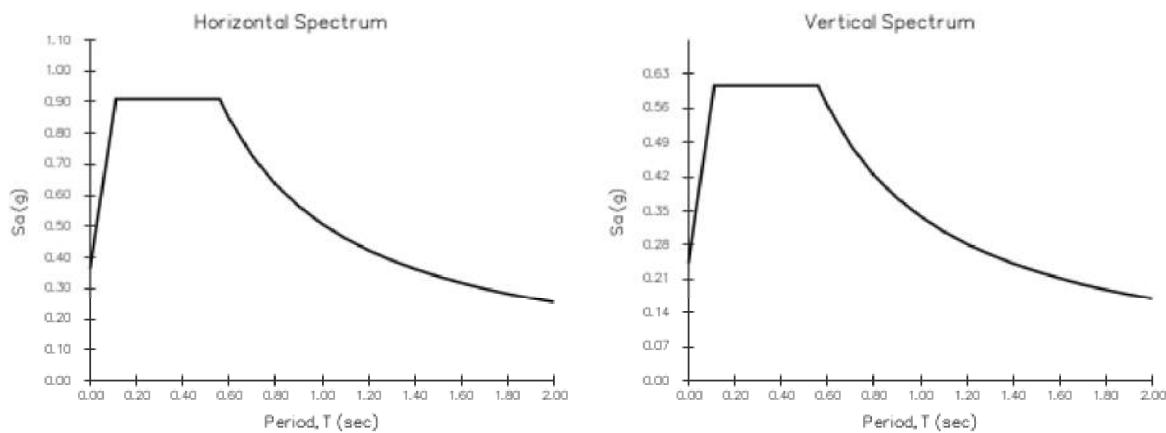
Figure 4.1: Spectral Ordinates per ASCE 41-13

Spectral accelerations were obtained from the USGS for the Basic Safety Earthquake-1E (BSE-1E) hazard level. The BSE-1E hazard level corresponds to an earthquake with an average return period of 225 years or 20% probability of exceedance in 50 years. BSE-1E spectral accelerations are used to evaluate the level of seismicity of the site as required for the Tier 1 Checklist. The ordinates are illustrated in Figure 4.1.

Site Soil Classification Site Class D – "Stiff Soil"

$S_{s,20/50}$	0.760 g	$S_{xs,BSE-1E}$	0.909 g
$S_{1,20/50}$	0.274 g	$S_{x1,BSE-1E}$	0.508 g

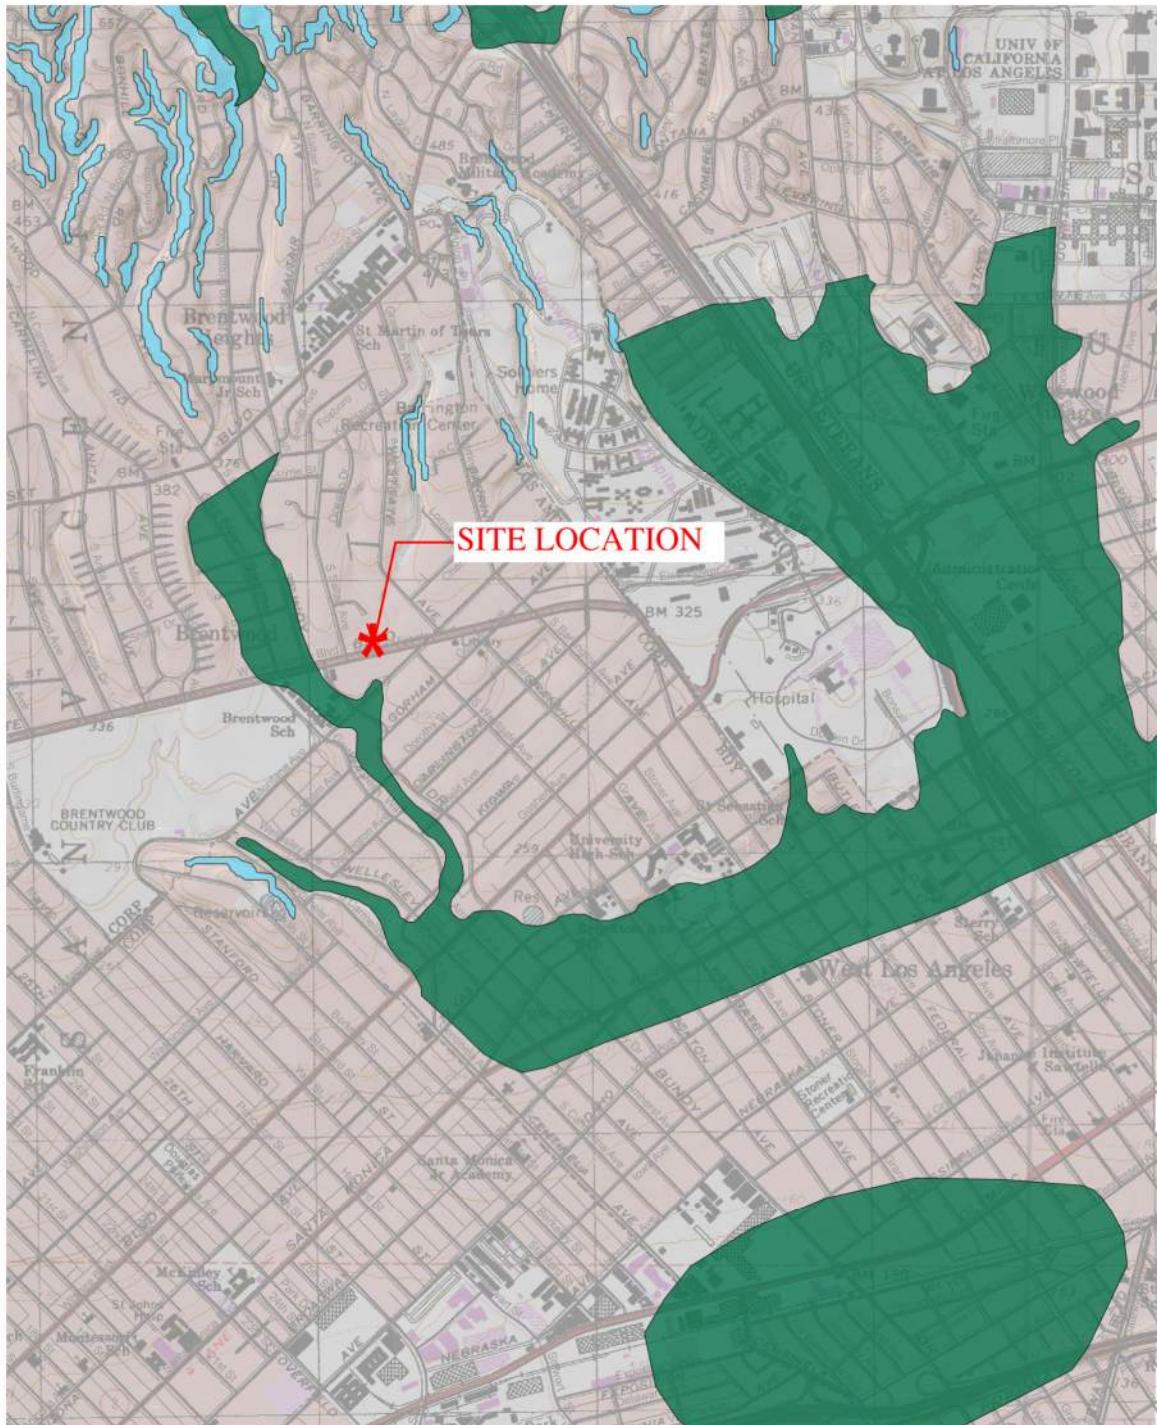
Figure 4.2: State of California Regulatory Map for Seismic Hazards
(Beverly Hills Quadrangle)

The state of California has issued a set of regulatory maps detailing regions of potential liquefaction, landside and ground fault rupture. This site is in the Beverly Hills Quadrangle, as shown in Figure 4.2. Areas shown in white have not been identified as locations of potential liquefaction, landside or ground

fault rupture. The map indicates that the site, shown in Figure 4.2, has not been identified as a potential location for any of these seismic or geotechnical hazards.

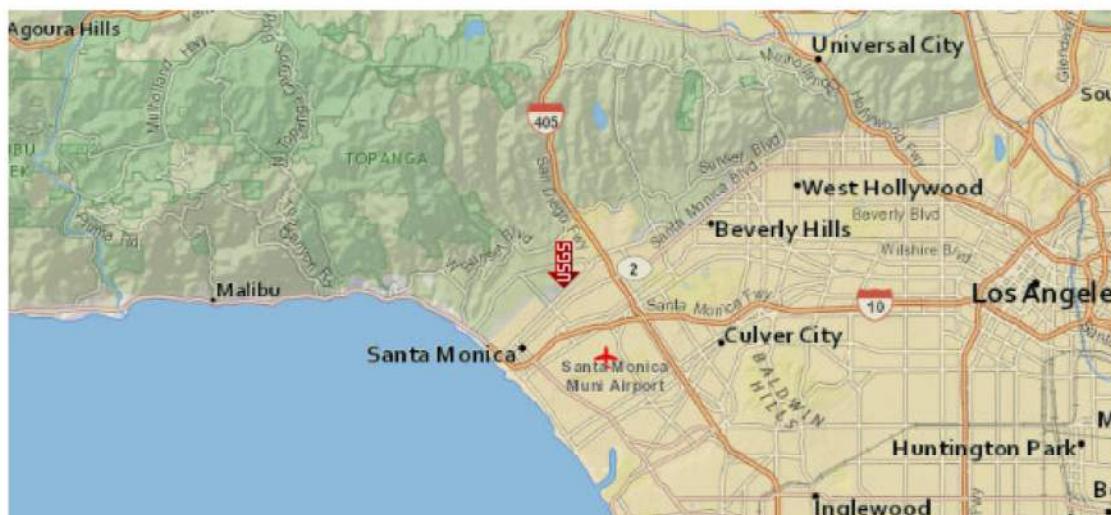
Figure 4.1: Spectral Ordinates per ASCE 41-13

Spectral accelerations were obtained from the USGS for the Basic Safety Earthquake-1E (BSE-1E) hazard level. The BSE-1E hazard level corresponds to an earthquake with an average return period of 225 years or 20% probability of exceedance in 50 years. BSE-1E spectral accelerations are used to evaluate the level of seismicity of the site as required for the Tier 1 Checklist. The ordinates are illustrated in Figure 4.1.

Site Soil Classification Site Class D – "Stiff Soil"

$S_{s,20/50}$	0.760 g	$S_{xs,BSE-1E}$	0.909 g
$S_{1,20/50}$	0.274 g	$S_{x1,BSE-1E}$	0.508 g

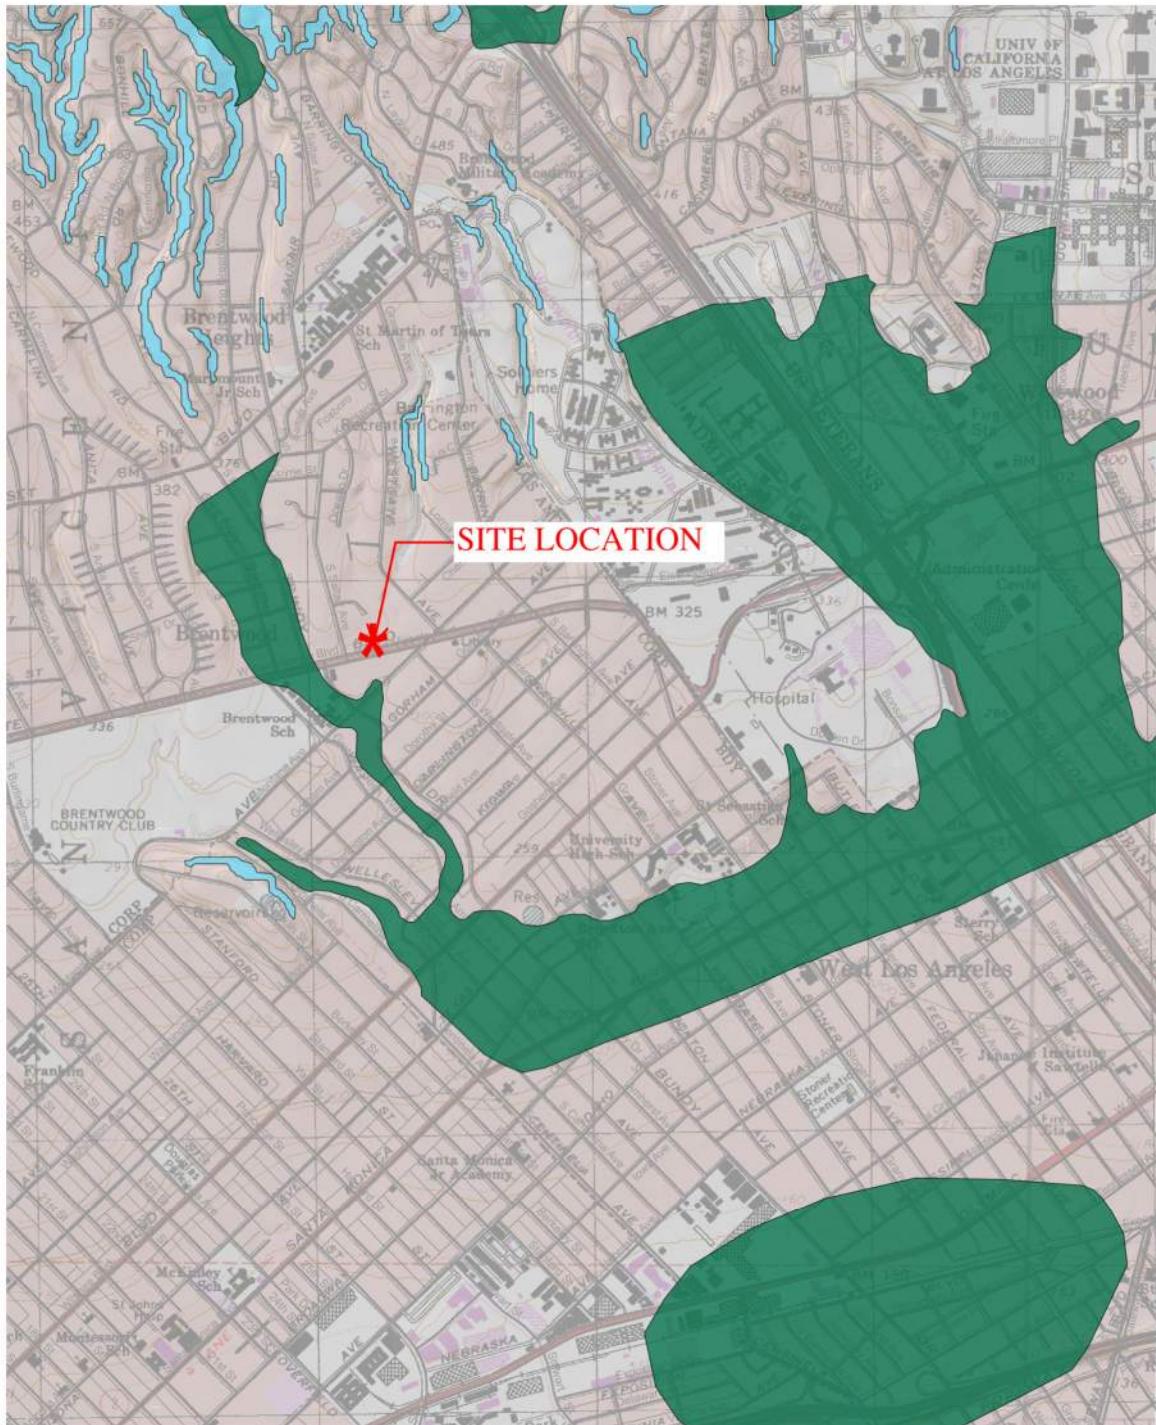
Figure 4.2: State of California Regulatory Map for Seismic Hazards
(Beverly Hills Quadrangle)

The state of California has issued a set of regulatory maps detailing regions of potential liquefaction, landside and ground fault rupture. This site is in the Beverly Hills Quadrangle, as shown in Figure 4.2. Areas shown in white have not been identified as locations of potential liquefaction, landside or ground

fault rupture. The map indicates that the site, shown in Figure 4.2, has not been identified as a potential location for any of these seismic or geotechnical hazards.
