**Barry Building  
Stairs & Benches Safekeeping**

**Report**  
of  
**James C. Wolf**

**January 15, 2024**

ASCE 41-13 Seismic Assessment

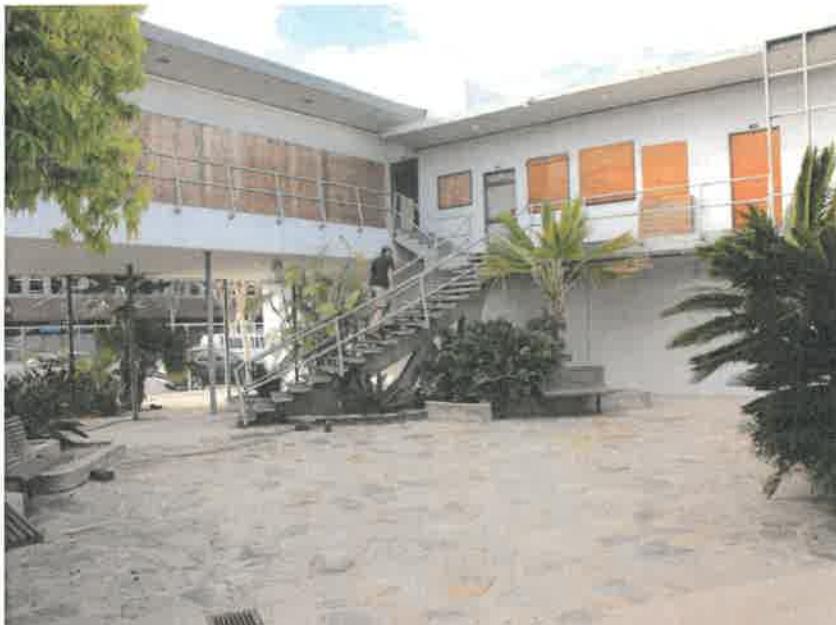
Central Courtyard View (looking south)

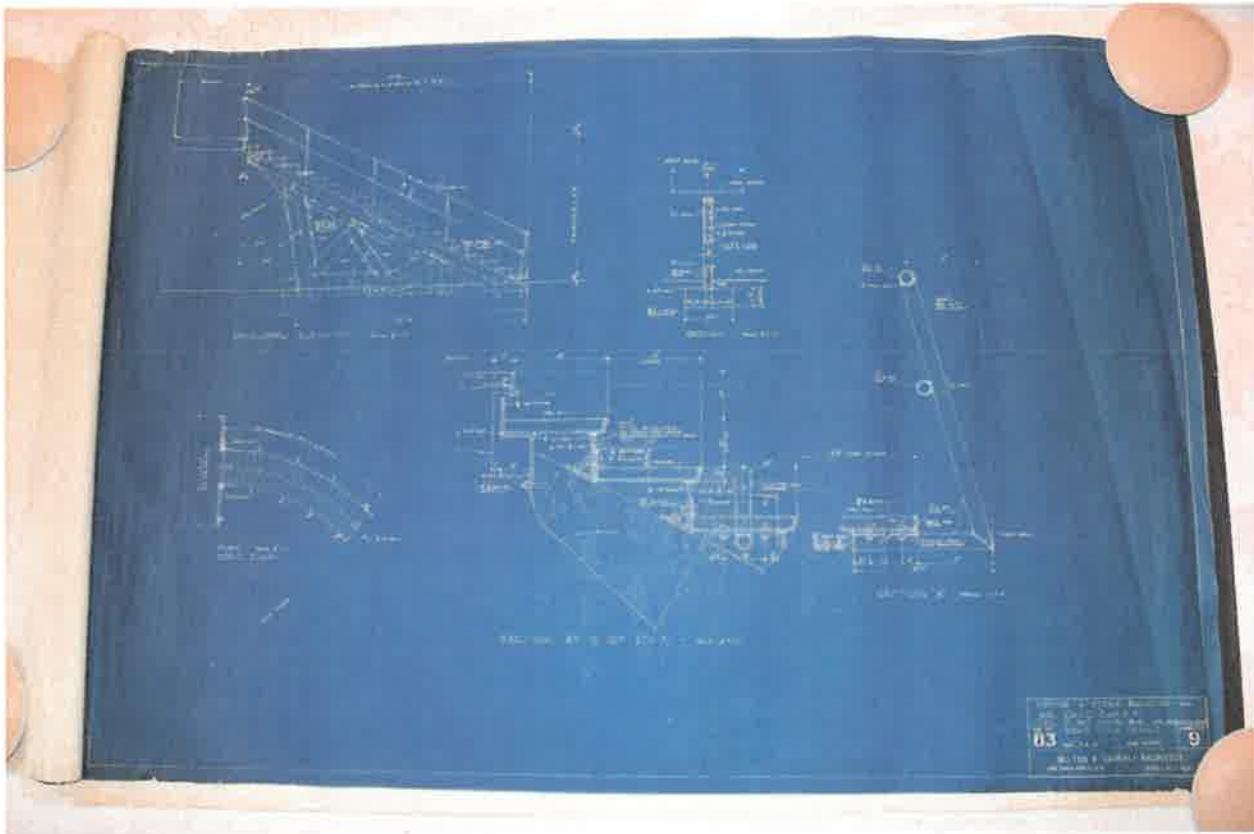
**Drawing: Courtyard Staircase Plan, Elevation and Details**

Shows Staircase footprint, geometry, profile and details as designed, dated 7-8-50

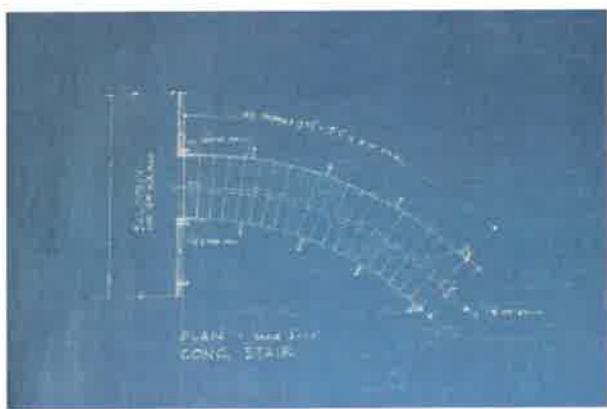
**Drawing: Staircase Plan**

Shows staircase footprint and curvature

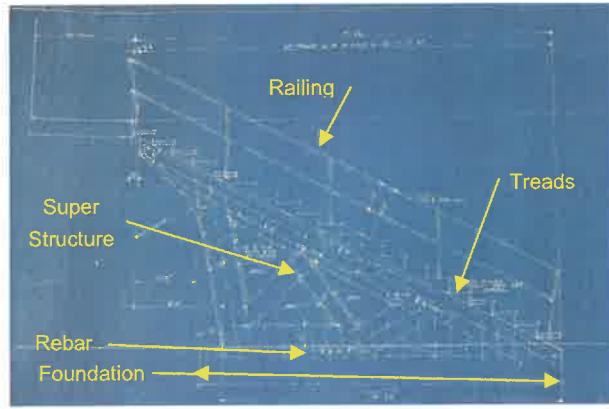
**Drawing: Staircase Elevation**

Shows handrail, treads, architectural pierced concrete super structure and rebar into the foundation

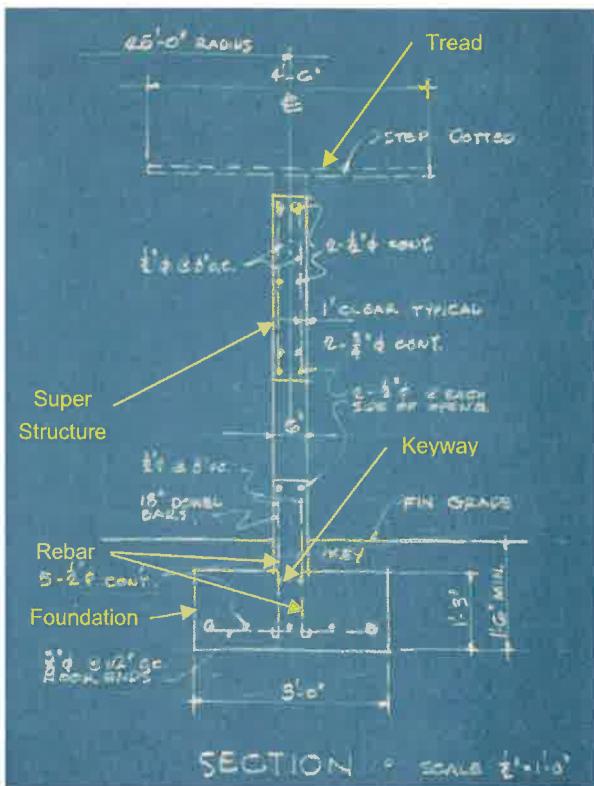
# **Drawing: Cross Section of Staircase Foundation and Architectural Pierced Concrete Super Structure**

**Foundation:** The foundation is made up of reinforced concrete (rebar and concrete) cast in an earthen trench. It is important to note the foundation construction involved creation of a keyway that makes a trough like formed depression in the top of the concrete that allows for later engagement of the subsequent super structure construction physically into the foundation. Making this engagement more structural, rebar that projects from the body of the foundation and keyway to engage the super structure concrete and rebar, in effect "marrying" the foundation to the super structure.

Shows Architectural Pierced Concrete Super Structure seated in the Foundation keyway (slot at top of Foundation to receive Architectural Pierced Concrete Super Structure) and Rebar tying the two elements together
