**ENCLOSURE: REPORT FROM WSP**

Regarding: Barry Building (11973 San Vicente Boulevard, Los Angeles, CA 90049)  
Opponent Expert's Report review

**Exhibit D – Englekirk Complete Seismic Assessment  
Report , dated June 6, 2022**

**ASCE 41-13 Seismic Assessment**

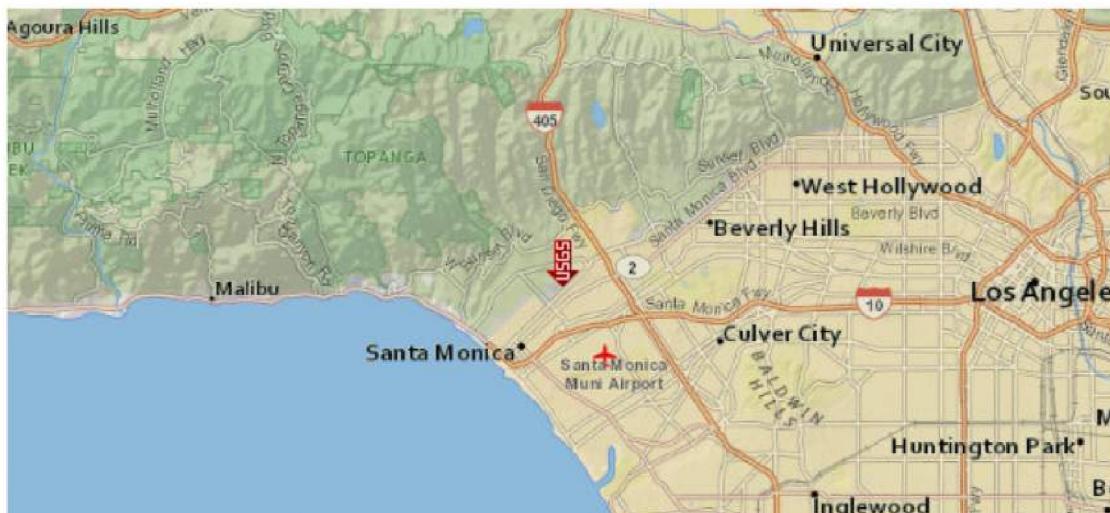
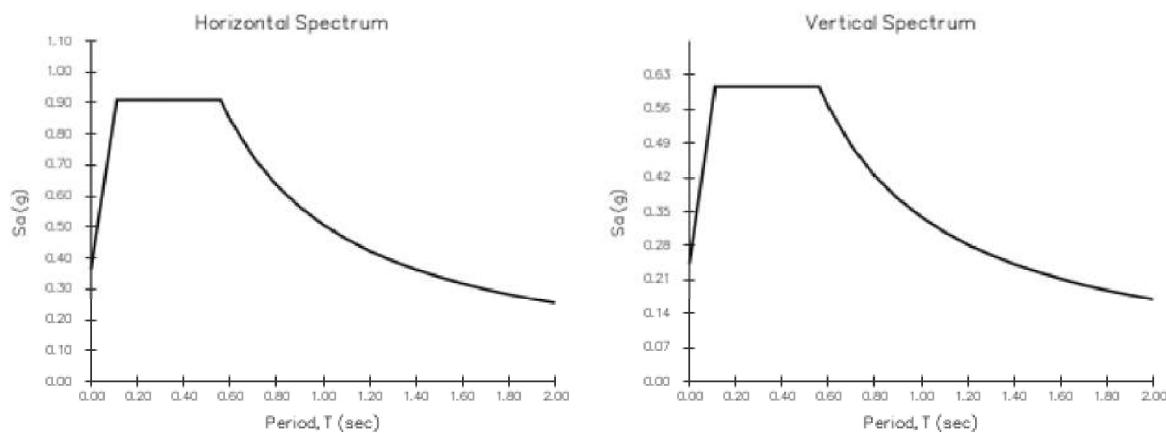
**Figure 4.1:** Spectral Ordinates per ASCE 41-13

Spectral accelerations were obtained from the USGS for the Basic Safety Earthquake-1E (BSE-1E) hazard level. The BSE-1E hazard level corresponds to an earthquake with an average return period of 225 years or 20% probability of exceedance in 50 years. BSE-1E spectral accelerations are used to evaluate the level of seismicity of the site as required for the Tier 1 Checklist. The ordinates are illustrated in Figure 4.1.

$S_{s,20/50}$	0.760 g	$S_{xs,BSE-1E}$	0.909 g
$S_{1,20/50}$	0.274 g	$S_{x1,BSE-1E}$	0.508 g

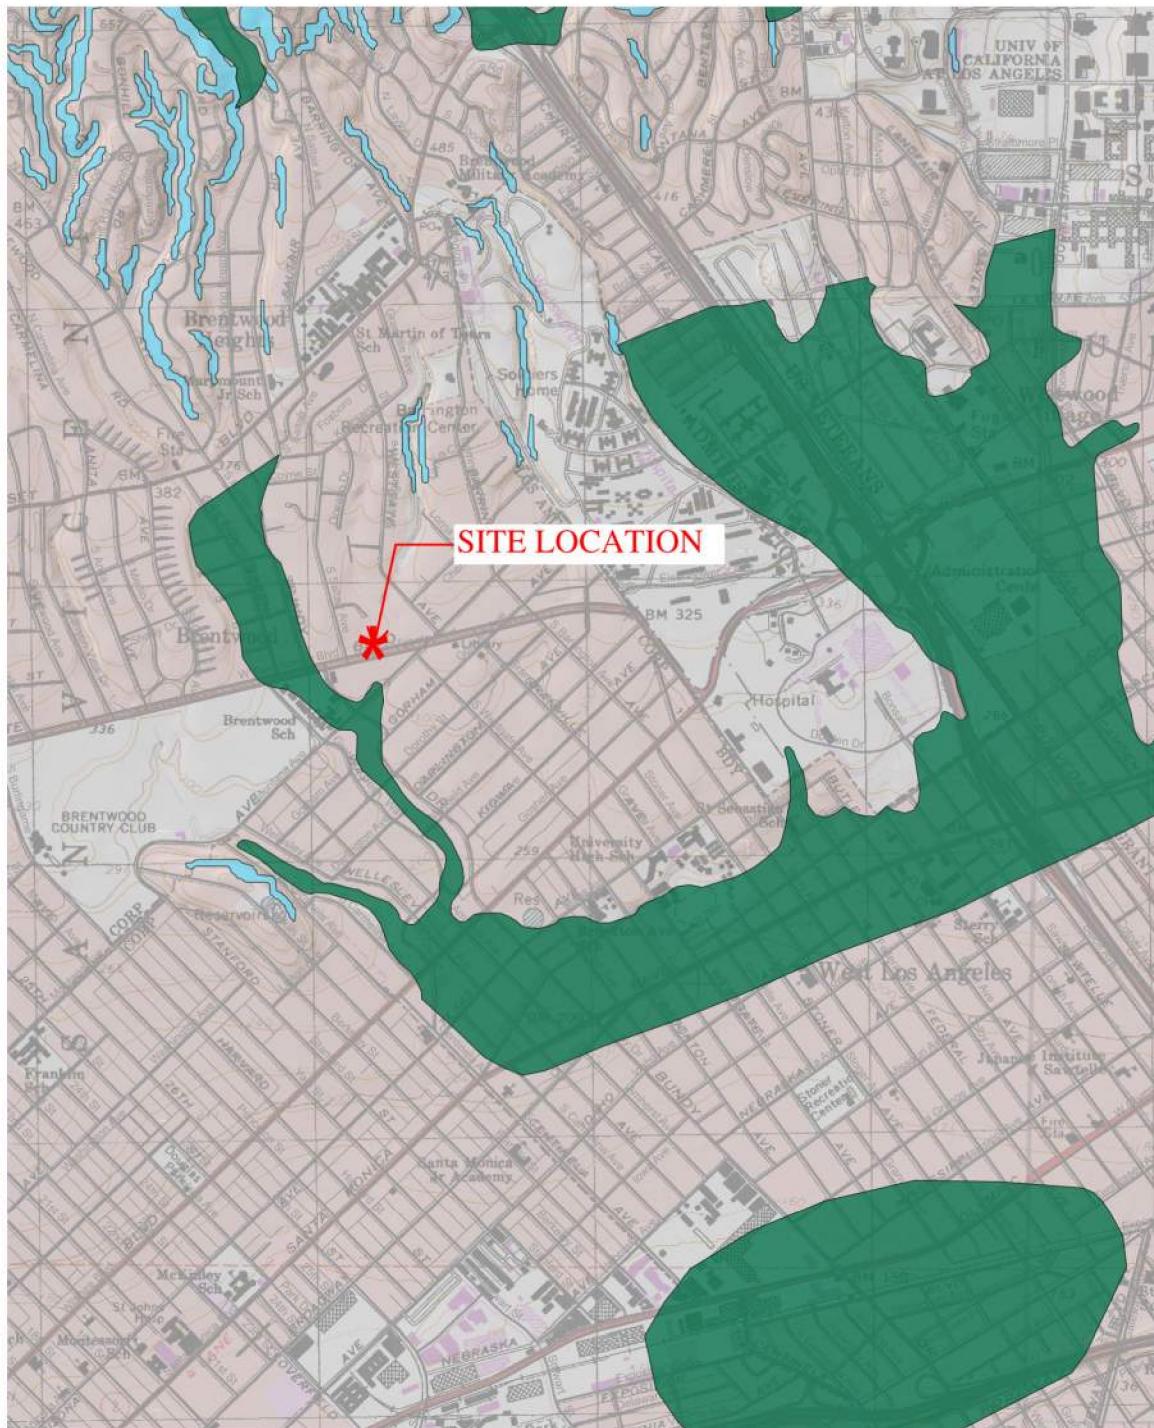
**Figure 4.2:** State of California Regulatory Map for Seismic Hazards  
(Beverly Hills Quadrangle)

The state of California has issued a set of regulatory maps detailing regions of potential liquefaction, landside and ground fault rupture. This site is in the Beverly Hills Quadrangle, as shown in Figure 4.2. Areas shown in white have not been identified as locations of potential liquefaction, landside or ground

fault rupture. The map indicates that the site, shown in Figure 4.2, has not been identified as a potential location for any of these seismic or geotechnical hazards.
