**RE: Request to Include Attachments in Council File 25-1518 (too large to upload via the City's Public Comment Portal) ... Please see email for details ... (Email 1 of 4) ...**

# THE BARRY BUILDING - 11973-11975 SAN VICENTE BLVD

May 26, 2021  
Job No. 12-L038B

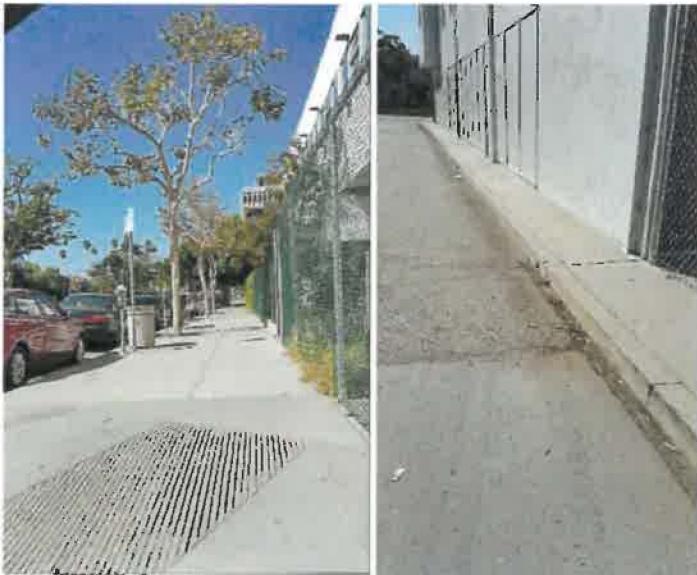
There is no passenger drop-off or a loading zone provided at the street or along the alley. This is not a code violation. If there is no passenger loading zone provided, then CBC Section 11B-503 does not apply.

The south sidewalk is lined with metered parking spaces. The east sidewalk has no passenger loading zone either.

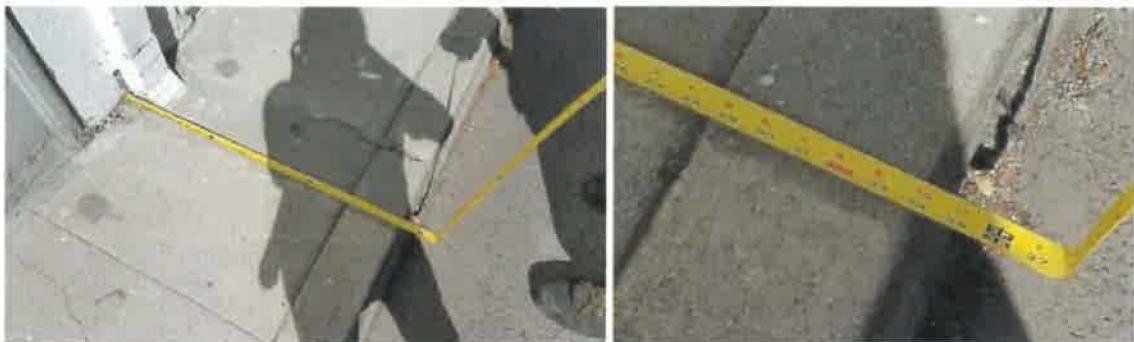
**The East sidewalk is 34" wide only. This is not in compliance with CBC Section 11B-403.5. This sidewalk is not a legal sidewalk for public access to the building and it is not an accessible route.**

The east sidewalk width is 34".

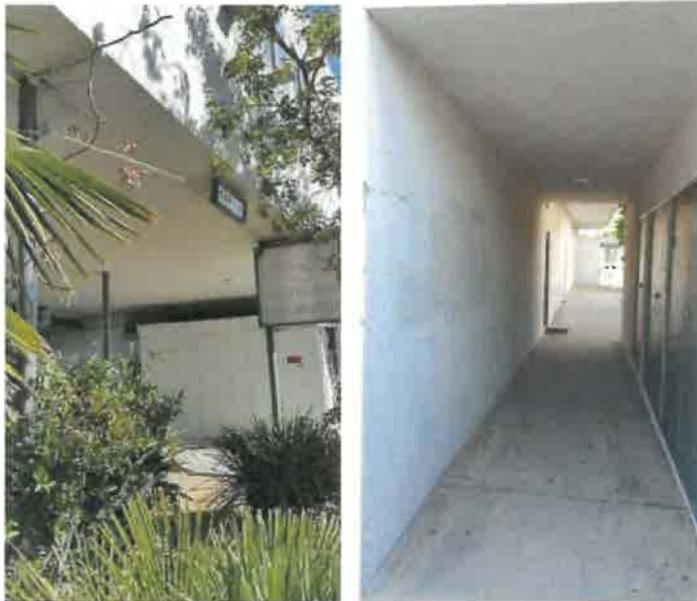
The site arrival point is in the rear parking lot and the only accessible route is through a passageway. Such accessible route does not coincide with and is not in the same area as the general circulation paths because the building's main entrance is in the front. The front entry is accessed by the pedestrians from the street, the meter parking, the sidewalk and the public transportation. **This may not comply with CBC Section 11B-206.3.**

The contrast between the front entrance and the accessible entrance from the rear parking lot.

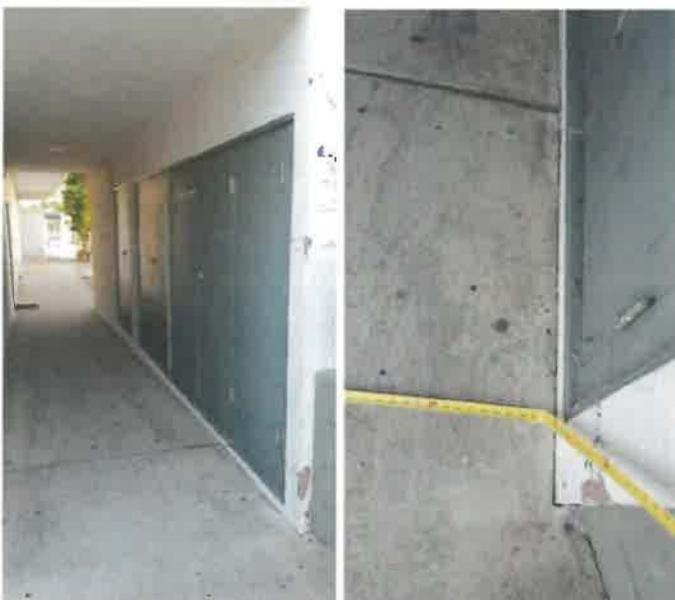
The only accessible building entrance is the 5' wide passageway which is next to the electrical closets and a service ramp. **This may not comply with CBC Section 11B-206.3.**

The Accessible Route/Building Entrance adjacent to the electrical closets and the service area.

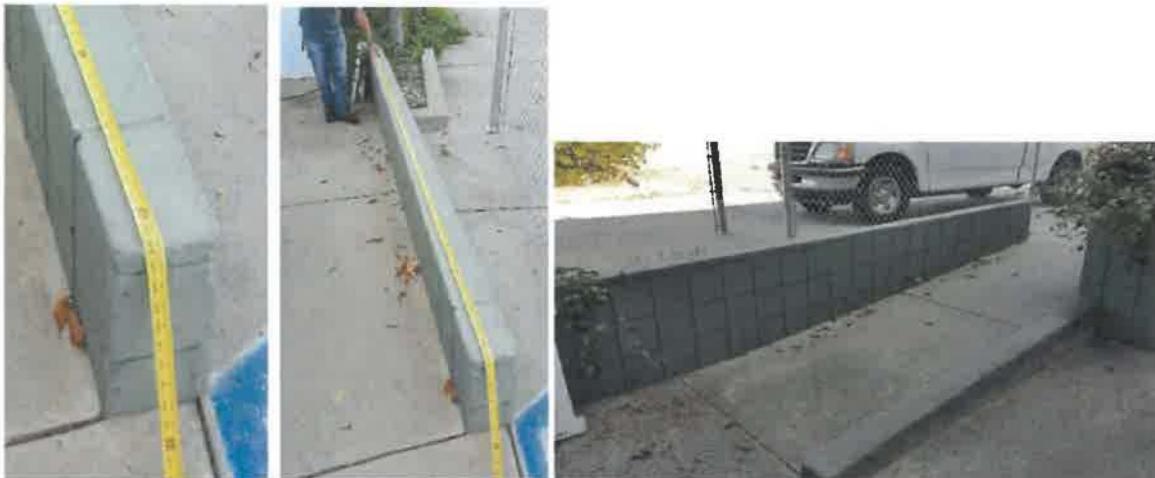
The ramp to the CMU Addition also leads to a north wing tenant's door. The ramp's slope is greater than 5% based on 10" rise and 12' length. **If the ramp is an accessible path as marked, it is not in compliance with CBC Section 11B-505.2 due to the lack of handrails.**

The ramp to CMU Addition and the North Wing Tenant Door has a greater than 5% slope (12' long with 10" rise).

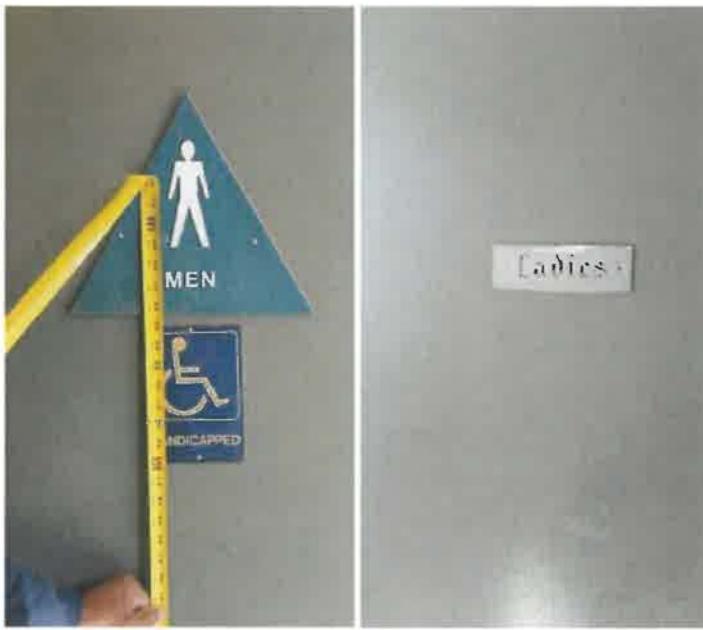
Only the men's restroom is in the accessible route. The only women's restroom is on the second floor, which is not accessible. There is no accessible, single unisex restrooms in the building. **This is not in compliance with CBC Section 11B-213.2.**

The only men's restroom is accessible. The only women's restroom is in a floor that is not accessible.

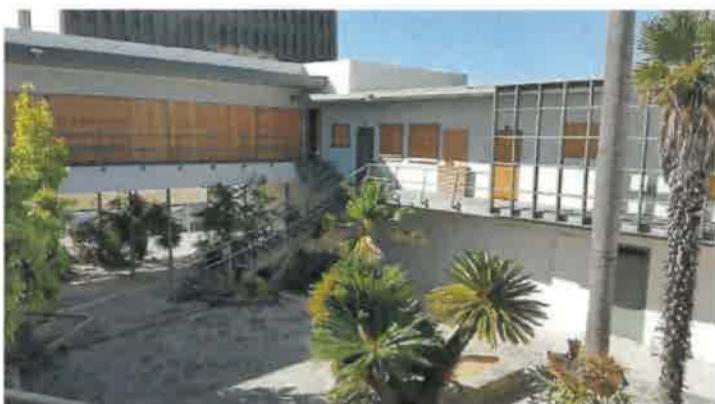
The second floor is not accessible and the building is over 3,000 sf per story. **This may not comply with CBC Section 11B-206.2.3.** Exception 1.2 applies *if a reasonable portion of all facilities and accommodations normally sought and used by public in such a building are accessible to and usable by persons with disabilities.* The first floor is 50% of the overall building area, so it may not satisfy the definition of a reasonable portion. The women's restroom is a facility normally sought and used by the public, but is not available on the first floor.

Only 50% of the building area is accessible. The first floor does not offer an accessible women's restroom.

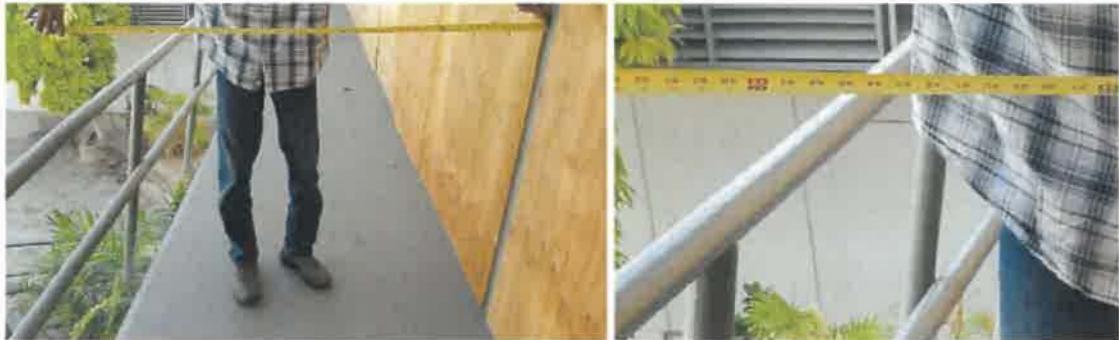
The second floor balcony is 50" wide. It is not wide enough to provide an Area of Assisted Rescue because a minimum of a 44" exit width and additional 24" wheelchair space will be required. **If 1009.7 Area of Assisted Rescue cannot be satisfied, then the second floor is not in compliance with CBC Section 11B-207.**

The balcony width is 50". The slanted railing reduces the balcony's clear width.

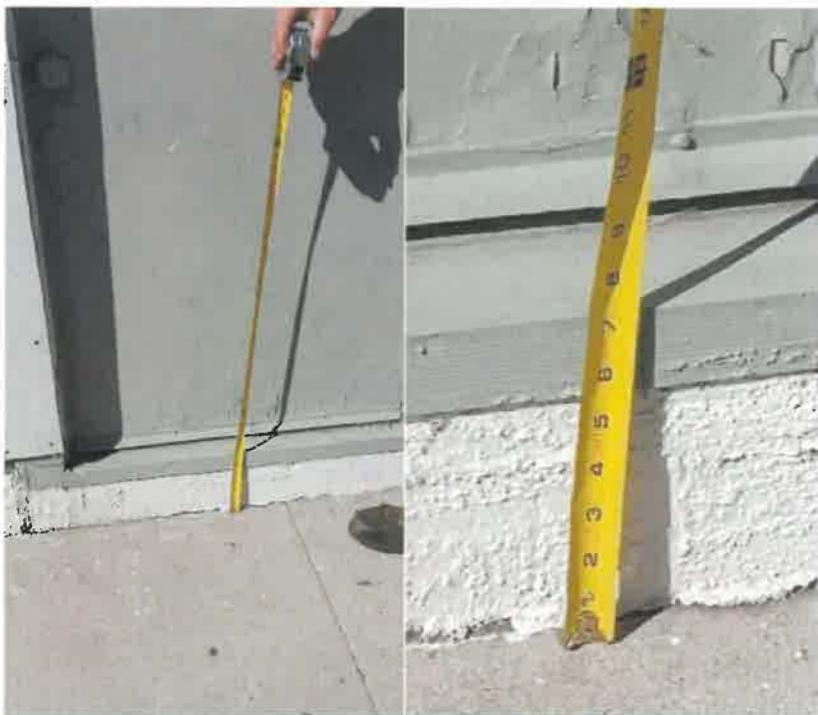
**The door threshold is not in compliance with CBC Section 11B-303.2.**

A few doors at the east elevation have a straight drop at the sidewalk which exceeds the maximum allowed, such as the 7" shown.

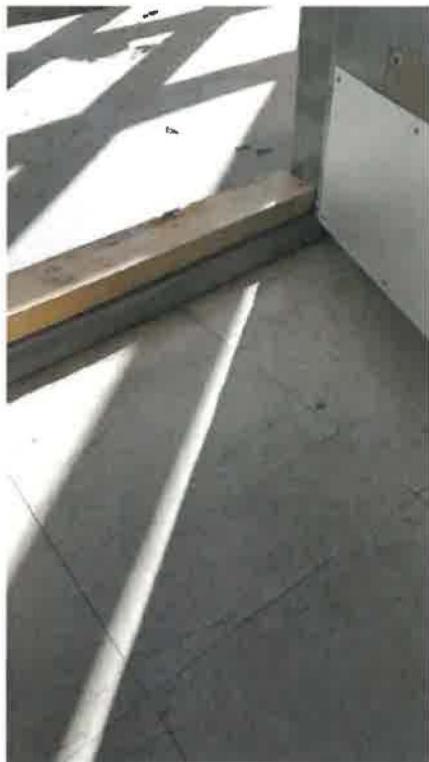
**The door threshold is not in compliance with CBC Sections 11B-404.2.5 & 11B-303.3.**

The women's restroom door threshold has a bevel that exceeds the 1:2 slope.

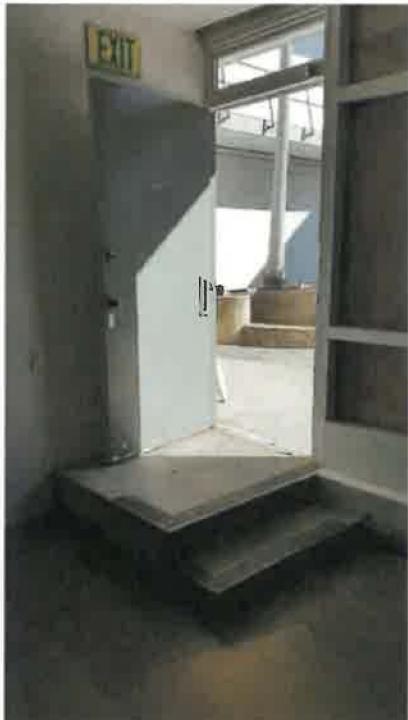
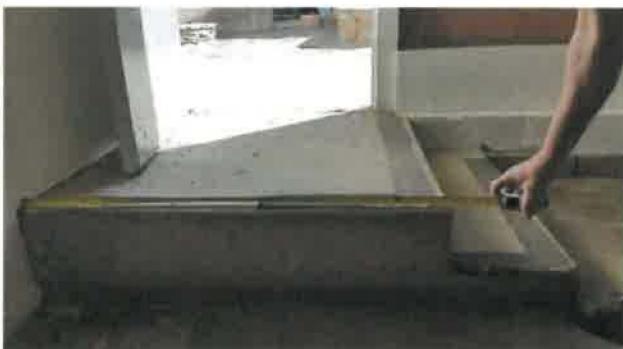
The door landing is not in compliance with CBC Section 11B-404.2.4.4

A first floor tenant's interior does not have a level landing at the entry door maneuvering space.

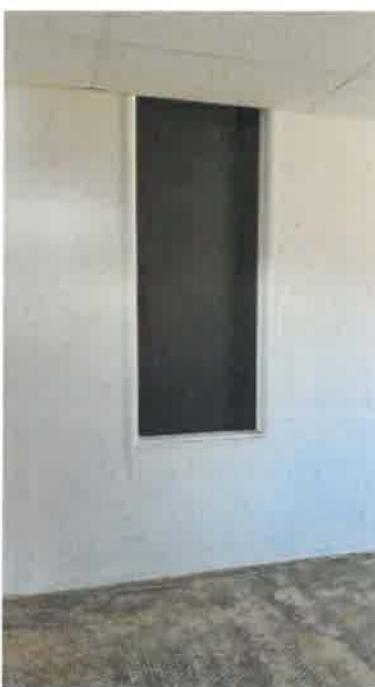
A second floor tenant's interior does not have a landing at a door. The door may have not been used due to the lack of a door knob.

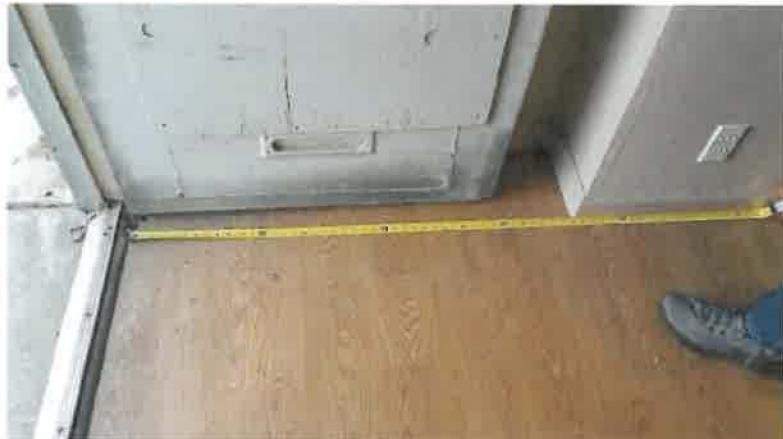
**The door maneuvering clearance is not in compliance with CBC Section 11B-404.2.4.1**

A first floor tenant's entry door only has 42" deep maneuvering clearance due to a projected wall.

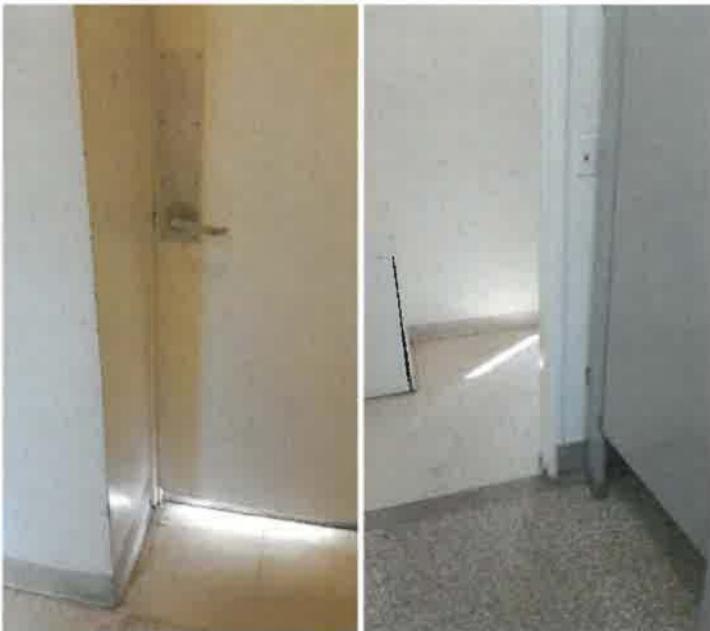
**The door maneuvering clearance is not in compliance with CBC Section 11B-404.2.4.1 at a restroom.**

The women's restroom does not have pull side and push side clearance at the entry and the vestibule door.

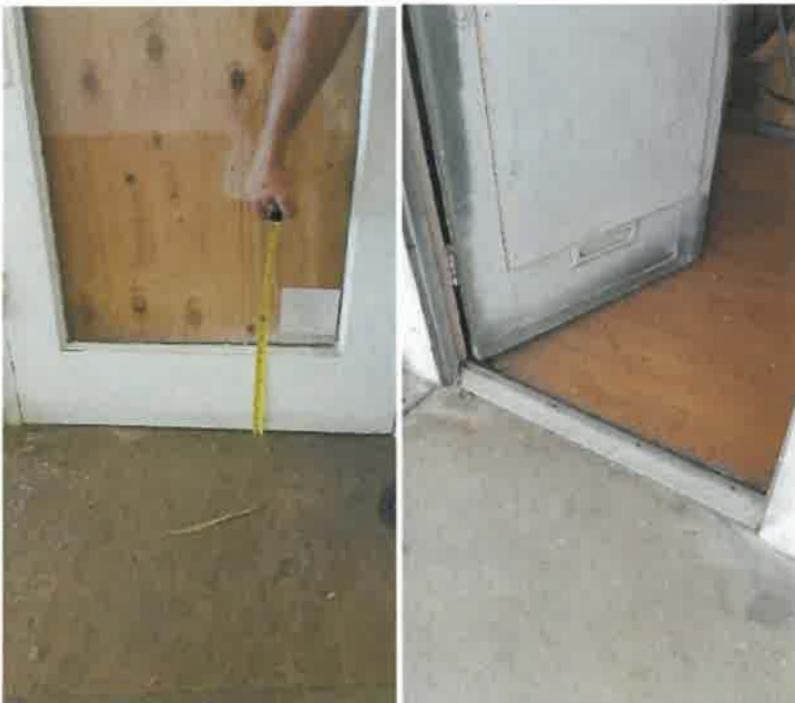
**The door bottom is not in compliance with CBC Section 11B-404.2.10.**

The original glass door's bottom is less than 10" high. The mail slot is not a smooth surface for a wheelchair.

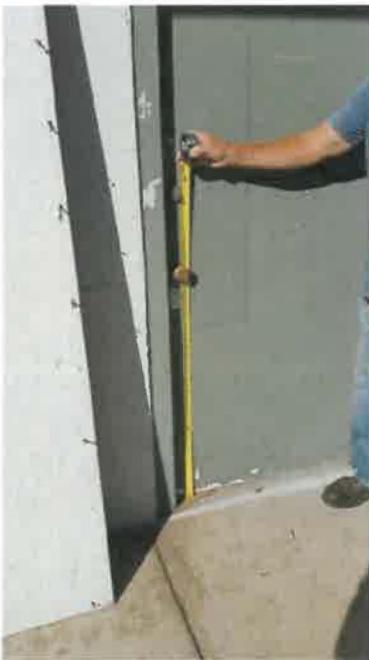
**The door hardware mounting height is not in compliance with CBC Section 11B-404.2.7 & 11B-309**

A first floor tenant's lock is mounted at 46" above floor.

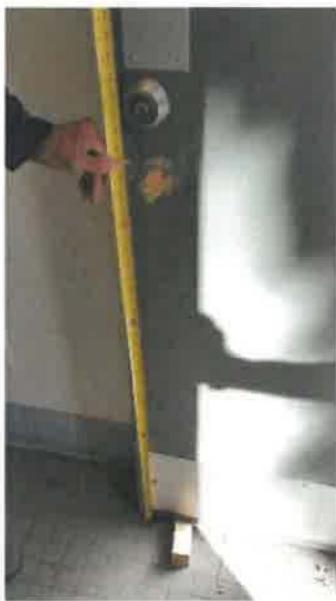
**The door hardware type is not in compliance with CBC Section 11B-404.2.7 and 11B-309.4.**

The first floor men's restroom does not have a lever activated lock. The push plate is accessible if the door is not latched and remains unlocked.

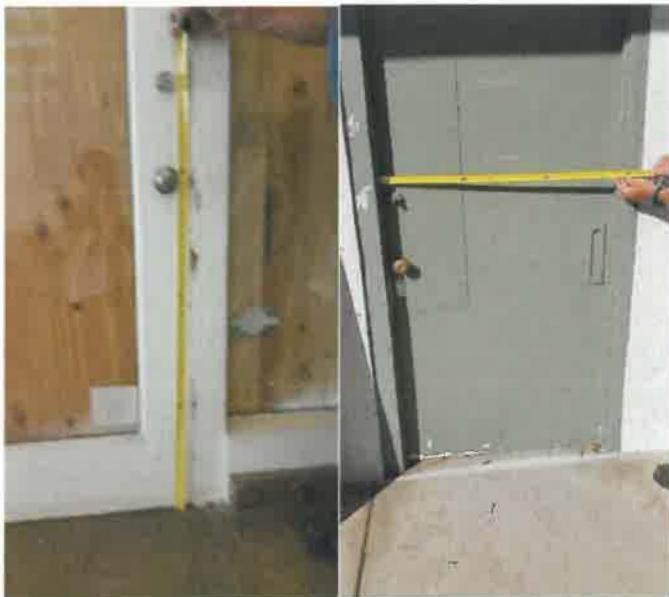
**The door hardware type is not in compliance with CBC Section 11B-404.2.7 and 11B-309.4.**

The original wood framed glass doors and the exterior wood doors all have non-lever type hardware.

A116AD	REPLACE DOOR & FRAME FOR DOORS LESS THAN 34" W
A116AE	MODIFY & REINSTALL NECESSARY DOORS TO OPEN 90 DEGREES
A116AF	PROVIDE CODE COMPLIANT SIGNS FOR TENANT ENTRY DOOR
A116AG	LEVER DOOR HANDLES
A116AH	WINDOW REPLACEMENT
A116AI	REPLACE EXTERIOR WALL FINISHES
A117	ABATEMENT
A117AA	ABATEMENT
A118	SITE IMPROVEMENTS
A118AA	SITE IMPROVEMENTS
B1	OWNER'S COSTS
B111	OWNER'S COSTS
B111AA	OWNER'S COST

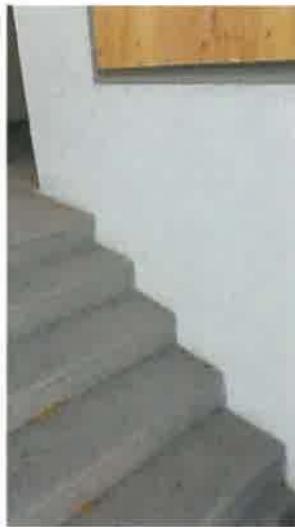
The four second floor stairs connecting the balconies do not have handrails on both sides. This is not in compliance with CBC Section 11B-505.2.

**The four second floor stairs are not in compliance with CBC Section 11B-504.4.1 due to the lack of the contrasting stripes.**

The four second floor stairs do not have a handrail on the wall side. They also do not have the contrasting stripe at the top approach and at all the treads.

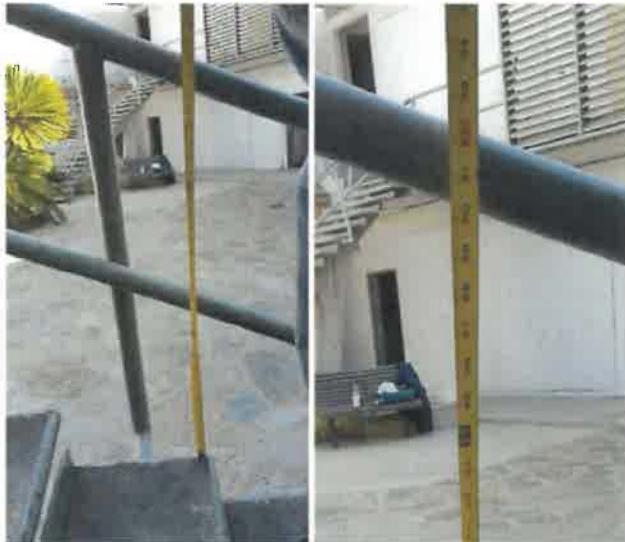
**The two main stairs connecting the first floor and the second floor have handrails less than 34" high; therefore, they are not in compliance with CBC Section 11B-505.4.**

The main stair's handrail is 32" high measured from the nosing.

As part of the building access recommendations were modifications to the handrails at the existing stairs and the second floor railings. These recommendations were made from a perspective of Historical preservation only and the means and methods were not considered. The recommendations made are not constructible as there is no way of welding additional steel elements to 60-year-old steel pipe. The only way to achieve what is required is to replace all railings with what is required by code.

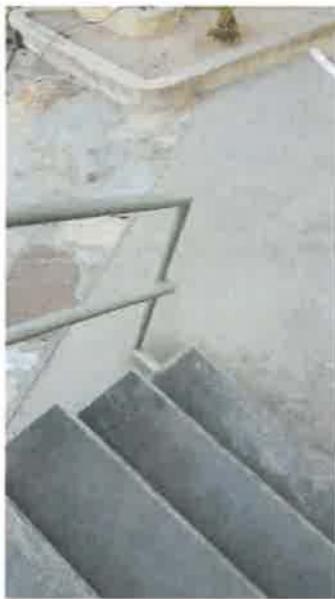
**The two main stairs do not have bottom handrail extensions; therefore, they are not in compliance with CBC Section 11B-505.10.3.**

**The two main stairs do not have contrasting stripes; therefore, they are not in compliance with CBC Section 11B-504.4.1.**

The main stair's handrail has no extension at the bottom and no contrasting stripes at the treads.

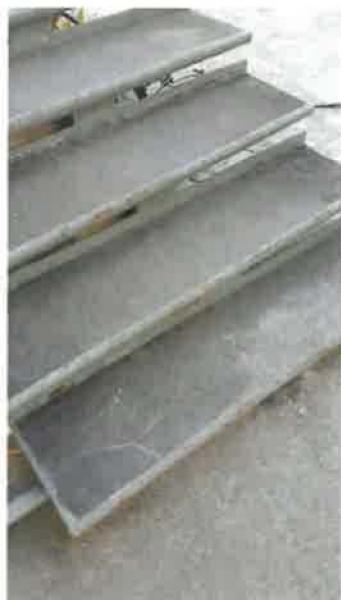
**The two main stairs connecting the first and second floors have open risers; therefore, they are not in compliance with CBC Section 11B-504.3.**

Main stairs have open risers.

A114AA	ADD A SOLID OR PERFORATED STEEL PANEL AT EACH OPEN RISER	0.37/SF	40@ 141.37RISERS	3,504	1,635	516	0	5,655
A114	ADD CONTRASTING STRIPE AT EACH RISER	0.09/SF	40@ 36.54EA	481	862	119	0	1,462
A114AB	ADD CONTRASTING STRIPE AT EACH RISER	0.09/SF	40@ 36.54EA	481	862	119	0	1,462
A114	REPLACE EXISTING STEEL GUARDRAILS WITH NEW ONES	2.81/SF	175@ 247.52LF	28,469	13,283	1,563	0	43,315
A114AC	REPLACE EXISTING STEEL GUARDRAILS WITH NEW ONES	2.81/SF	175@ 247.52LF	28,469	13,283	1,563	0	43,315
A114	REPLACE EXISTING 2ND FLOOR BALCONY GUARDRAILS	3.16/SF	197@ 247.52LF	32,048	14,953	1,760	0	48,761
A114AD	REPLACE EXISTING 2ND FLOOR BALCONY GUARDRAILS	3.16/SF	197@ 247.52LF	32,048	14,953	1,760	0	48,761
A114	WALL MOUNTED HANDRAIL AT EA OF 4 STAIRS BETWEEN 2ND FLOOR LEVELS	1.38/SF	120@ 177.61LF	13,515	6,726	1,072	0	21,313
A114AE	WALL MOUNTED HANDRAIL AT EA OF 4 STAIRS BETWEEN 2ND FLOOR LEVELS	1.38/SF	120@ 177.61LF	13,515	6,726	1,072	0	21,313

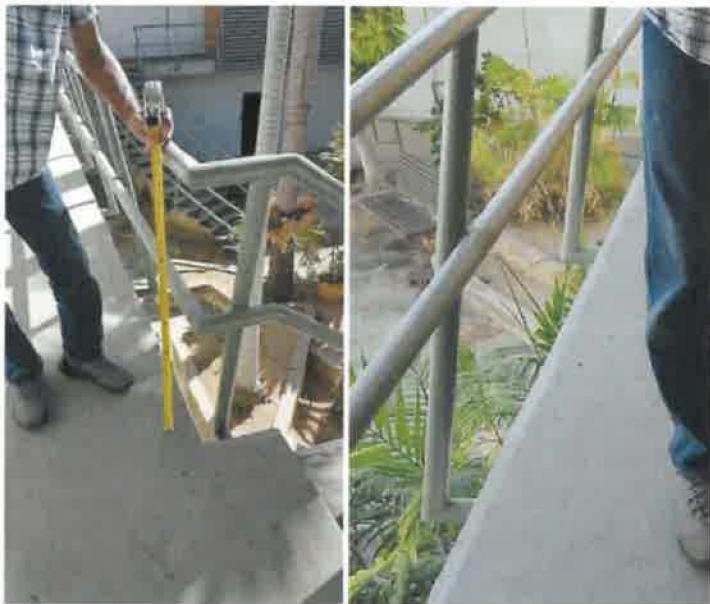
The second floor's balcony guardrail height is 32". This is not in compliance with CBC Section 1015.3 (Chapter 10). The handrail configuration does not offer the edge protection or a barrier at the balcony edge. **CBC Section 11B-405.9 or 11B-405.9.2 (handrail for ramp) may apply due to concern of the wheel entrapment.**

The balcony guard rail height and the lack of the edge protection.

The second-floor walkway and railing does not meet code requirements. In order to address this issue ramps will need to be added to the second floor walkway at four locations where there are steps. This modification will impact the existing railing height, the location of second floor entry doors. In addition, the railing not impacted by the ramp requirement is not to code either in height or the spacing of vertical members. The net result is that ramps will need to be added at four locations and all second floor and stair railings will need to be replaced.

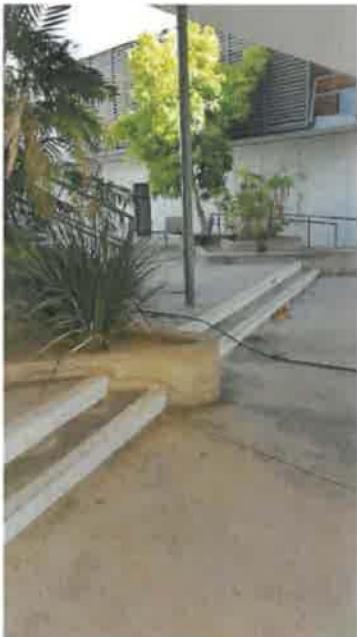
**The courtyard steps do not have handrails; therefore, the courtyard steps are not in compliance with CBC Section 11B-504.6.**

The courtyard steps have no handrails.

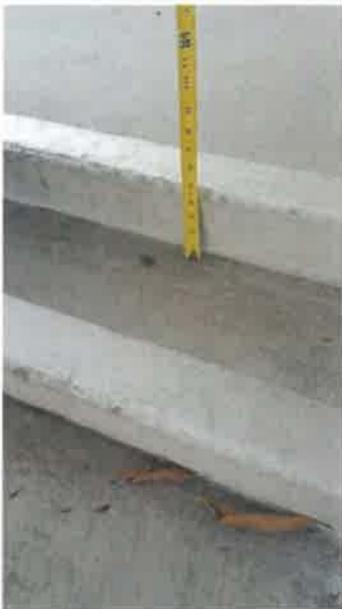
**The courtyard step's contrasting stripe is not in full compliance with CBC Section 11B-504.4.1.**

The contrasting stripe placed on both the treads and the risers, while only the treads require it.

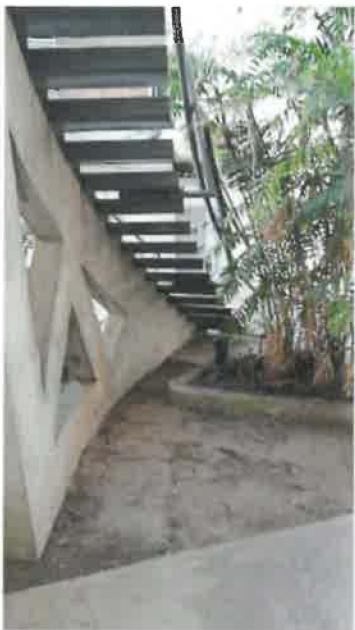
**A barrier shall be provided where the vertical clearance is less than 80" high, per CBC Section 11B-307.4.**

The space under one of the main stairs has less than 80" vertical clearance and does not have a barrier.

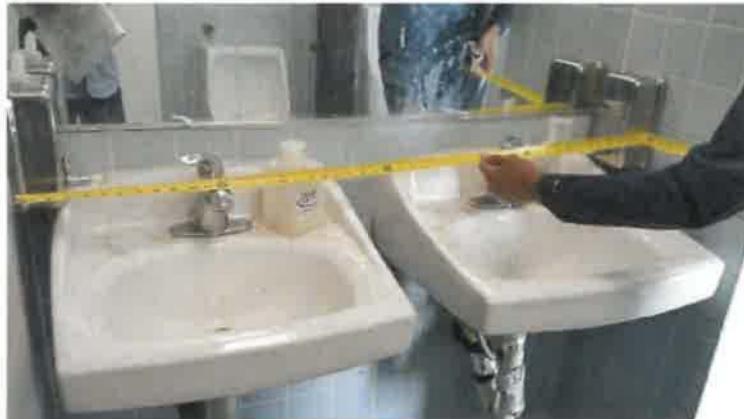
The first floor men's restroom lavatories do not have the required clearance from the adjacent wall to the center of the fixtures; therefore, it is not in compliance with CBC Section 11B-606.6.

The distance from the adjacent wall to the center of the fixture is only 12" for each lavatory.

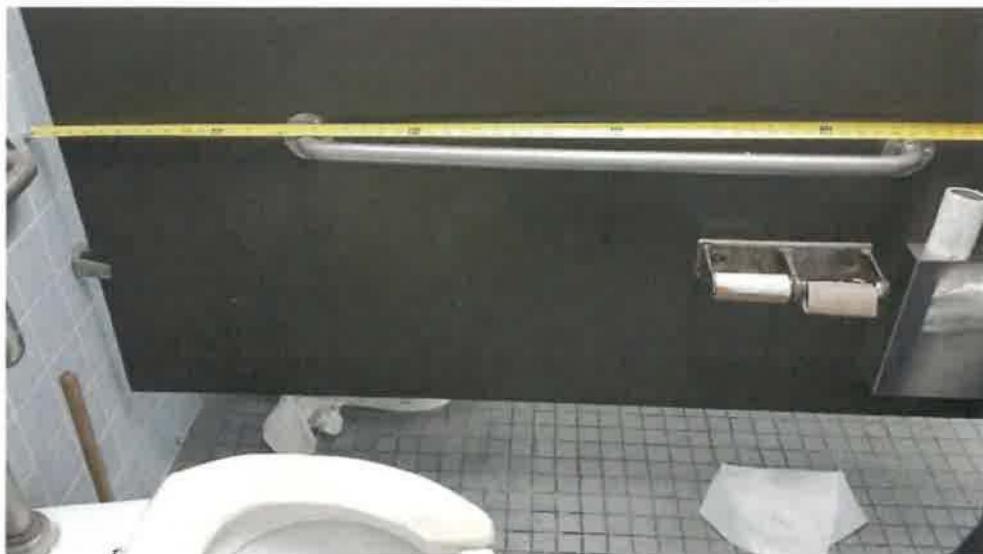
The side wall grab bar shall be 42" long minimum, located 12" maximum from the rear wall. The ADA stall side grab bar is not in compliance with CBC Section 11B-604.5.1.

The distance from the rear wall to the end of the grab bar is 17" and the grab bar length is 36".

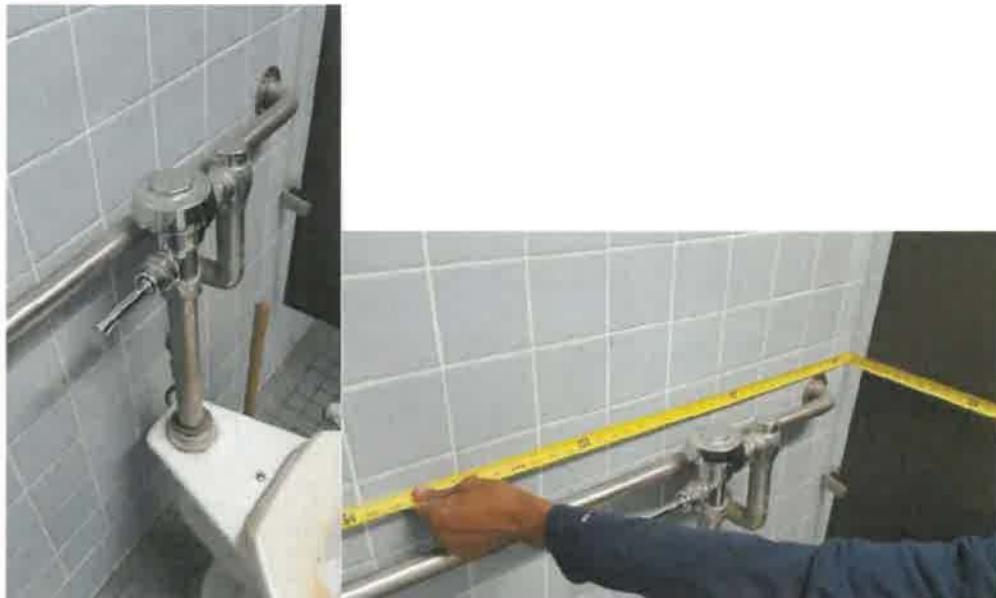
The rear wall grab bar shall be 36" long min and extend from the center line of the water closet 12" min on one side and 24" min on the other side. Exception 2: Where an administrative authority requires flush controls for the flush valves to be located in a position that conflicts with the location of the rear grab bar, then the rear grab bar shall be permitted to be split or shifted to the open side of the toilet. **The rear grab bar may conflict with the flush valve and is not located per CBC Section 11B-604.5.2.**

The rear grab bar is not split or shifted to the open side at the flush valve.

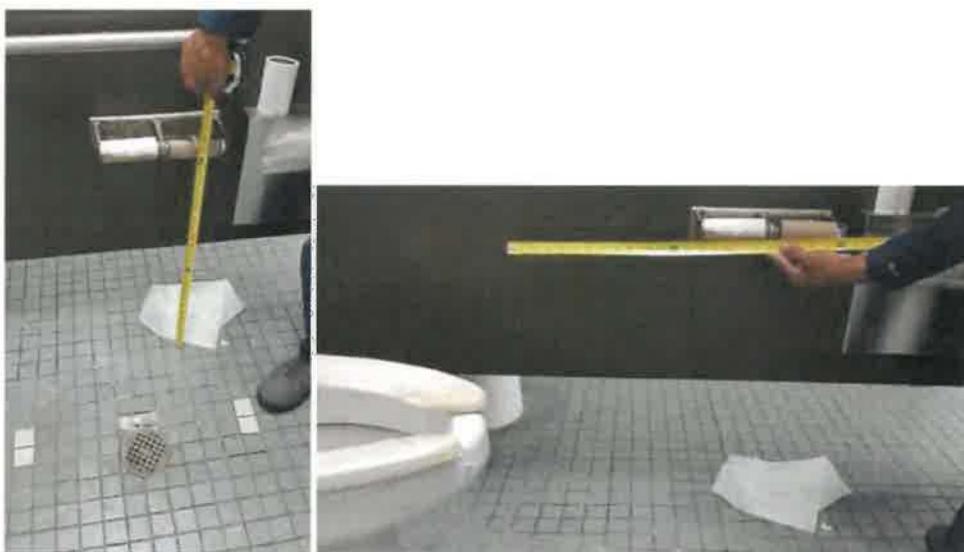
The toilet paper dispenser shall be 7" minimum and 9" maximum in the front of the water closet measured to the center line of the dispenser. The outlet of the dispenser shall be 14" minimum and 19" maximum above the finish floor. **The toilet paper dispenser mounting is not in compliance with CBC Section 11B-604.7.1.**

The toilet paper dispenser is 19" in front of the water closet and is 24" above floor at the outlet.

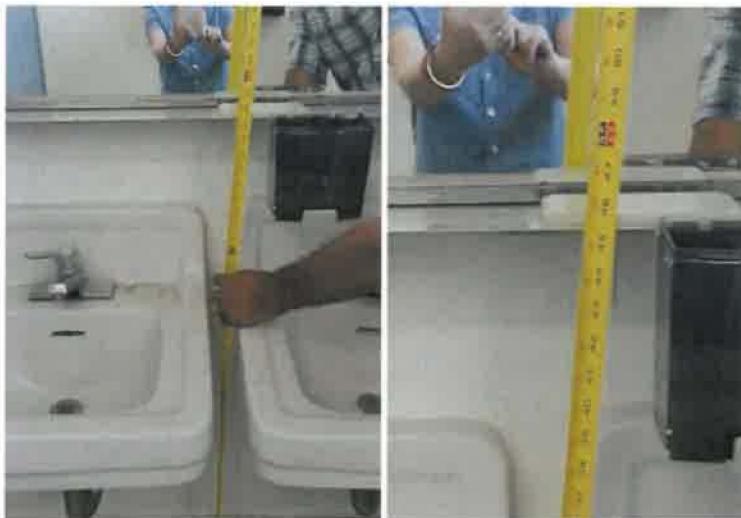
**The second floor women's restroom** (The only women's restroom on the site is not on an accessible floor).

The women's restroom lavatories are spaced close to each other and to the adjacent wall. The mirror height is more than 40" above the floor; therefore, it is not in compliance with CBC Section 11B-603.3.

The mirror height is 45" above the floor.

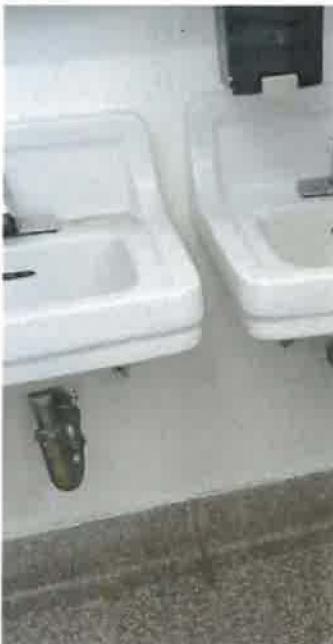
**The women's restroom water supply and the drain pipes under the lavatory are not insulated; therefore, it is not in compliance with CBC Section 11B-606.5.**

There is no insulation for the water supply and the drain pipes.

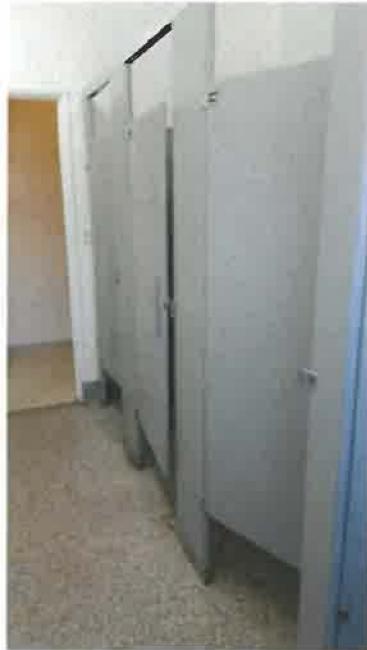
The second floor women's restroom has three regular stalls, no ADA stall or the minimum ADA clearance outside the stalls. **It is not in compliance with CBC Sections 11B-213.2 and 11B-603.2.**

There are three regular toilet stalls. There is no ADA stall or the minimum ADA clearance outside the stalls.

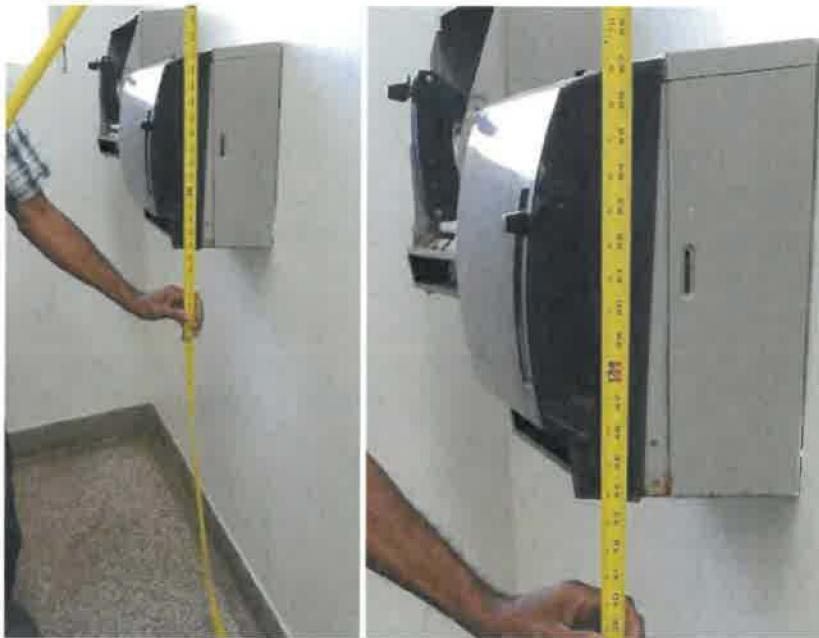
**The second floor women's paper towel dispenser has operable part higher than 40" above the floor; therefore, it is not in compliance with CBC Section 11B-603.5.**

The paper towel dispenser's highest operable part is at 53" above the floor.

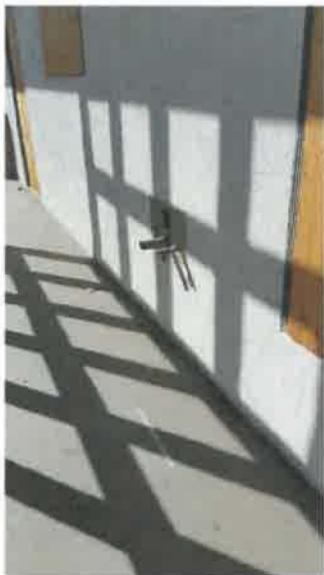
Currently, there is no drinking fountain on the site. The plumbing code requires drinking fountains. **CBC Section 11B-202.4 requires drinking fountains to be in the Accessible Path of Travel.**

A removed drinking fountain was spotted at the second floor balcony which is not accessible.

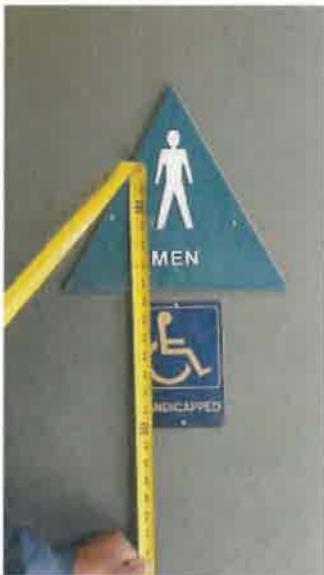
ISA should not contain HANDICAPPED letters. The door mounted triangular or the circular restroom sign normally does not have Braille letters. A tactile room sign should also be located alongside the door at the latch side. The Braille letters should be positioned on the room sign below the corresponding tactile letters. **The men's restroom sign is not in full compliance with CBC Section 11B-703.**

The ISA symbol does not contain the letter HANDICAPPED. The Braille letters should be on wall-mounted room sign.

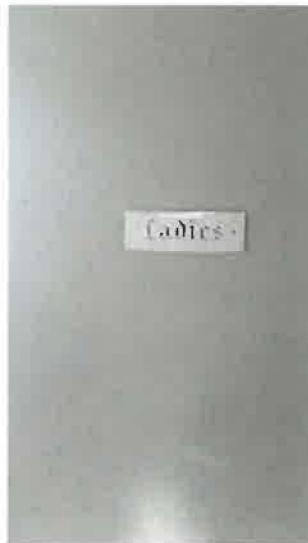
The women's restroom door sign commonly is a circle. A tactile room sign should also be located alongside the door at the latch side. The Braille letters should be positioned in the room sign below the corresponding tactile letters. **The original women's restroom sign does not comply with CBC Section 11B-703.** It may be preserved; however, an additional sign adjacent to the door should be provided to serve the visually impaired.

The original ladies' room sign is not the circular symbol nor a pictogram. It is not of raised characters and it does not contain Braille letters. It does not have a color contrast and the type is not San Serif.

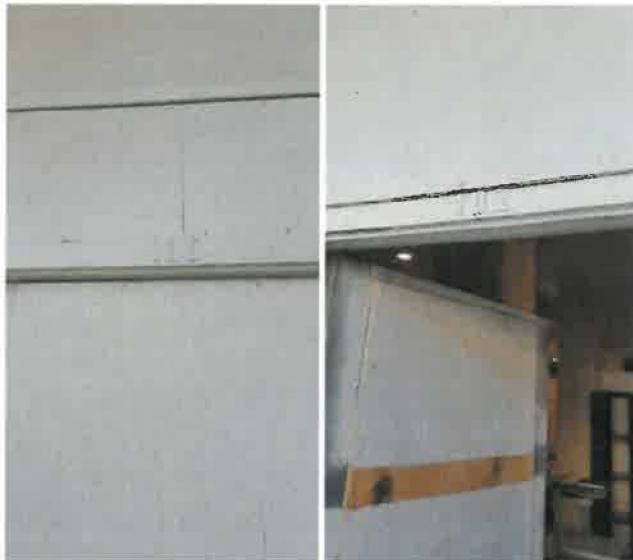
Under CBC Section 11B-703.4.1, the code required room sign should be centered at 60" above the floor and should be located next to a door. It requires a certain visual and tactile characters including a color contrast. These original suite numbers may not comply with the current code requirements.

The original suite numbers are mounted above the door and have a low color contrast.

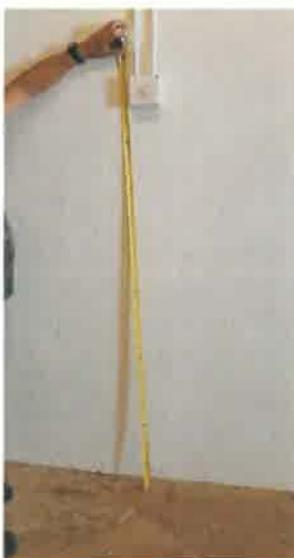
The electrical switches' mounting height should be 48" maximum. **Some of the switches are mounted too high to be in compliance with CBC Section 11B-308.1.**

A switch is mounted at 67" above the floor.

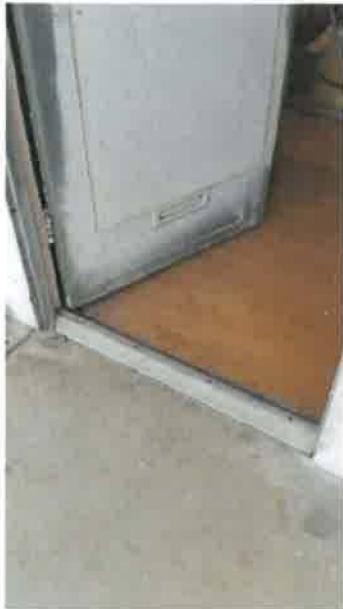
Mail boxes provide at least five percent, but none less than one of each type should comply with **CBC Section 11B-309**. Some of the original mail slots are mounted lower than 15" from the floor; therefore, they do not comply.

An original mail slot mounted at about 9" from the floor.

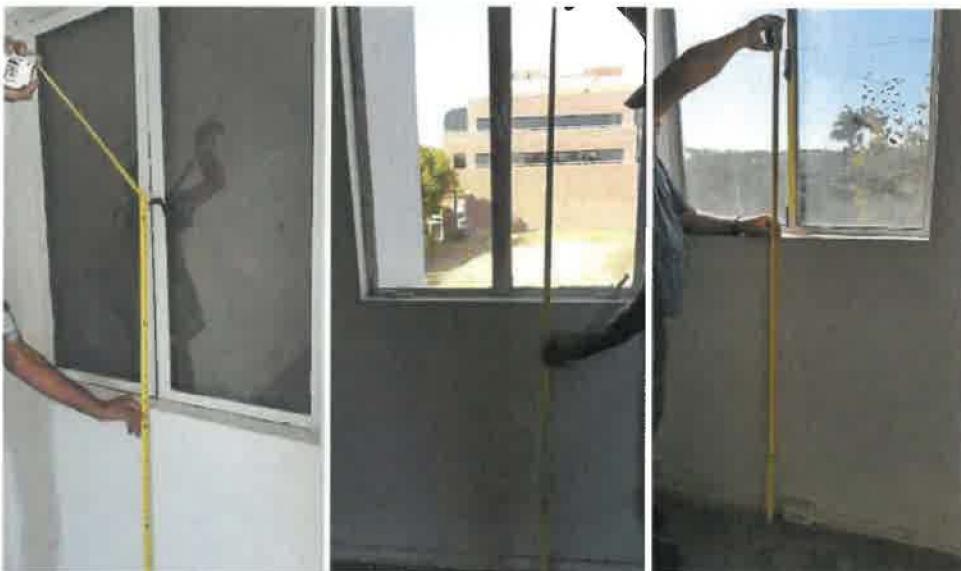
Per Section 11B-229.1, when glazed openings are provided at least one opening shall comply with **CBC Section 11B-309**. Almost all steel and wood window latches are mounted at more than 48" above the floor; therefore, latches are not in compliance.

Second floor steel window's latch is mounted at 62" above the floor.

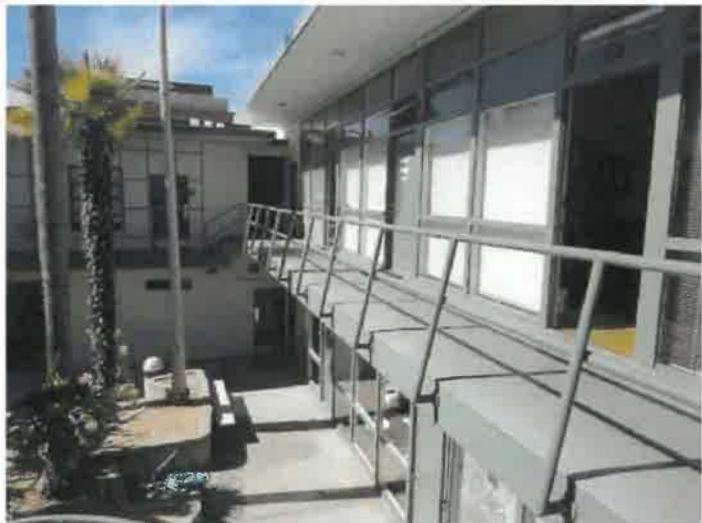
Most of the floor wood window's operable parts are mounted above the door height.
