## Arborist Report

2170-2172 Stanley Hills Drive  
Los Angeles, California

RE: **ARBORIST REPORT** – 2170-2172 Stanley Hills Drive, Los Angeles, California  
Proposed Lot Line Adjustment; Construction of 2 New Single Family Homes  
City of Los Angeles Tree Ordinance No. 186873

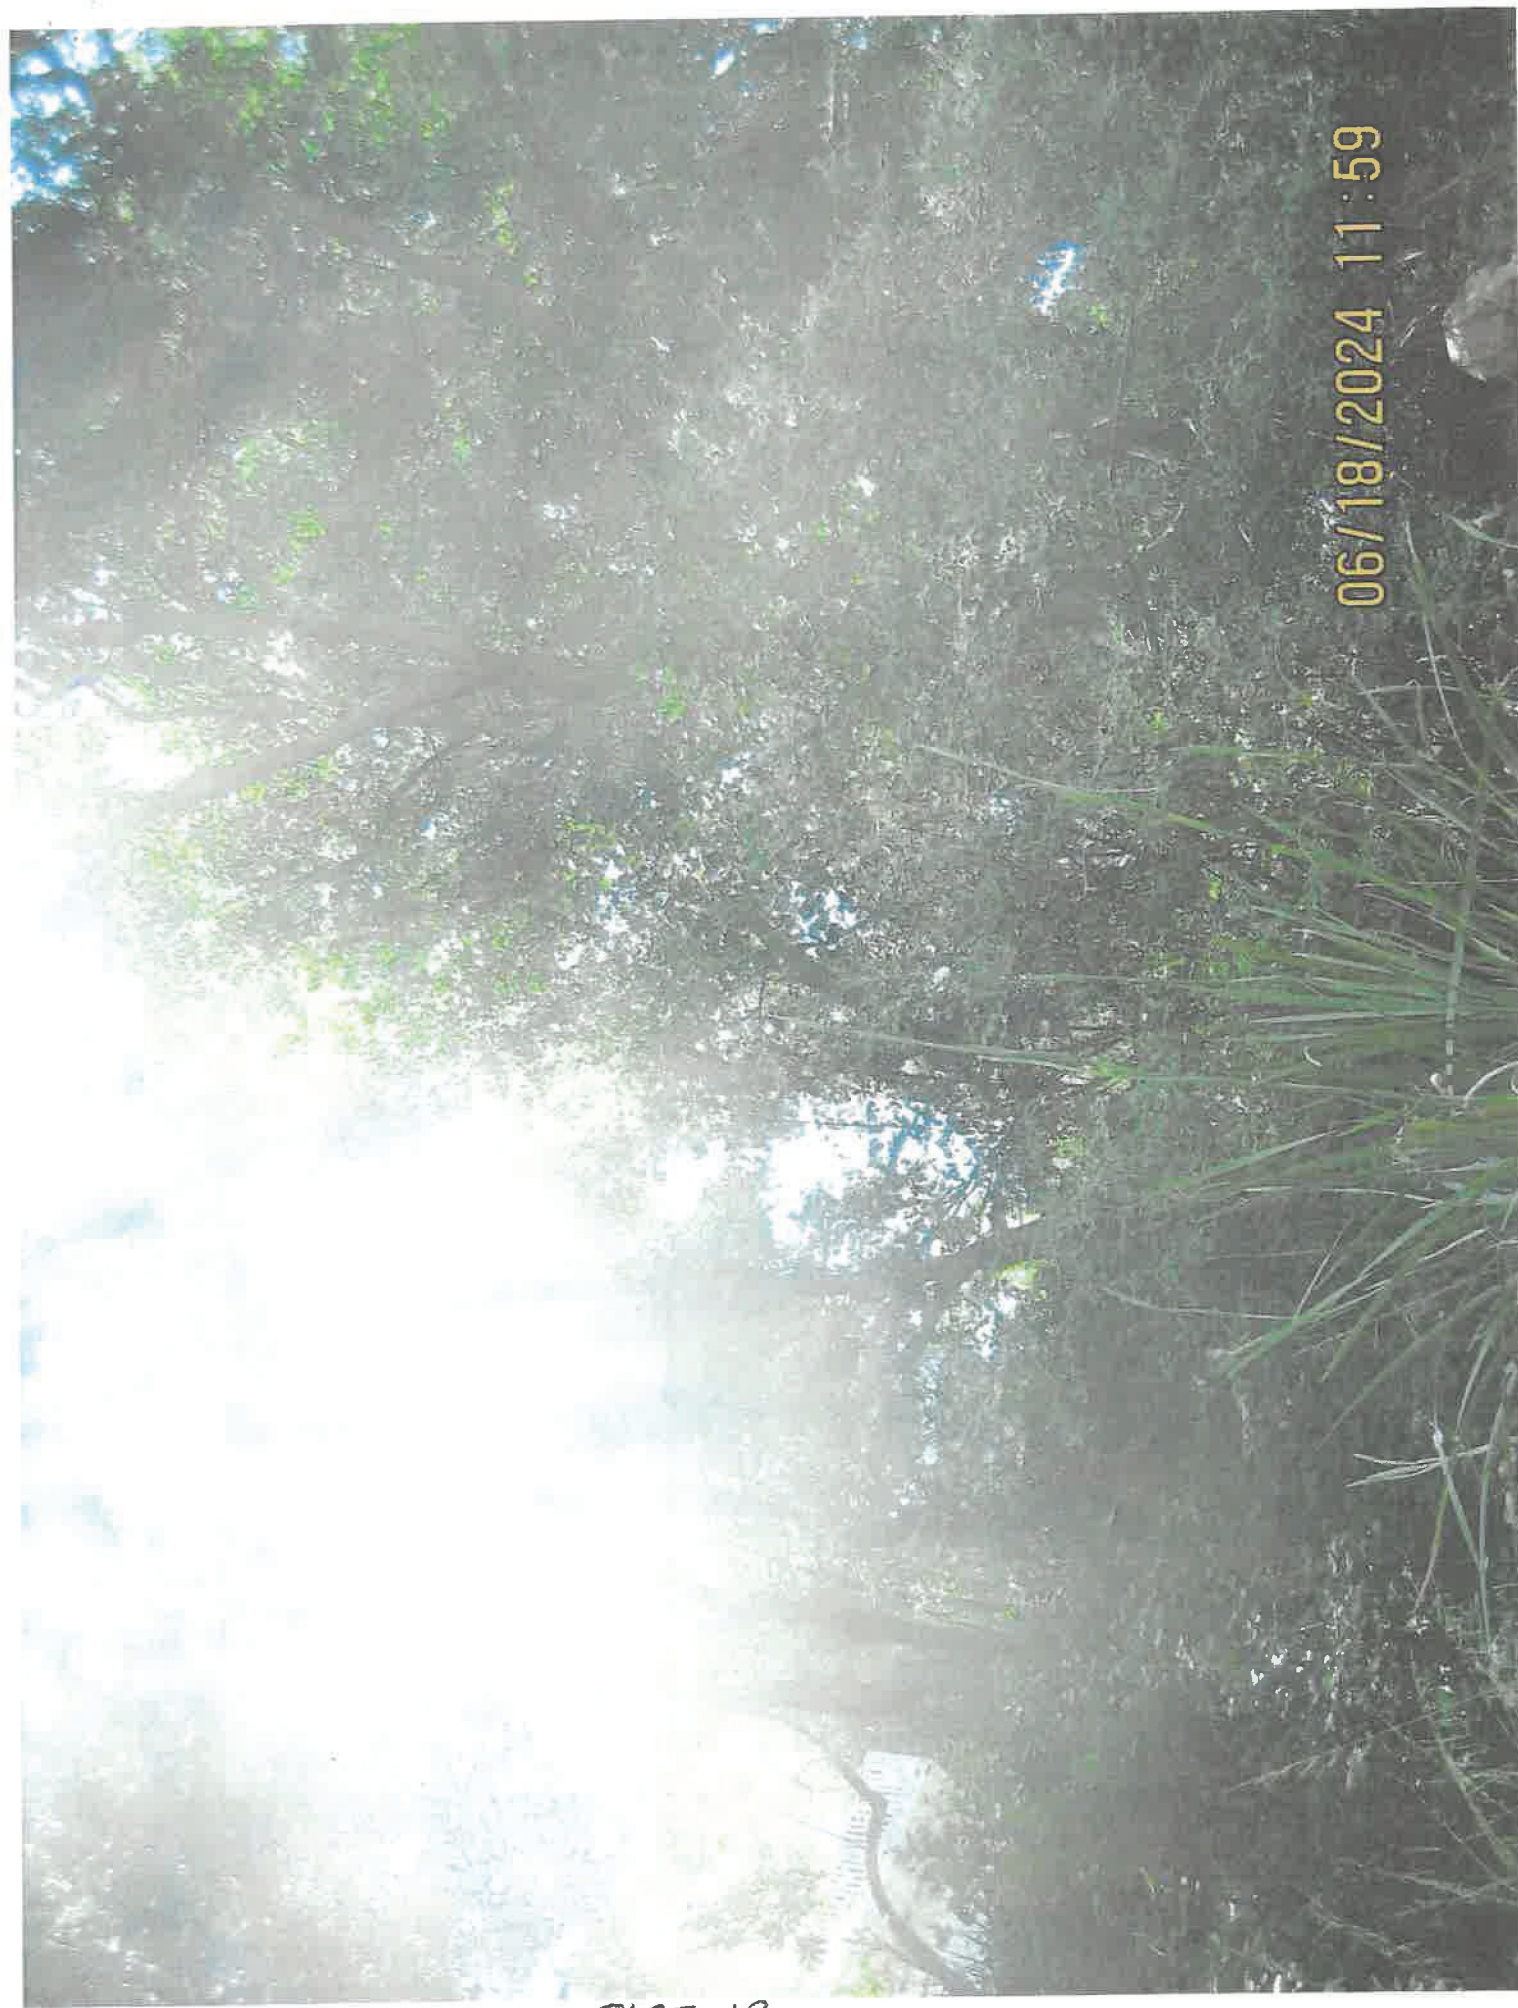
TREE # 10

**Tree #10** is a Quercus agrifolia or Coast Live Oak. The tree measures 12 inches in diameter at D.B.H. The tree has a dripline which measures 12 feet from the tree trunk and it has a 24 foot spread. It is estimated to be roughly 30 feet tall. The tree is located uphill, east of Tree #9 on a Poison Oak covered slope. The crown has been pruned and raised. The tree is balanced. It is crowded by other trees. The foliage size and color appear normal. The density is normal. The tree is in below average health and condition. Rating: B-
