INTERDEPARTMENTAL CORRESPONDENCE  
LOS ANGELES HARBOR DEPARTMENT  
ENGINEERING DIVISION  
425 S. Palos Verdes Street  
San Pedro, CA 90733-0151

**SUBJECT: COMPLIANCE WITH ENVIRONMENTALLY PREFERABLE PURCHASING POLICY (C.F. # 13-0600-S109)**

Attachment 1: City of Los Angeles Harbor Department Sidewalk Survey Map

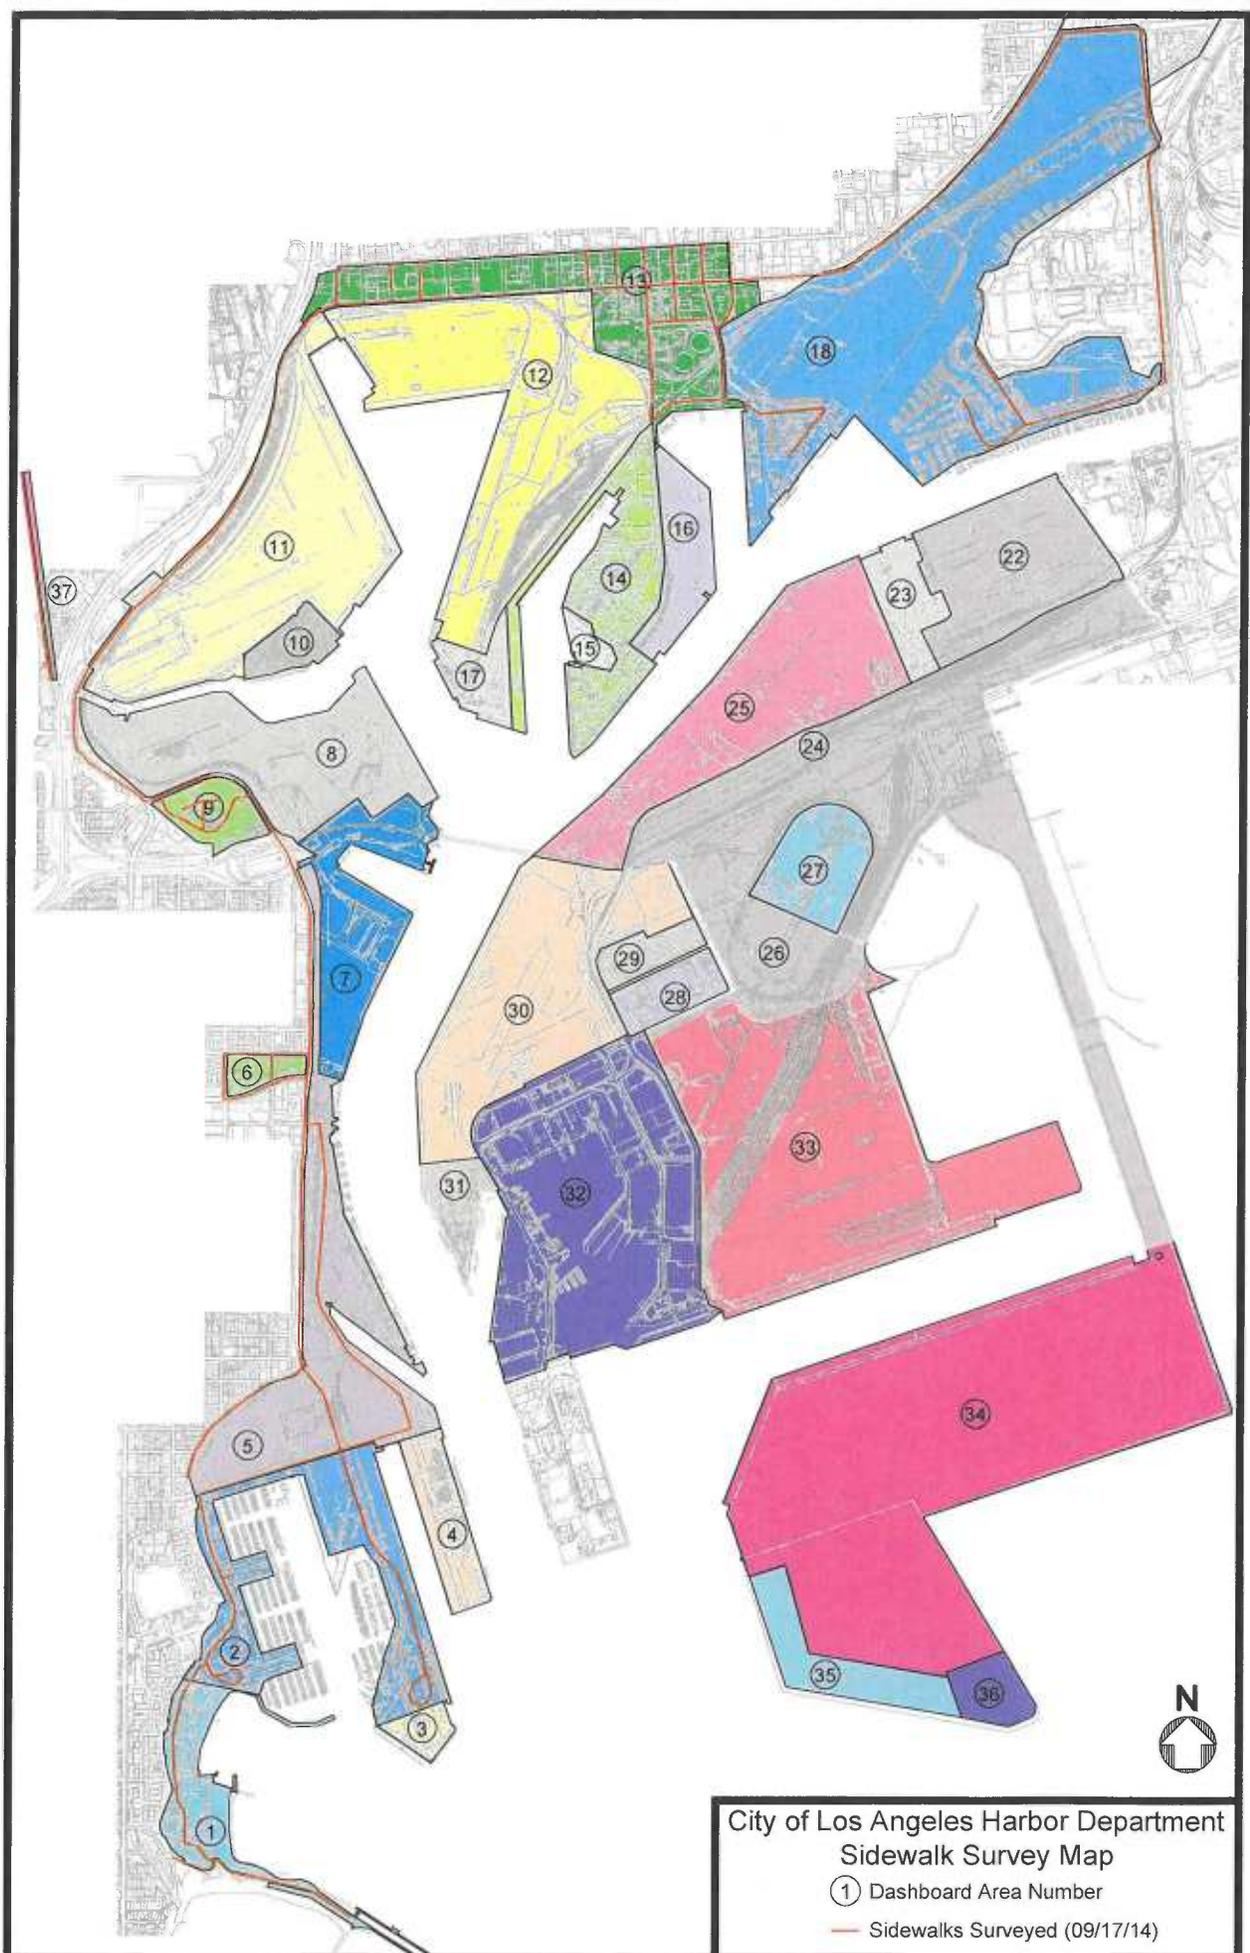
In September of 2014 nine two-person teams surveyed a total of 17.5 miles of streets adjacent to Harbor Department facilities in the communities of San Pedro and Wilmington, as shown on the attached map. Both sides of the streets were surveyed for damage or other obstructions that would affect pedestrian access. Sidewalks adjacent to Harbor Department property on Terminal Island have not yet been surveyed, due to the general lack of pedestrian traffic in the entirely industrial area, but will be surveyed by the end of 2014. Results for the approximately 35 miles of sidewalks surveyed are summarized below:

City of Los Angeles Harbor Department  
 Sidewalk Survey Map  
 ① Dashboard Area Number  
 — Sidewalks Surveyed (09/17/14)
