# **Street Damage Restoration Fee Study**

## **Testing Portion**

**City of Los Angeles**

**Test Report of  
Los Angeles Street Damage Restoration Fee (SDRF) Update Study**

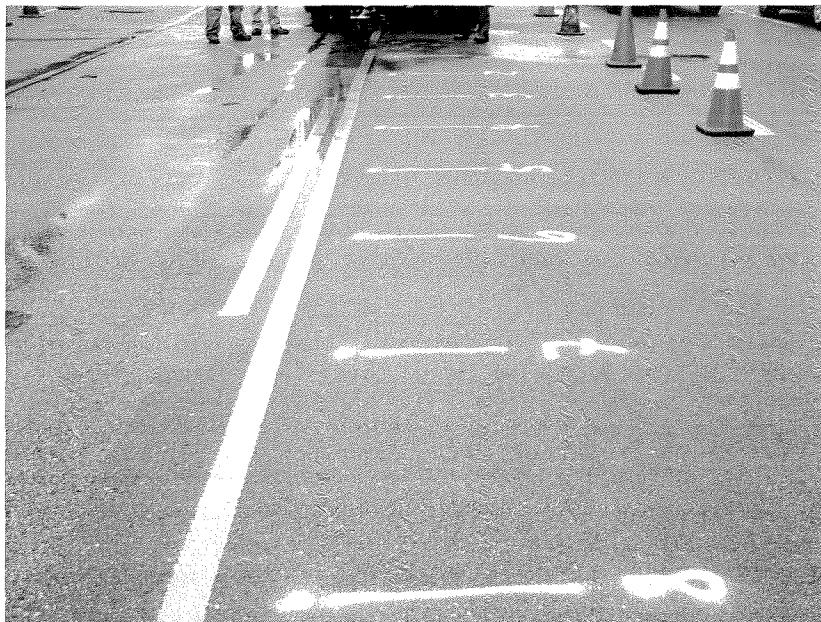
**Figure 3:** Shows FWD to be measured in a control area with consistent Asphalt thickness structure.
