Cover Note from Pico Robertson Coalition with appended documents on the West Pico Drill Site Pipeline Leak and Spill: Documents from PCEC and CalGEM, December 2021 to January 2022.

**Re: SPILL/INCIDENT, PACIFIC COAST ENERGY COMPANY LEASE, BEVERLY HILLS FIELD
VIOLATION I.D. 12242781**

December 11, 2021 Incident Root Cause Analysis:

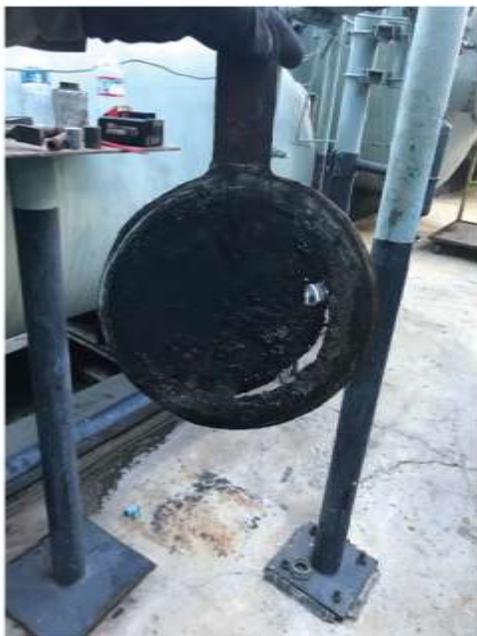
- The slip blinds have protruding handles to aid in installation and removal because slip blinds are meant for short-term use to temporarily isolate a section of pipeline for maintenance work. Here is a photo of the slip blind that played a role in the leak and spill (photo from the CalGEM inspection report submitted to the Council File on 5/4/22) and an image from a slip blind manufacturer. The point is that the handle protrudes from the pipeline:

Figure 12. This picture shows the corroded blind slip that was the root cause of fluid entering the out of service pipeline that is buried near surface expression of the leak in the alley.

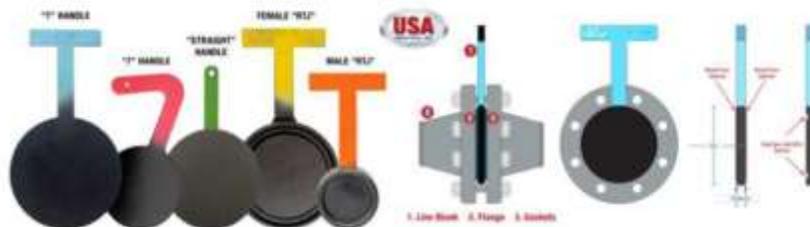
- For 20 years the protruding handles of the slip blinds stuck out from the pipelines in the large open-air vault shown in the photo PCEC attached to its January 10 “Root Cause” report. The protruding handles were red flags that the drill site operator and crew ignored for 20 years.

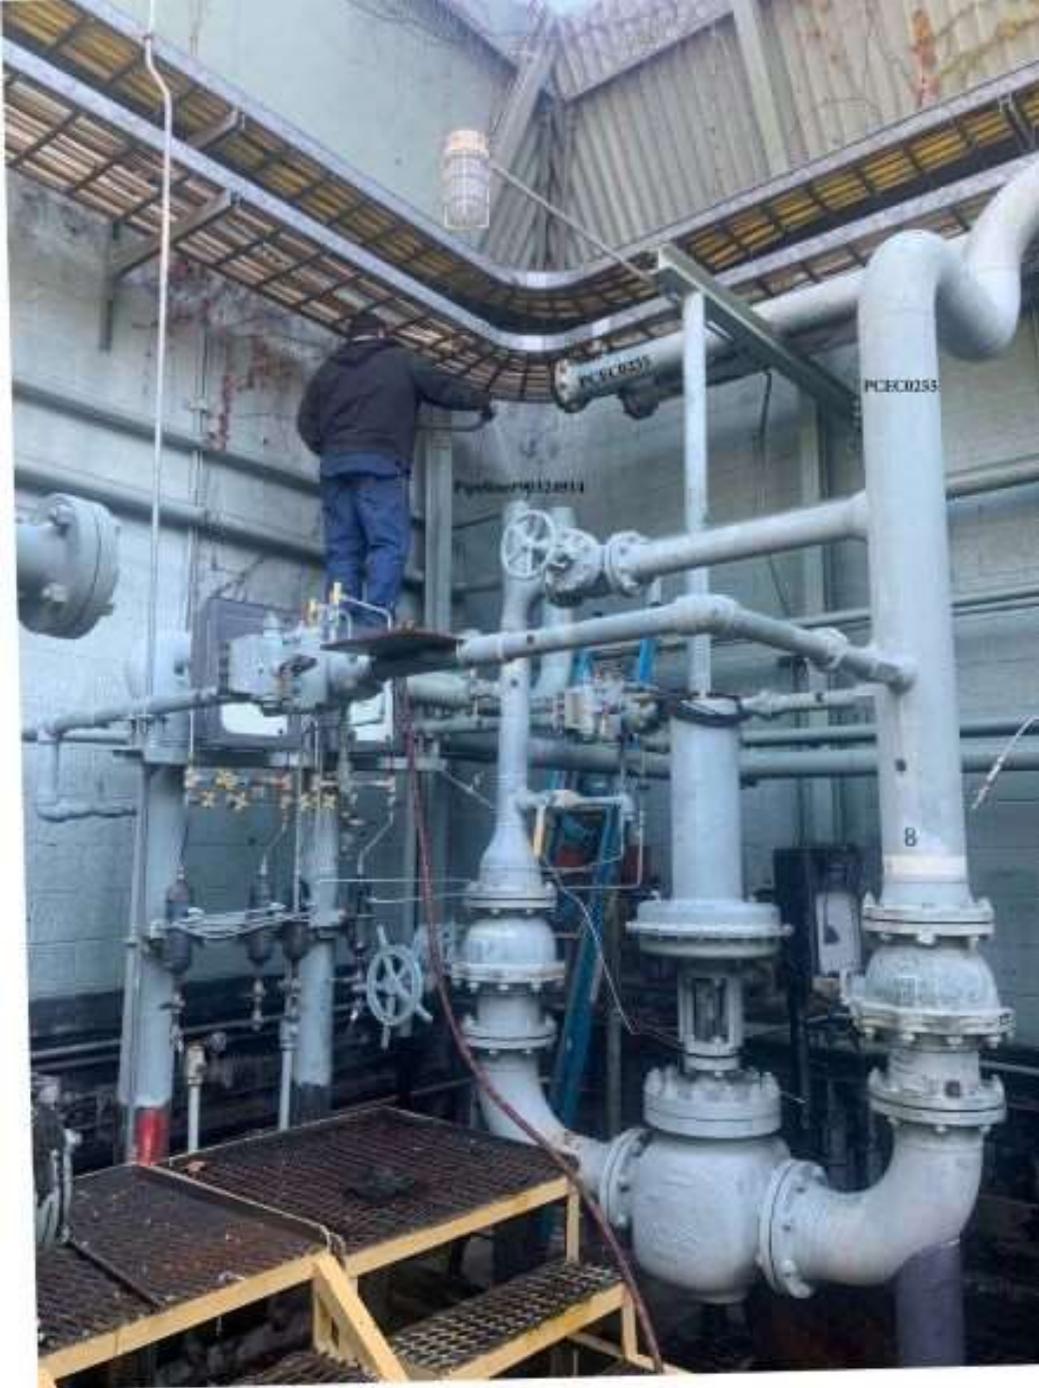
- Last, please look at the photo of the open-air pipeline vault that PCEC attached to its January 10 “Root Cause” report.
 - The size of the vault and the easy visibility of the pipelines are significant.

- This vault is where the illegal slip blinds were installed and were left in place for 20 years (duration admitted by PCEC in their testimony to LA County FD and in later communications with CalGEM and the City Zoning Administrator).

Prior to returning West Pico Facility to service, pipeline # 90324914 and the adjacent pipeline had sections of pipe removed and blank flanges installed on pipeline #PCEC0225 to permanently isolate and prevent future occurrences from these out of service pipelines. (see attached picture).
