# Southwest Museum Rehabilitation Study

Phase I Planning

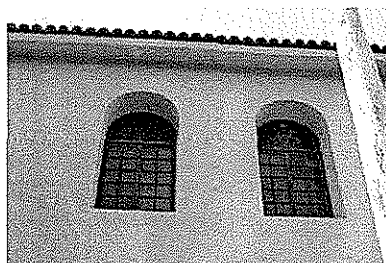
HR004 - South elevation of main building; original windows at West End

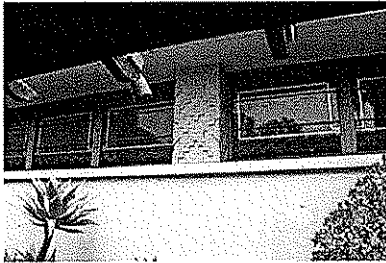
HR037 - Poole Wing: ornamental pilasters

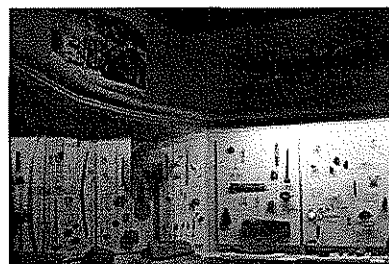
HR038 - Poole Wing original display cases in California Hall

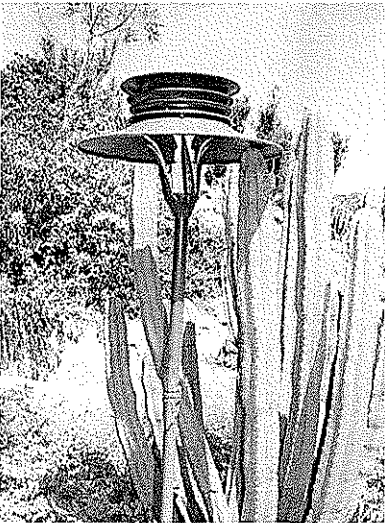
HR041 - Historic site lighting fixture

Lighting fixtures along the steps leading to the Museum buildings from the parking lot appear to have been added to the site during the Poole Wing addition by Gordon B. Kaufmann and therefore are considered significant. A cannon was placed on the Entrance Terrace in the 1930's, and a flag was added nearby in 1966, providing a meeting space for visitors along the Main Building's south elevation. Both are from the Museum's artifact collection. (See photos HR041 and HR042).

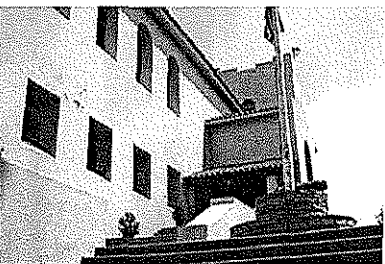
HR042 - Cannon & flagpole on south entry terrace

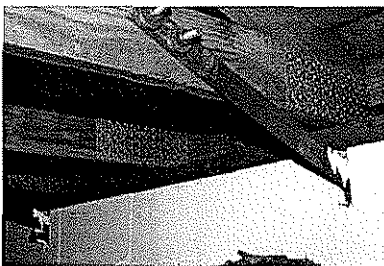
The lateral force resisting system is provided by the stiffness of the exterior reinforced masonry shear walls in both the longitudinal and transverse directions. The plywood sheathing at the roof and concrete topping at the elevated floors function as load distributing horizontal diaphragms. The transfer of lateral loads from the roof diaphragm to the walls is accomplished by nailing the sheathing to continuous wood nailers bolted to the tops of the walls. The transfer of lateral loads from the floor diaphragm to the walls is accomplished by dowels. The transfer of lateral loads from the walls to the foundation system is also accomplished by dowels. Positive wall anchorage between the walls and roof framing was detailed on the plans and observed during the site visits (see photos S005 and S006). This connection is not adequate for the expected loads and repair is proposed.

S006 - Braun Library: roof connection detail

Section D/6 of the Glenn E. Cook drawings shows the typical positive wall anchorage at the roof. As drawn this anchorage has three load path deficiencies that limit its capacity:

- Reliance on the 1/8-inch plate to transfer loads from the wall to the roof truss by compression.
- Reliance on (2) 5/8-inch diameter machine bolts to transfer loads from the plate to the bottom chord of the typical roof truss.
- Reliance on the truss bottom chord, panel point connections, and web members to transfer loads from the truss to the plywood diaphragm. *Photographs S005 and S006* show the as-built deficiencies of the positive wall anchorage along the south wall observed during the site visits.
